July 2018
GEF/DAS.01

Design and Access Statement

Proposed Development at:

**Green End Farm
Green End
Goathland
North Yorkshire
YO22 5LQ**

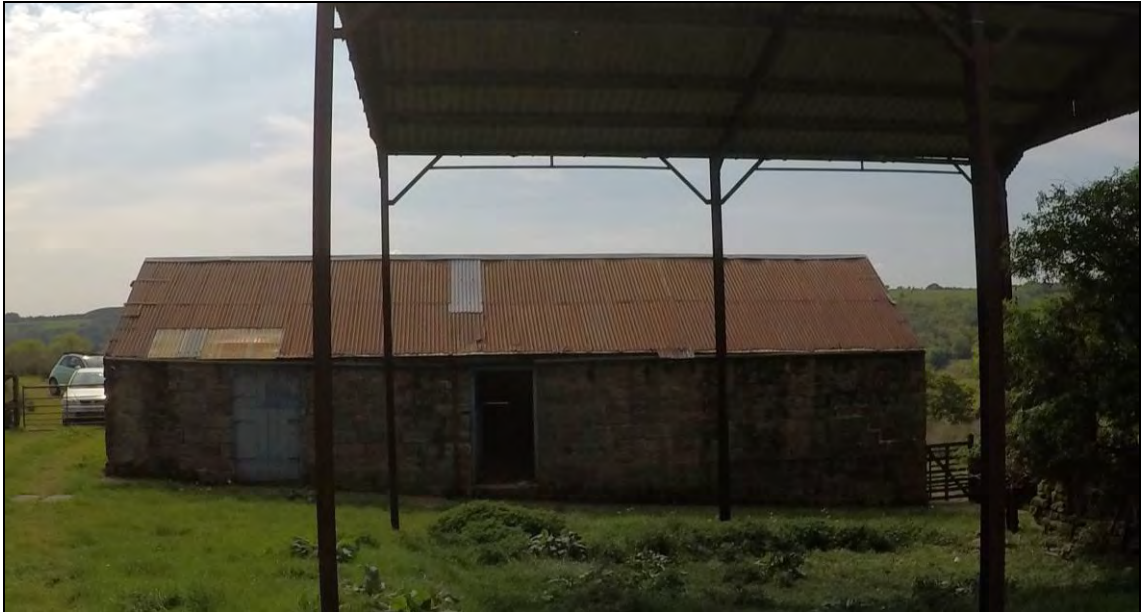
Figure 6: Existing photograph of Barn 1 front elevation / east side

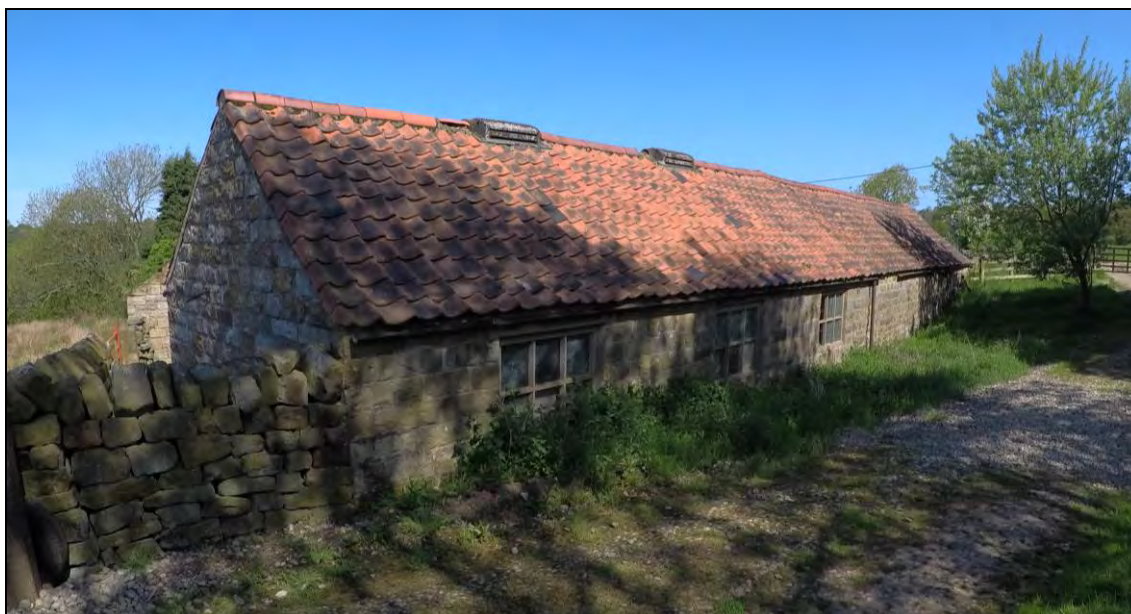
Figure 8: Existing photograph of Barn 2 rear elevation / south side (note: ground level built up against back wall and existing vehicular track passing towards proposed car parking corral beyond)

Remaining vehicular traffic, including the Applicant's own cars, will access the proposed car parking corral via a gateway and drive to the south side of Barn 2. There is currently an existing gated access here for agricultural vehicles, which is also used to provide access for the public footpath that crosses the application site. However, the position of this gate is hard up against the southern corner of the barn, causing the ground levels to be built up approximately 1m against the barn walls. In order to safeguard the barn and prevent damp ingress, it is proposed to move the access over, to allow the ground levels behind to be banked down to the rear wall of the barn. On looking at the dry stone wall in which this gated access is located, it is apparent that the gate has previously been moved over to its current position. When viewed from the common land, the left hand gate post (up against the barn) is concrete; the right hand one is stone, but back to front in terms of its profile. To the right of the stone post are two infill panels of dry stone walling, the width of the access, with clean cut vertical joints in the wall where a corresponding post would previously have been. The proposal is therefore to reinstate the gateway to its former position.

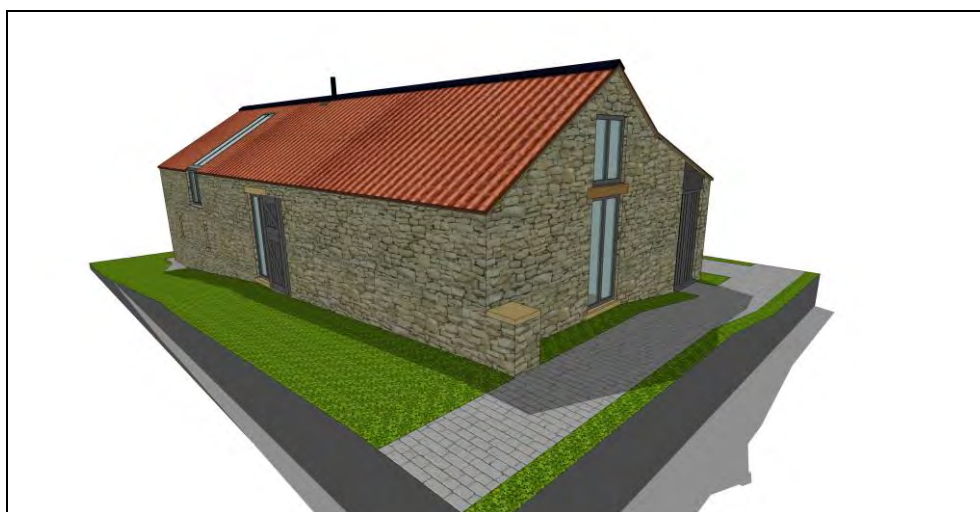
Figure 10: Sketchup model of proposed Barn 1, viewed from south-west

The corrugated roof will be replaced with a new pantile clad roof with angled blue / black ridge tiles, with large steel framed rooflights as shown on the drawings, two to the east slope and one to the west, as part of a rooflight / window combination in the position of an existing high level hay loft loading door.

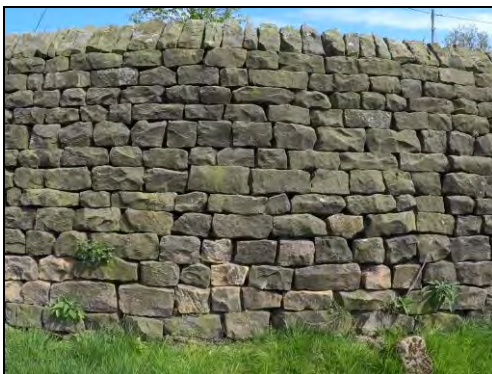
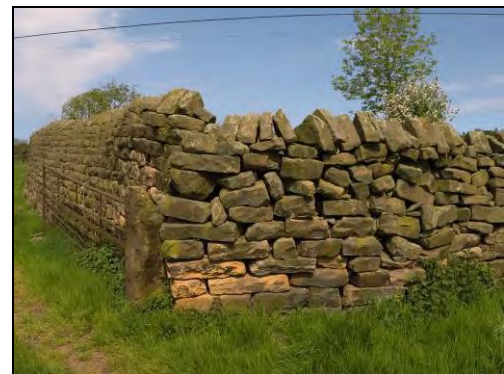
Figures 17 & 18: Existing drystone walls to corral to be retained; where wall is in deteriorated / partially collapsed state, wall to be reinstated, with some realignment as noted

Existing drystone walls will be retained, though a portion of the partially collapsed wall enclosing the existing corral to the east of the courtyard will be reconstructed on a new alignment, to open up views from Barn 2 (see figure 18 below). Similarly, to the east side of the corral the existing wall is also partially collapsed, and will be reconstructed on the same alignment with a new opening to allow vehicular access.

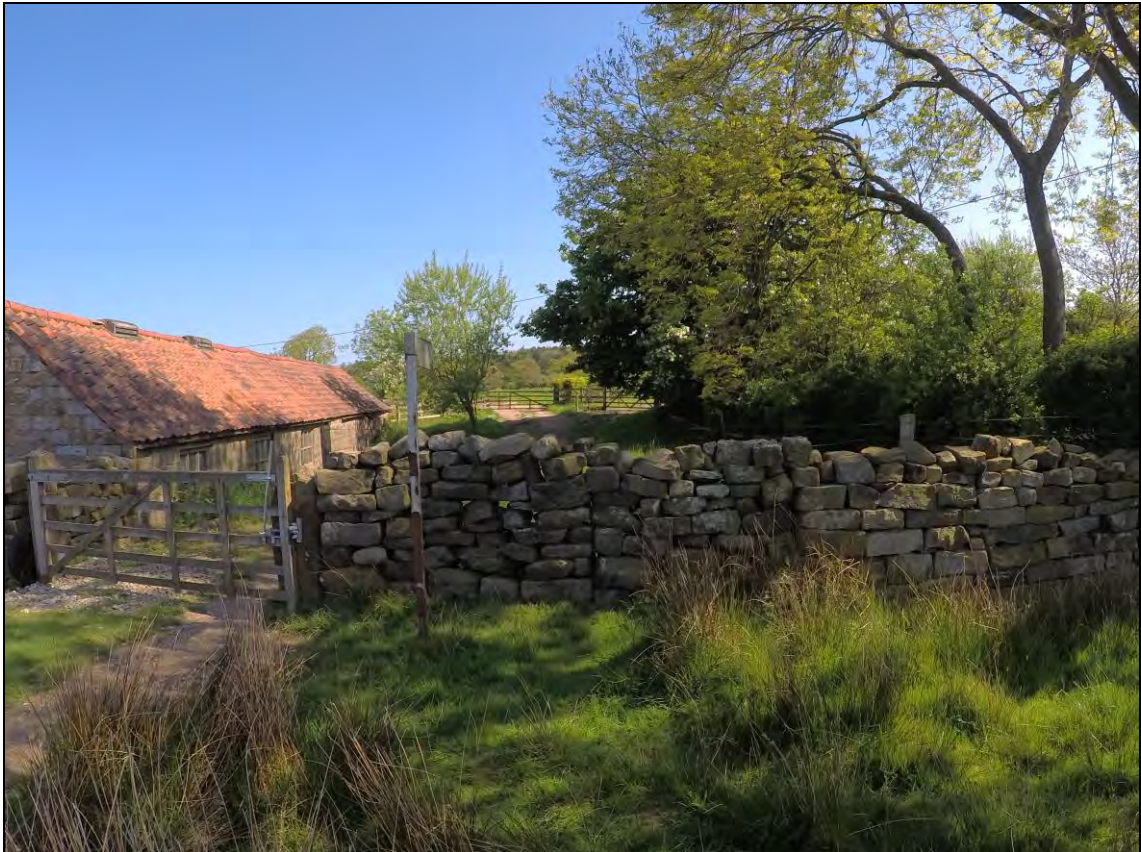
Figure 20: Existing gated access to south of Barn 2. Concrete post can be seen to left hand side; stone post to the right has cut, dressed face to right hand side, indicating it previously would have stood as the left hand post...furthermore, two stages of infill of a previous opening can be seen in the stonework to the right

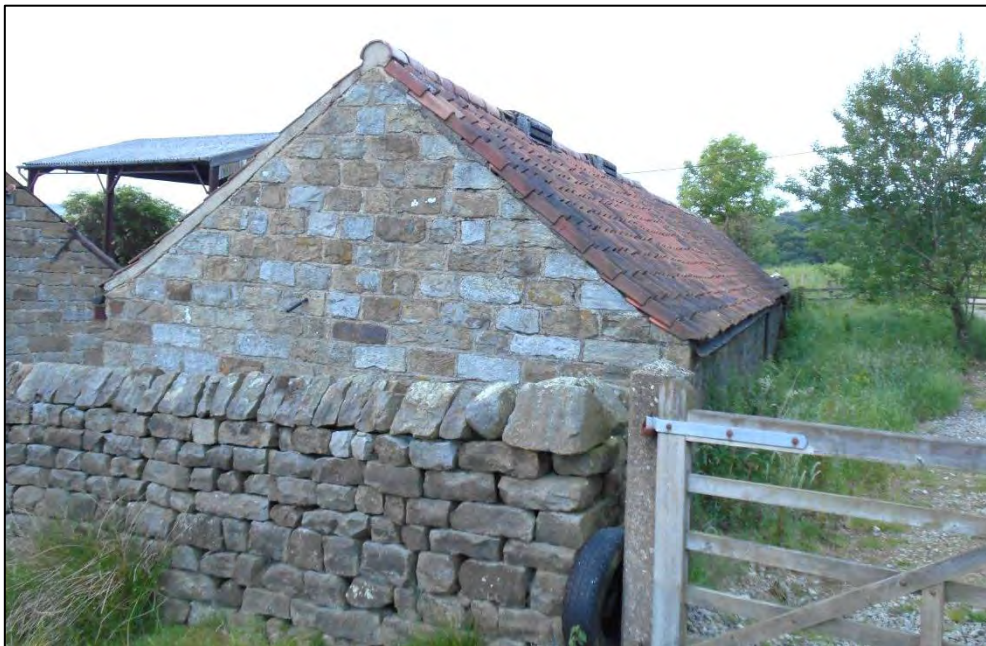
Figure 7: West end and south side

Building 1 is a single-storey barn along the south side of the site. The building is sunk into the hillside such that the lower part of the south wall is below ground level. The eastern half of the building is open fronted on the north side. The pantile roof of that section is lined with underfelt. The western half of the building comprises three rooms, all fitted with doors on the north side. The roof of the western half is of pantiles, with wooden laths on the underside. There are gaps between many of the pantiles of a sufficient size to permit the passage of bats. There are also raised vents on the ridge of the roof which have gaps at the base. The walls are of stone, with some gaps in the pointing.

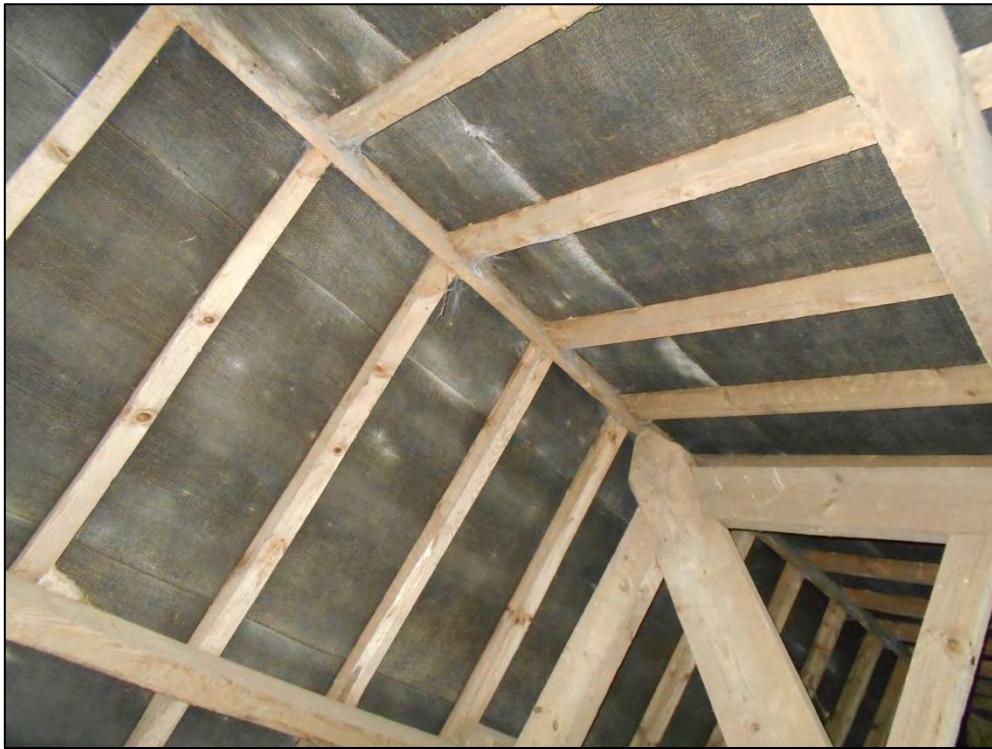
Figure 10: Underside of roof of eastern part of the building

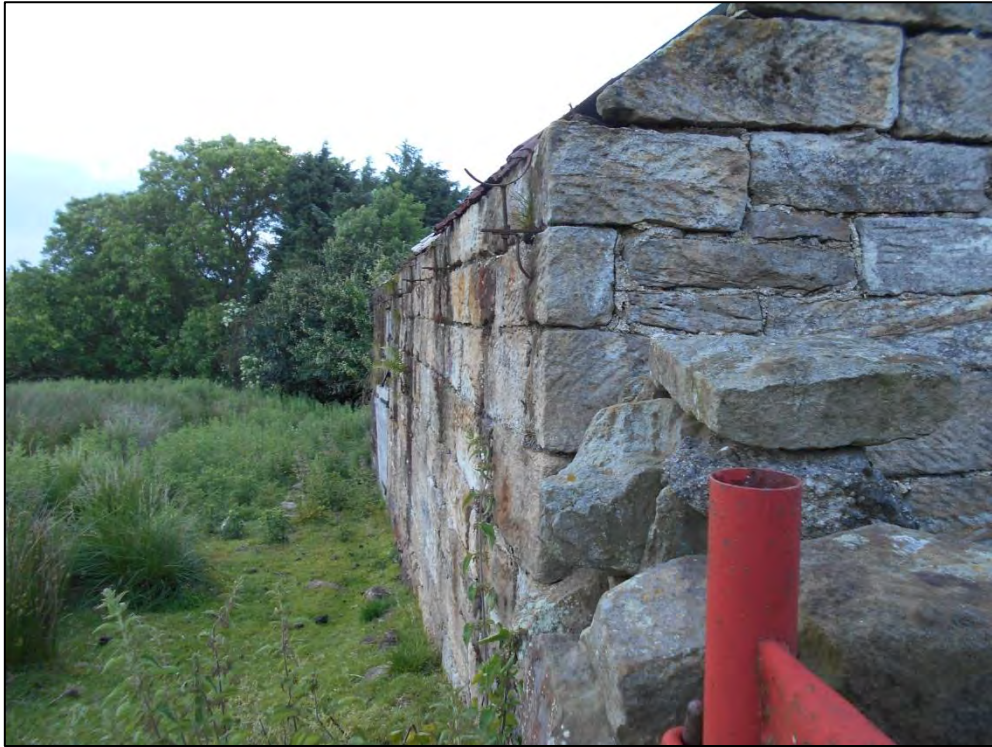
Figure 13: South-west corner showing gaps in exterior pointing

This building is a single-storey stone barn, divided into two rooms accessed via doors in the east side. There are numerous crevices in the exterior wall-pointing. The roof is of unlined corrugated metal sheeting. The interior walls are partially whitewashed. There are gaps around doors, at the wall tops and between the corrugated roofing sheets. There is a 'sparrow-terrace' nest box on the exterior north wall.

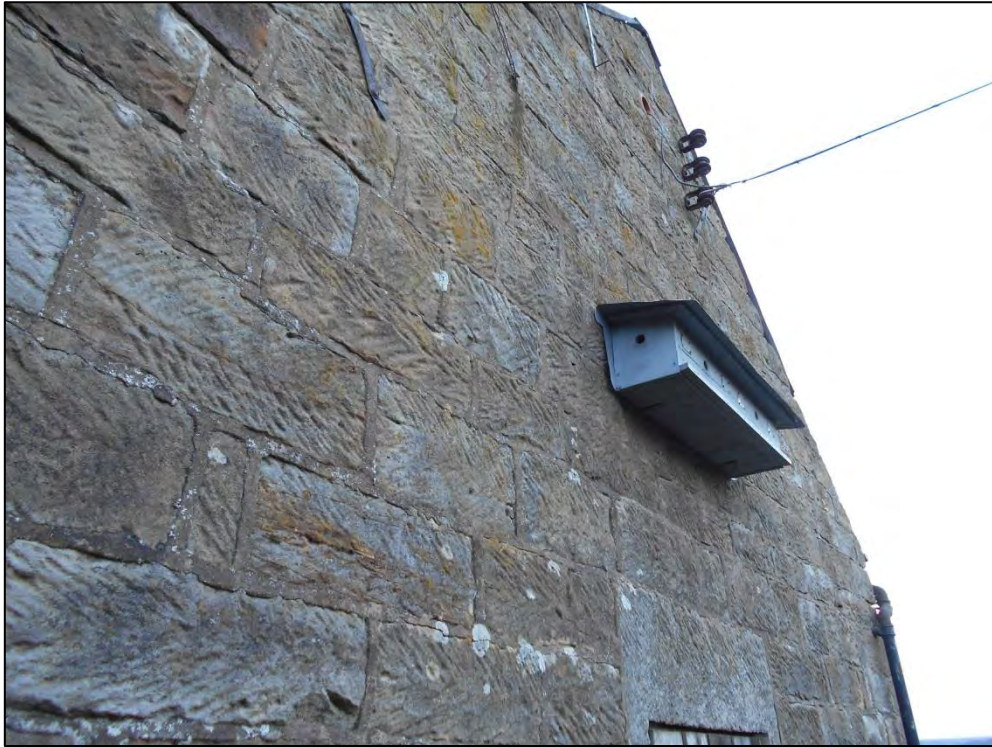
Figure 15: North gable end wall and sparrow terrace

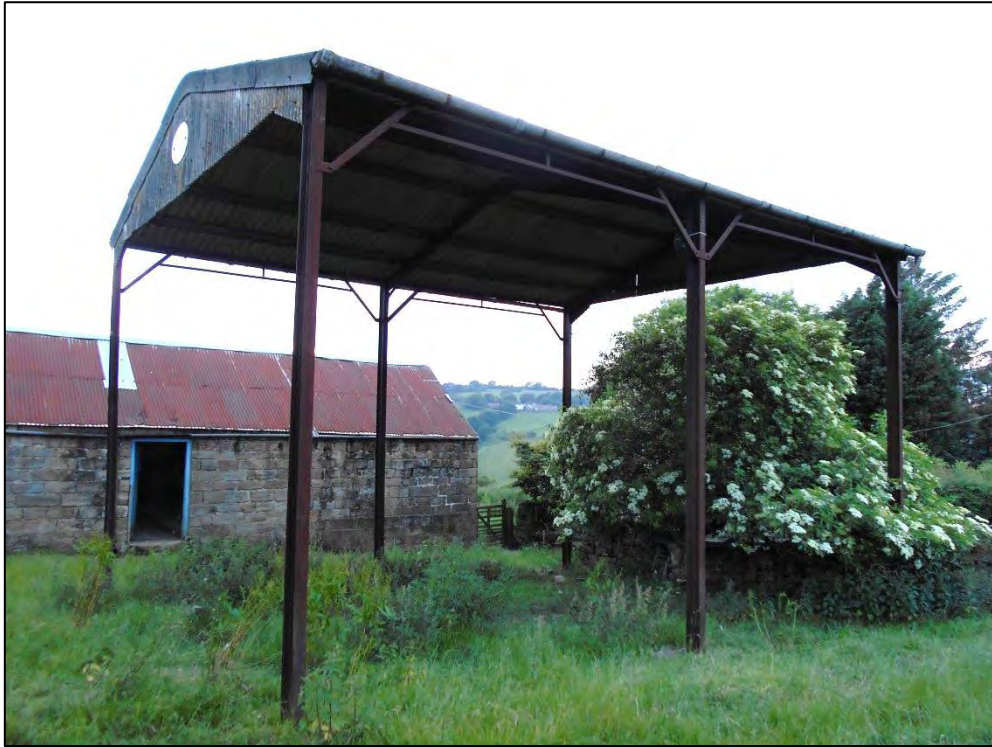
An open-sided Dutch Barn with a corrugated sheet canopy supported on a metal frame.

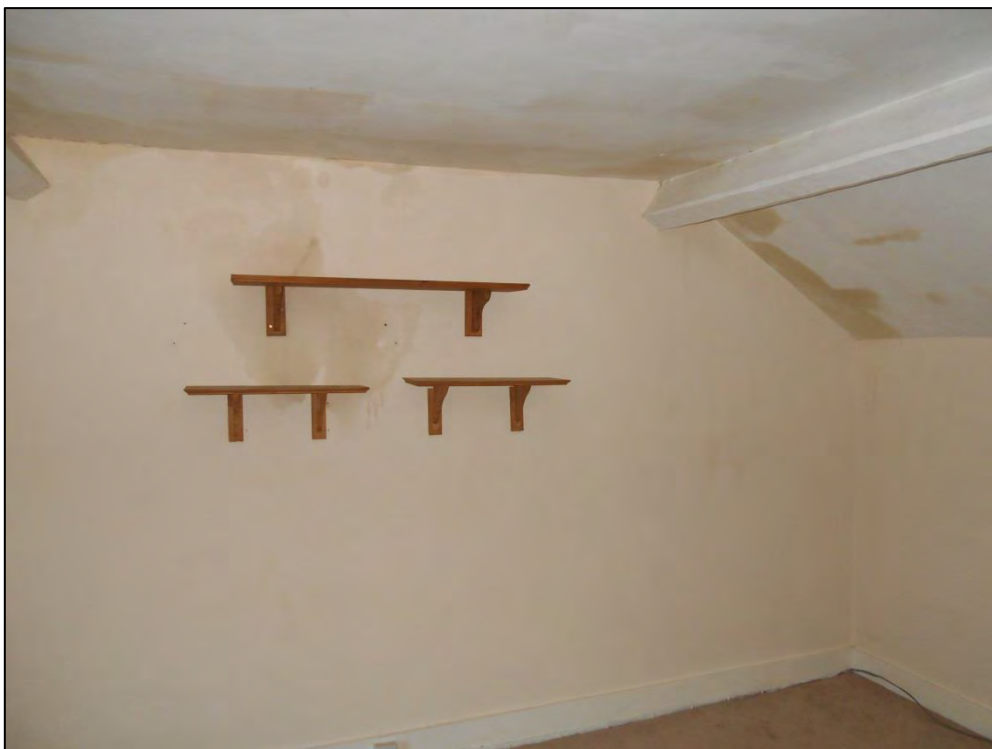
Figure 23: Interior of first floor of house showing absence of roof void

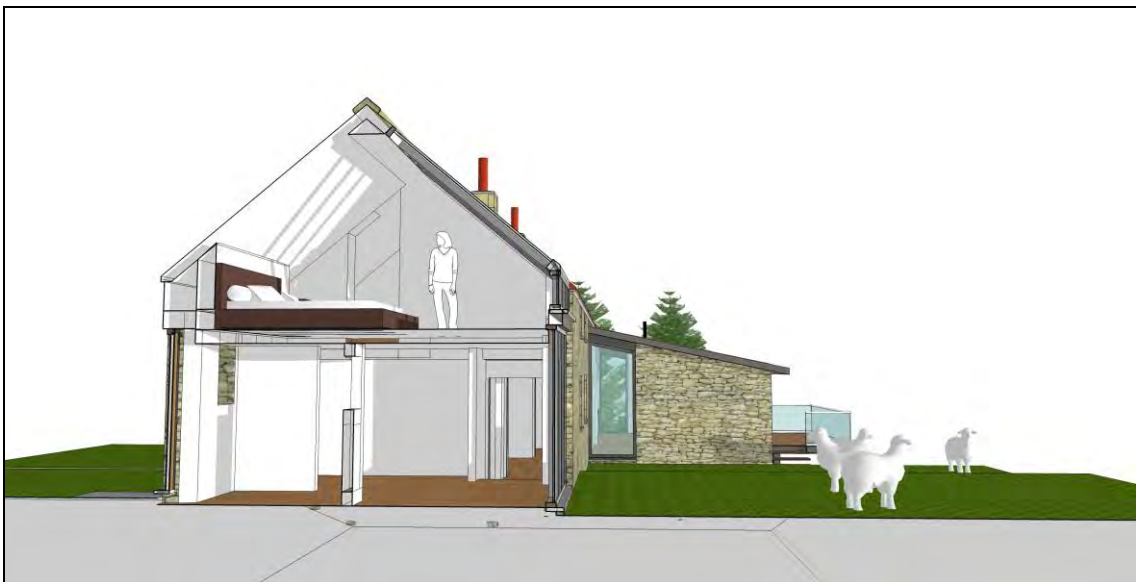
IMAGE 7: SECTION THROUGH PROPOSED MEZANINE FLOOR TO GUEST COTTAGE

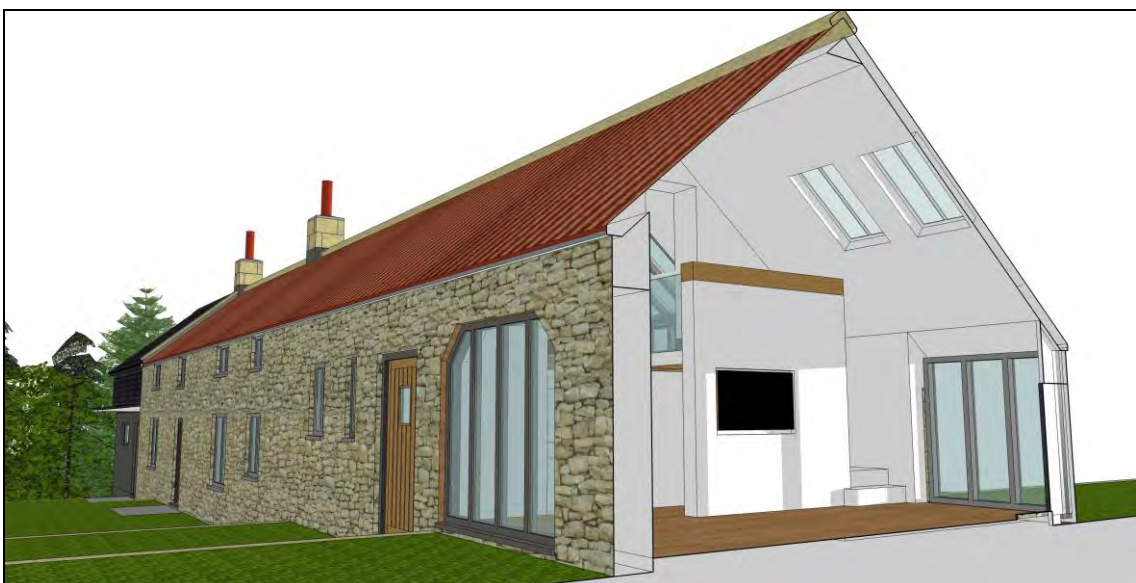
IMAGE 8: SECTION THROUGH GUEST COTTAGE LIVING ROOM

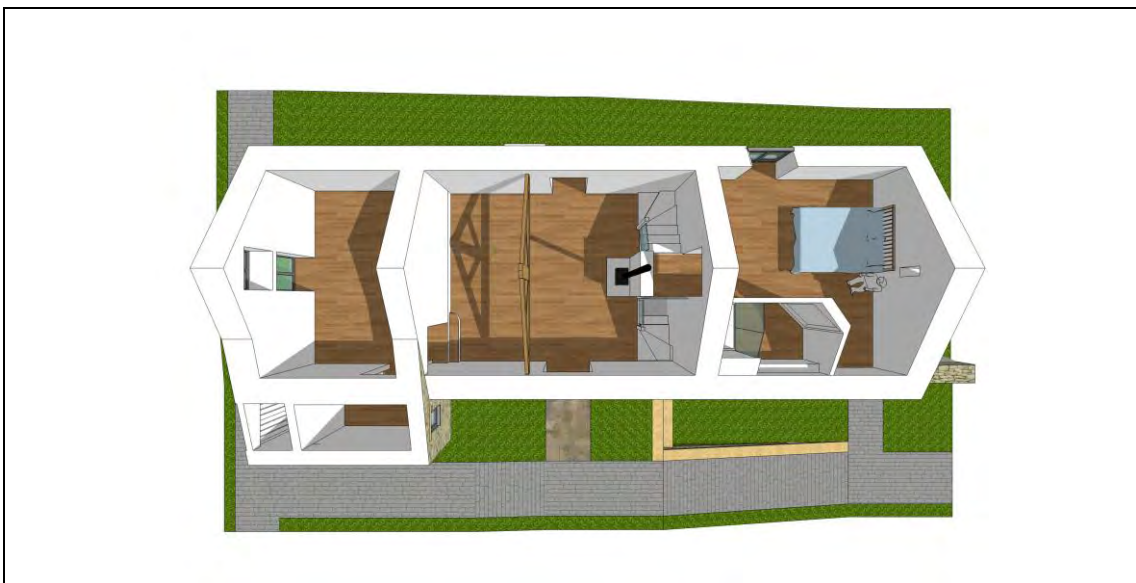
IMAGE 5: PLAN VIEW FROM ABOVE, SHOWING FIRST FLOOR TO NORTH BAY

The existing fall in the ground level allows the installation of a first floor to the north end, to provide a double bedroom upstairs with small ensuite. This is accessed by a staircase from the central living space, from which the ground floor kitchen can also be accessed. The kitchen area includes dining space, and room enough to house coats, boots and wet dogs away from the rest of the cottage. To the south end a second bedroom occupies the single storey room. Early design discussions looked to provide a ground floor bathroom facility at the north end, but this led to restricted kitchen / dining space, and would have resulted in a lengthy night time walk from the second bedroom to the bathroom, via a half flight of stairs. An alternative layout was considered which included a small shower room ensuite within the second bedroom space, but this would have restricted the bedroom itself to a single bed, one person room. Given this limitation on the rental opportunities of the property, it was discussed pre-application with Parks that a small extension be added to the south-east corner, to provide a shower ensuite and a small plant space. The extension will be modest in size and built with matching stonework (salvaged from alterations to existing buildings on site) under a cat-slide pantile roof. The small window will be steel framed to match the rest of the barn, while the plant cupboard door will be oak, under horizontal oak boarding above.

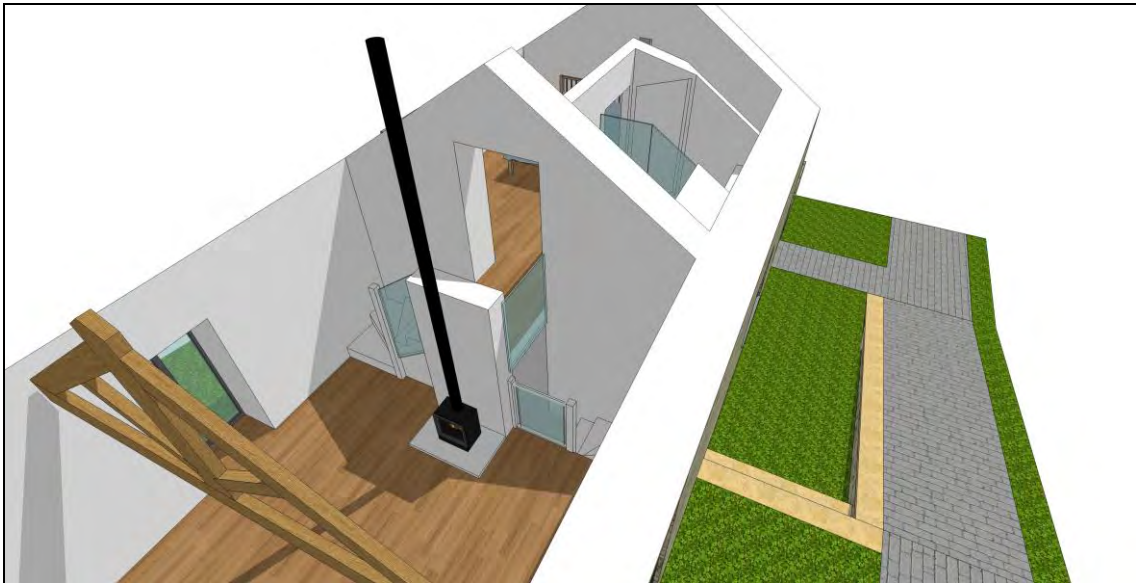
IMAGE 7: ELEVATED VIEW OF LIVING SPACE & STAIRCASE CONFIGURATION

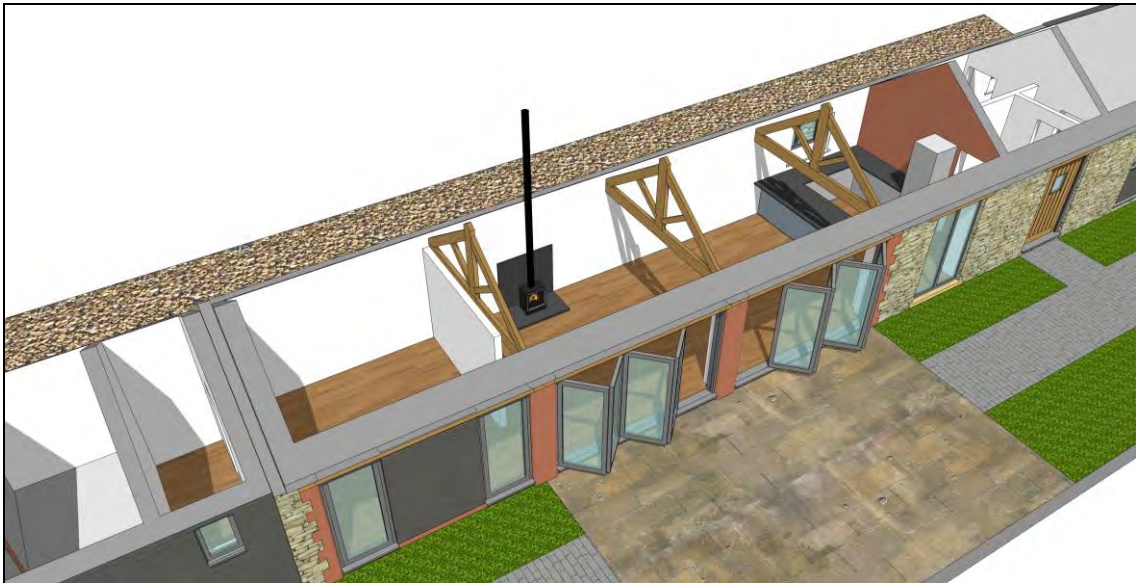
IMAGE 7: ELEVATED VIEW OF INTERNAL LAYOUT

1. The small, cellular rooms to the west end will provide a bedroom with ensuite bathroom facility, a hallway with coat / boot storage, and the kitchen area; the dividing wall between the cellular rooms and the open plan cart sheds will be removed in order to open the kitchen to the living area, and to compensate for the loss of the eastern cart bay (see next item)
2. The eastern cart shed bay will be closed off to provide the main bedroom
3. A small extension will be attached to the east end of the barn range to provide the main bedroom ensuite shower, together with a small boiler house, and a secure bike storage facility with hybrid electric bike charging points
4. The remaining two cart bays will remain open plan to provide a living and dining space
