Church of St Stephen
Church Lane
Fylingdales

PROJECT: OLD ST STEPHENS, FYLINGDALES
DRAWN: KS
CHECKED: KS
DATE: May 2018

A	OCT 2018	KS	DRAWN	CHECKED	REFERENCE TO CUPOLA AMENDED.
REVISION	DATE				DESCRIPTION
Do not scale from drawing. All dimensions to be checked onsite. Report all discrepancies.					
				CLIENT	SCALE
				no scale at A4	
				PROJECT	DATE
				DRAWN	February 2017
				CHECKED	
ST STEPHEN, FYLINGDALES					
DRAWING TITLE					
Photos of existing cupola 2.2.17.					
DRAWING NO.					
FSS000 / 010A

CUPOLA - TYPICAL POST REPAIR & STRENGTHENING SKETCH

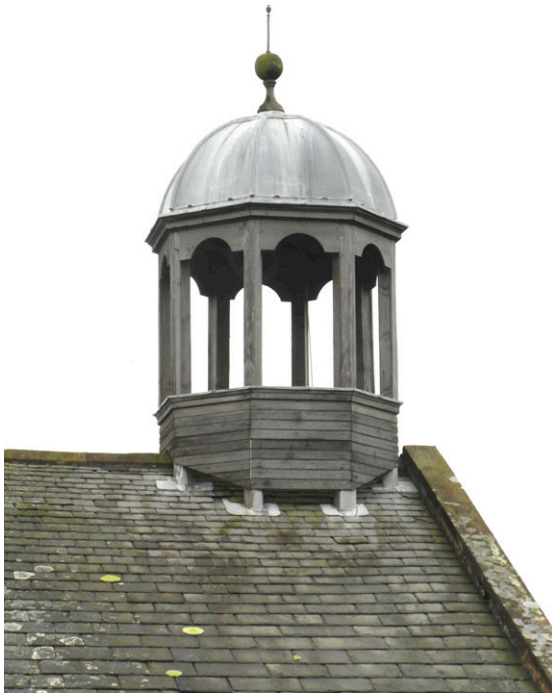
North side of the cupola.

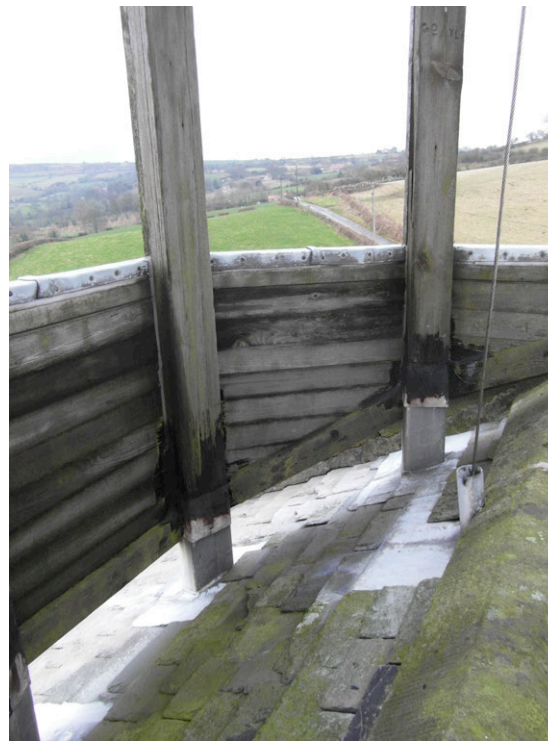
Inside the cupola .
The posts continue through the roof with a lead flashing. Water appears to be running down the posts, behind this flashing and down into the roof space.

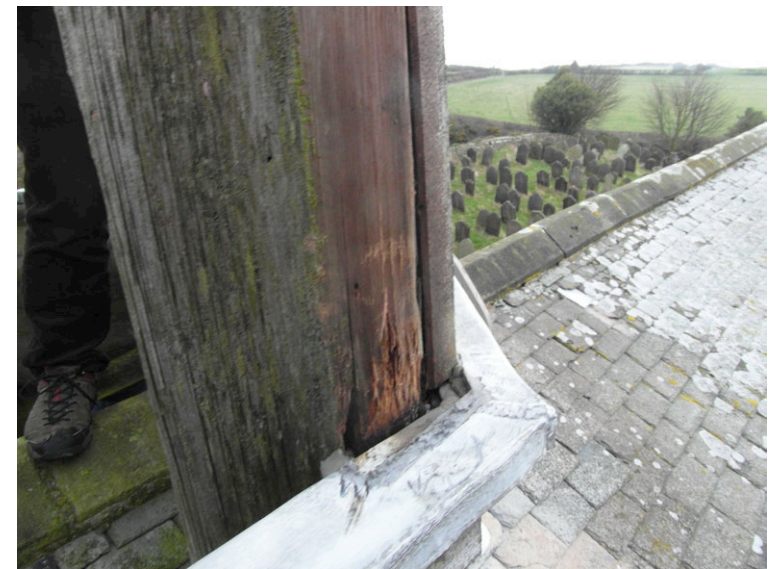
With the fascia removed decay can be seen in the post, a result of the water getting behind the fascia and not drying out.

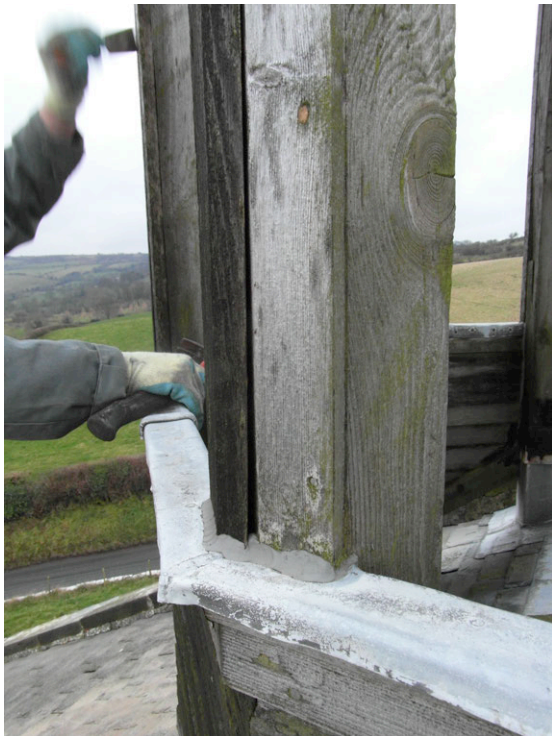
A fascia, made of two sections is nailed to the outward face of each post. This fascia sits on top of a lead capping/cill.

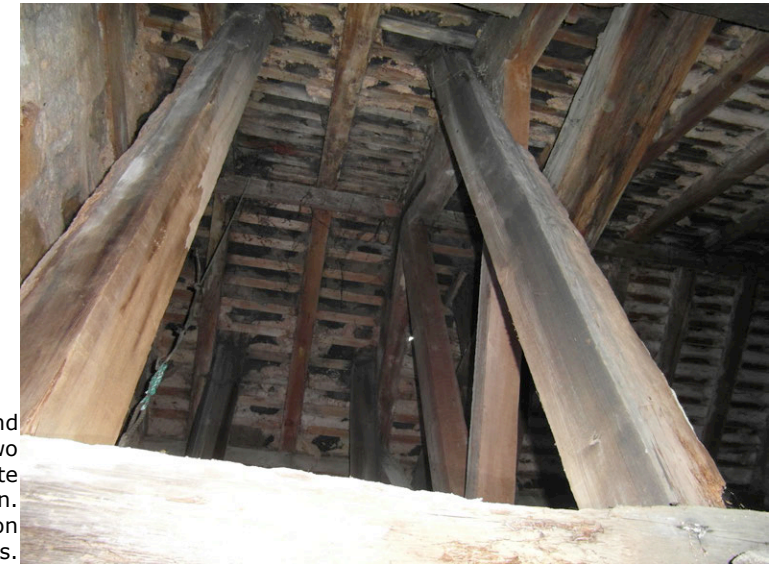
Inside the Nave roof. Decay and water staining can be seen on the two southern most posts of the bellcote and beam they are sitting on. Signs of staining can also be seen on the south side of the north posts.

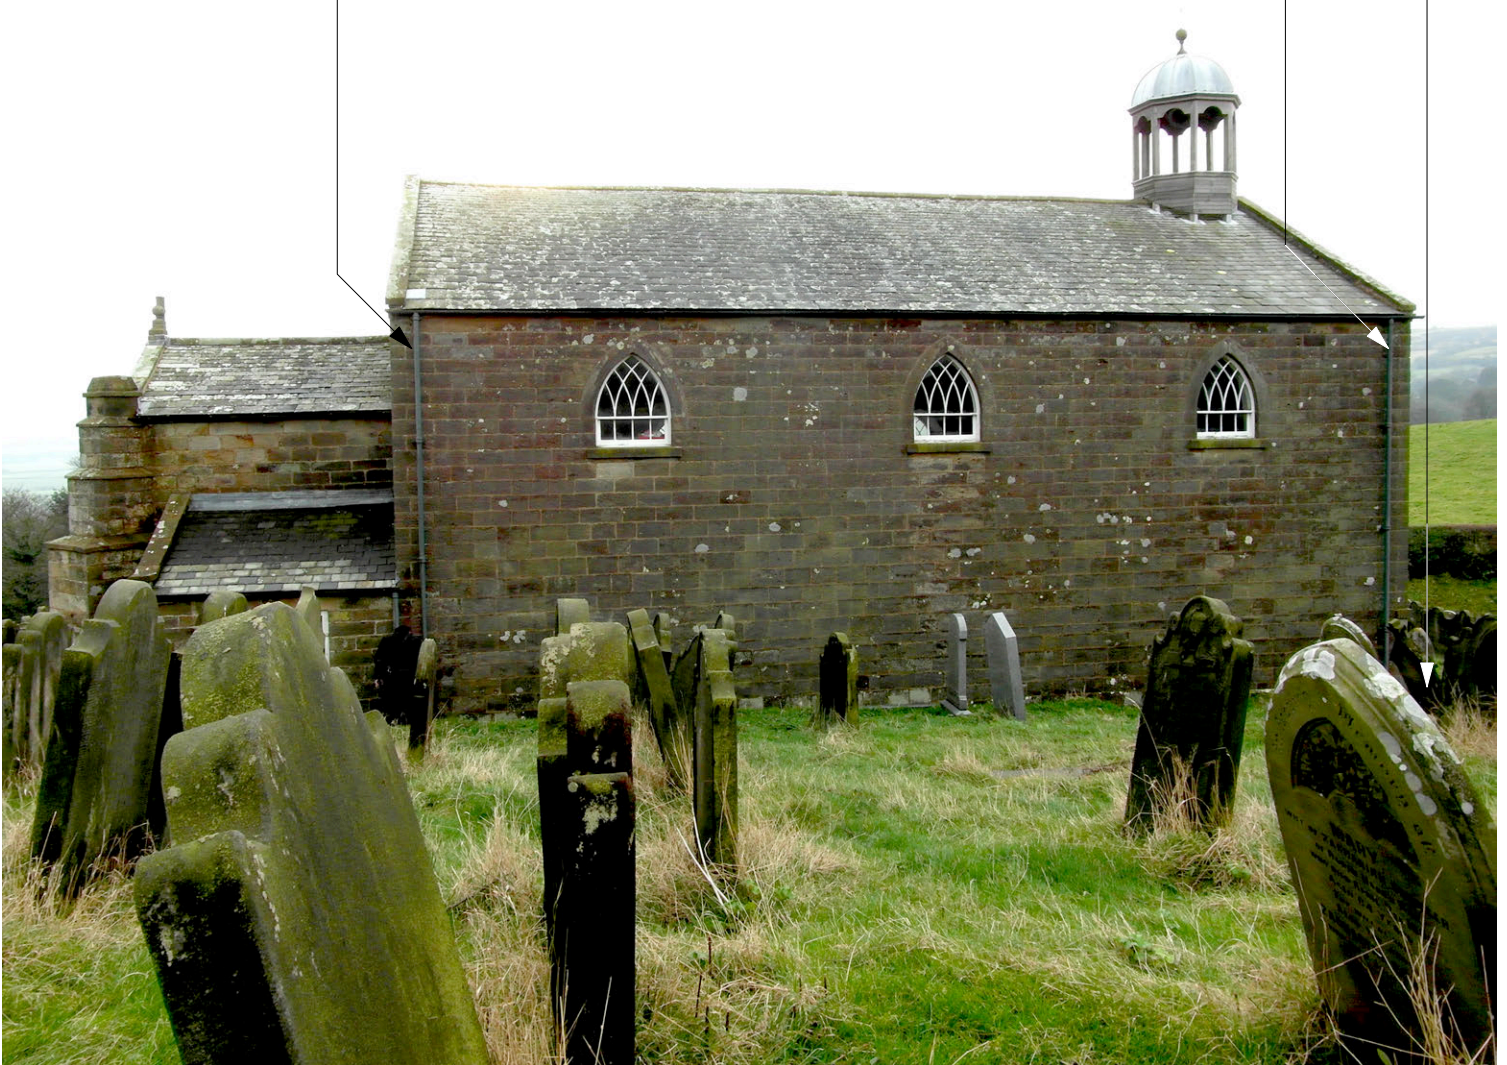
OLD ST STEPHENS CHURCH NORTH ELEVATION - EXISTING
 (before cupola boarding removed)

This downpipe to be removed.
 - the condition of the stone
 channel at the foot of the wall
 causes most of the water from
 this downpipe to drain into the
 ground below the church.

Existing gully
 draining west.

This downpipe to be
 100mm cast iron.
