Ecological Appraisal & Bat Activity Surveys

Faceby Lodge Faceby, Stokesley

Report Reference: BG14.211

August 2014

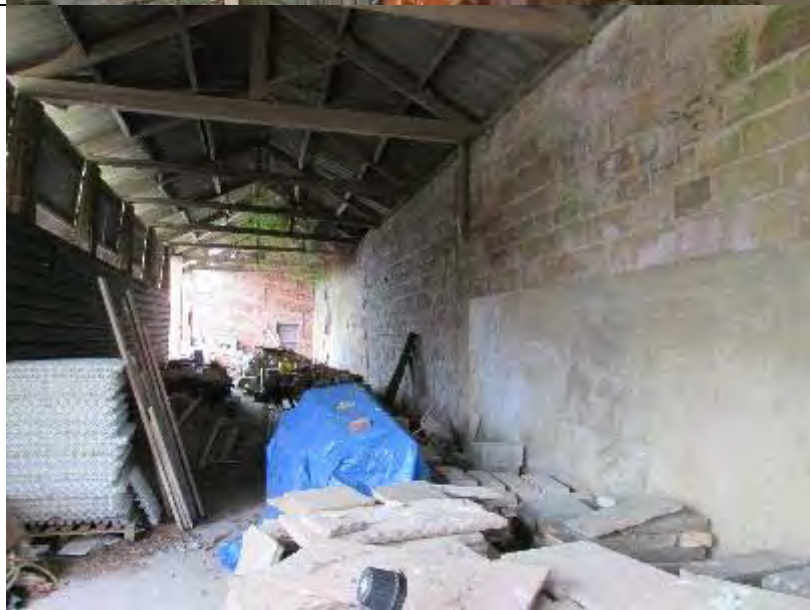
Internal view of 5.

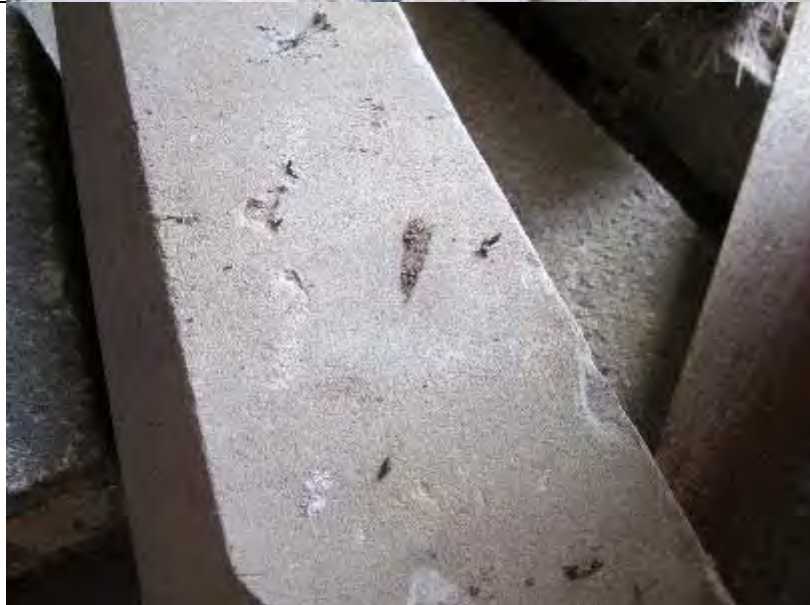
Bat droppings within 5.

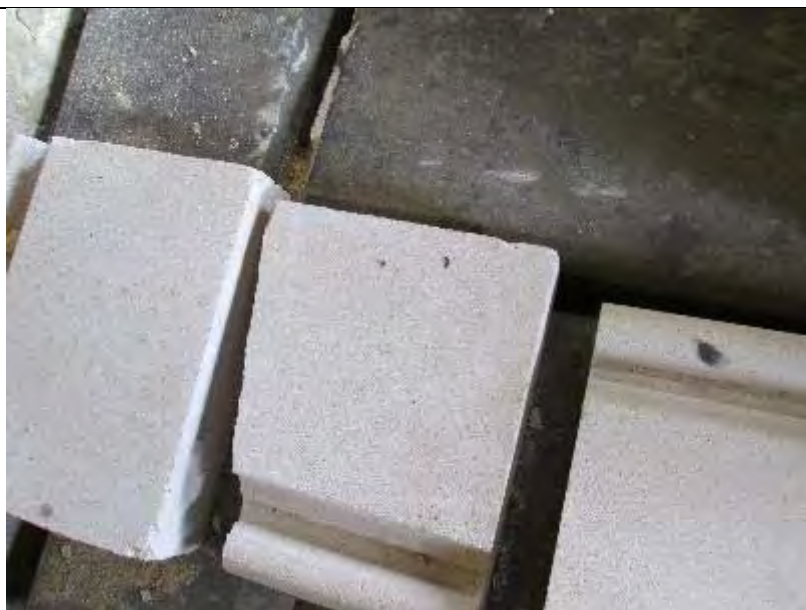
Bat droppings within 5.

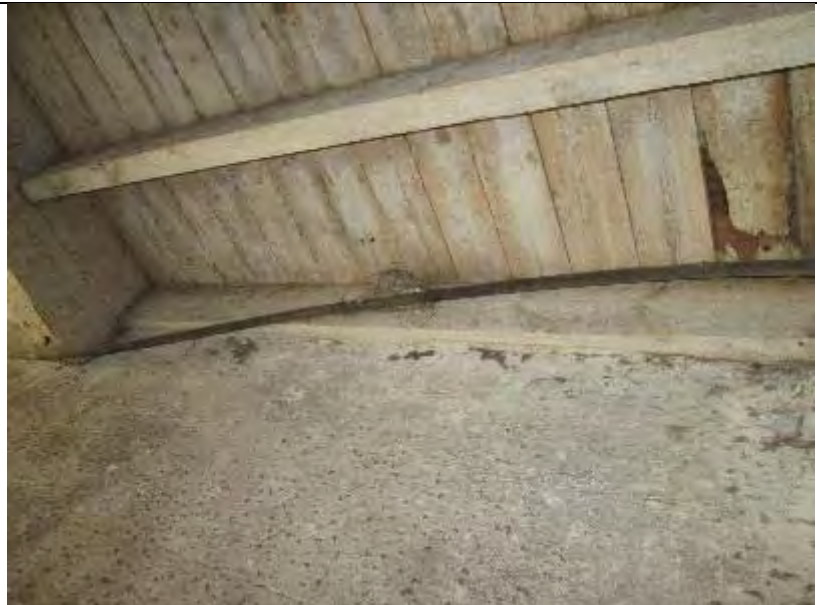
Barn swallow nest within 6 typically found to most buildings.

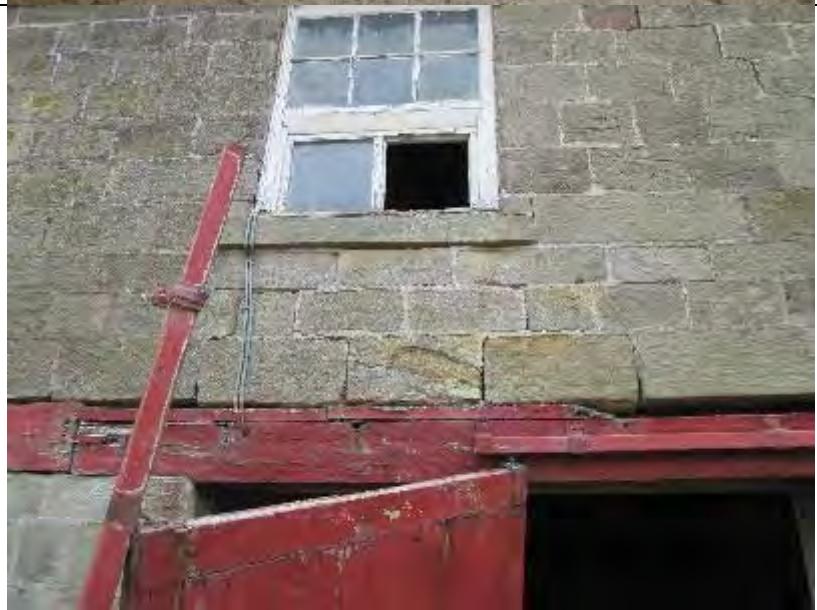
North wall of 6 note gaps between stonework providing potential cool and over winter roost sites.

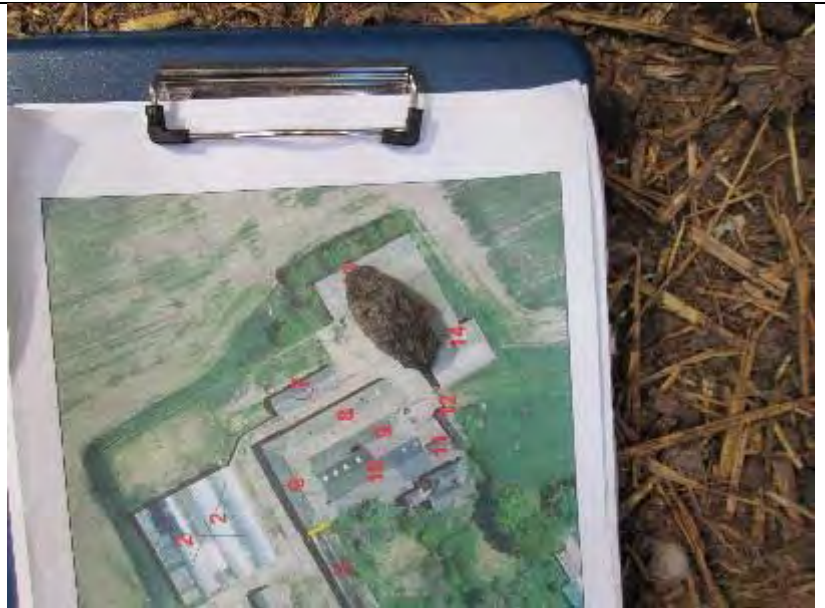
Barn owl pellet within 8.

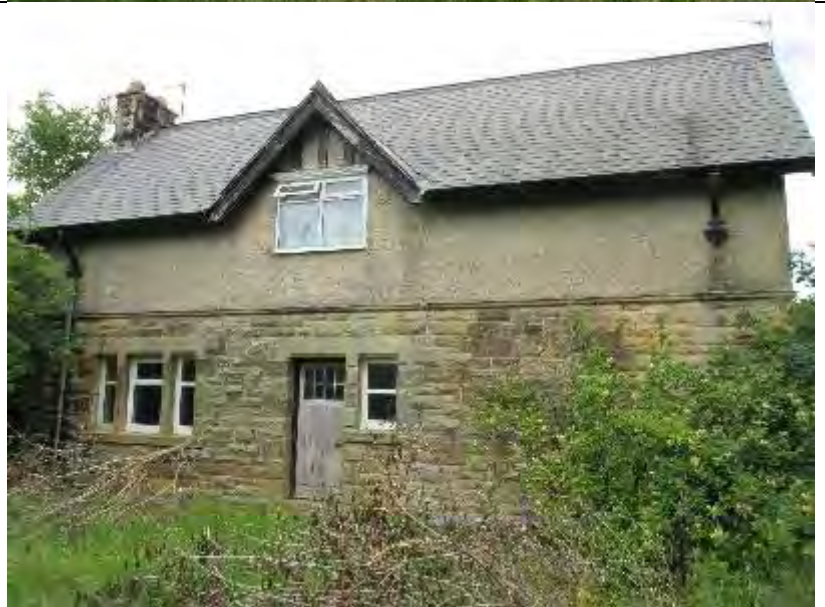
Former farmhouse to west where a considerable amount of bat activity was identified. Not forming part of the development but potentially a roost site.

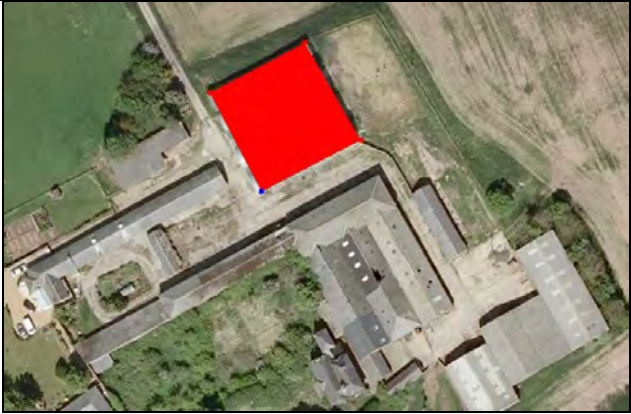
Building 2		
Bat Risk Category:	Negligible	Layout/Photographs:
<p>Single storey open barn building with arched corrugated roof. The building is in two sections, both of which are used as storage space.</p>

<p>No obvious opportunity for bats in the roof. The building offered little in the way of opportunities for roosting bats.</p> <p>No evidence of bats were found.</p>

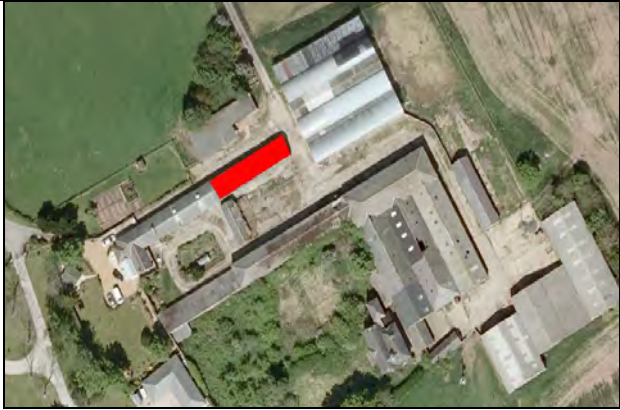
Building 3		
Bat Risk Category:	Moderate	Layout/Photographs:
<p>A brick built single storey stable block with a pitched slate roof.</p> <p>Multiple crevices in both the roof and walls were found in this building.</p>

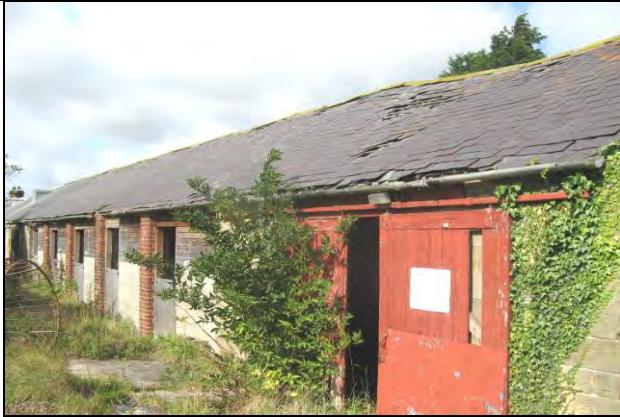
<p>Single storey stable block. At the eastern end of the row of stables - there is a sealed door frame with openings into the cavity walls. Several bat droppings were found in this area.</p>

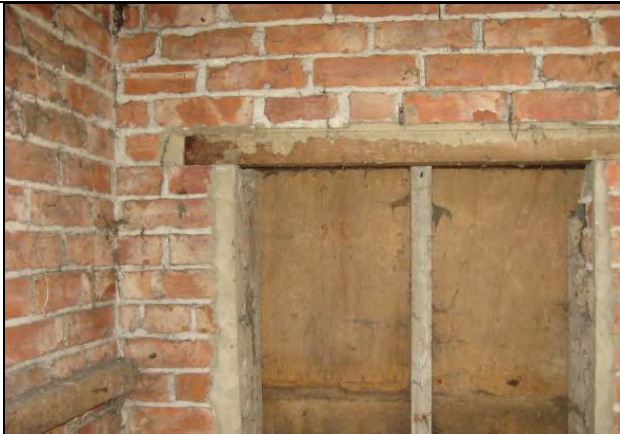
<p>Bat droppings were found in the area around this doorway that has been boarded up. Consequently this section of the stable was assessed to have Moderate Potential for roosting bats and as a consequence a bat activity survey is recommended for this building.</p> <p>Note: The Bat Activity Surveys found up to two Soprano Pipistrelle (<i>Pipistrellus pygmaeus</i>) roosting in the gap above this doorway.</p>

Buildings 3, 8, 9 and 10 will require a Natural England mitigation licence before any building work is carried out on the building. These licenses can only be acquired by suitably qualified ecologists.

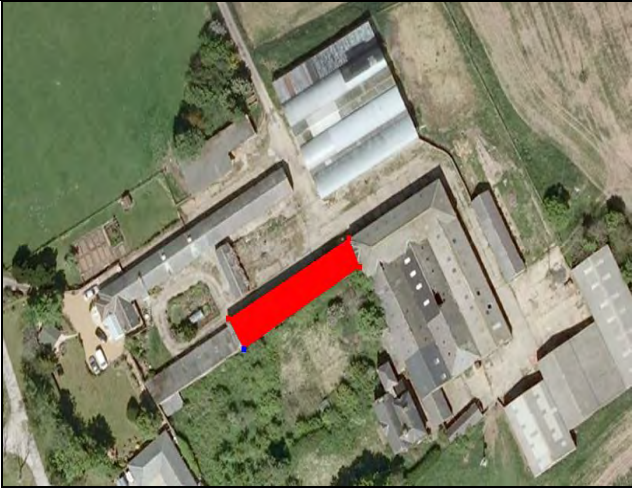
Building 5	
Bat Risk Category:	Low
Layout/Photographs:	
<p>A large stone built storage building with a pitched corrugated roof.</p> <p>This building adjoins building 6 on its eastern side.</p>

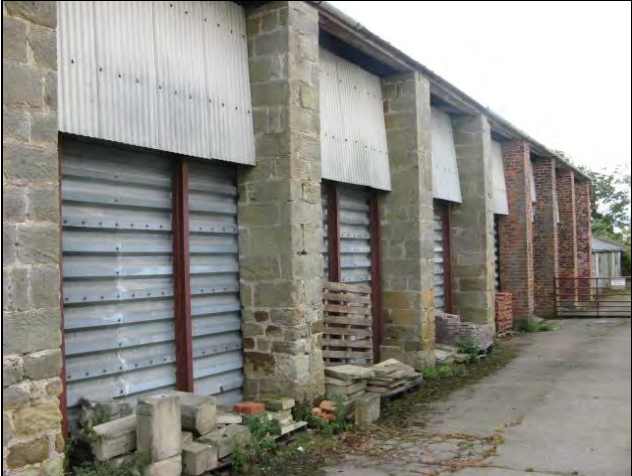
<p>A large stone built storage building with a pitched corrugated roof. There are several openings into the building offering easy access for bats.</p>

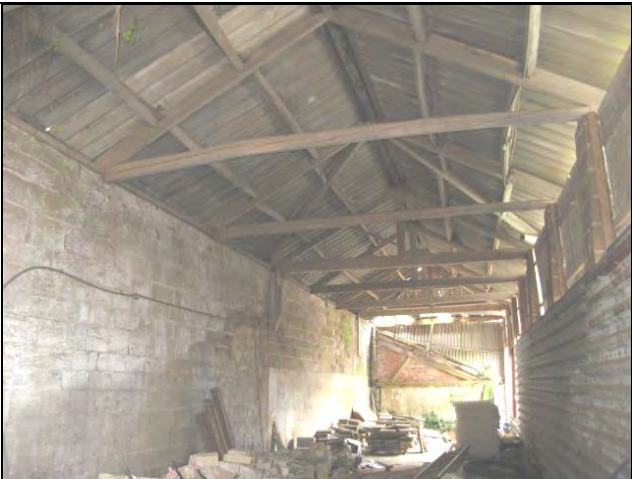
<p>Interior roof. Corrugated sheets over narrow wooden beams. The interior of this building contains many crevices within the walls, particularly along the southern side of the building.</p> <p>A few bat droppings were found on the floor of the building.</p>

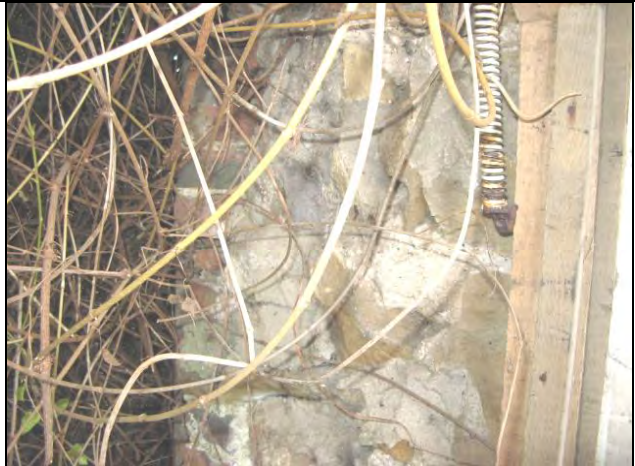
Width of wall approximately 0.5m wide.

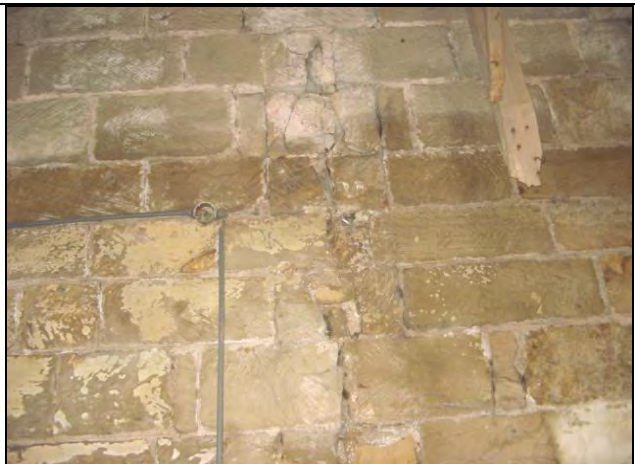
There are numerous cracks within this wall that could be suitable for bat roosts.

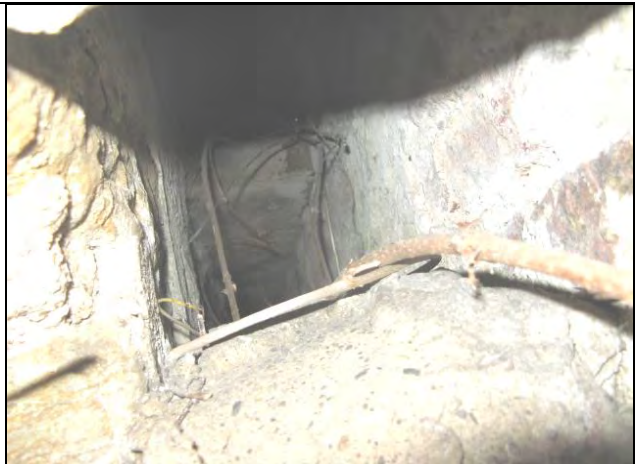
In the past a boiler was used to pump hot air through the walls in flues (pictured here). These flues extend through the whole length of the wall which could offer roosting opportunities for bats.

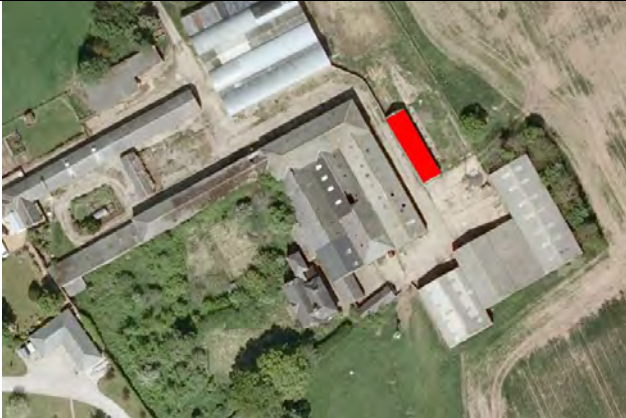
Building 7		
Bat Risk Category:	Negligible	Layout/Photographs:
<p>A disused pig pen of large stone structure with a pitched slate roof.</p>

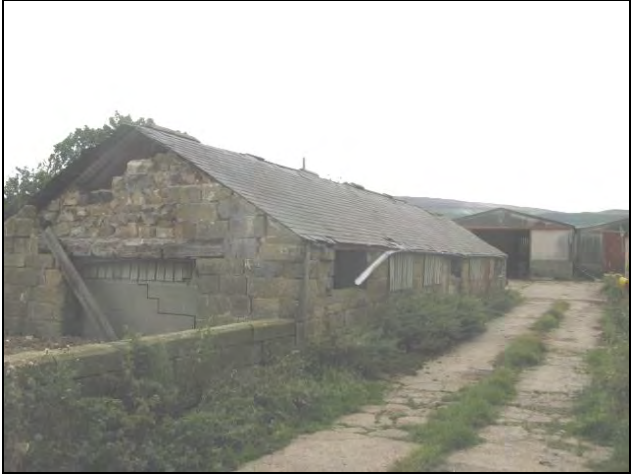
<p>View of the building looking south.</p>

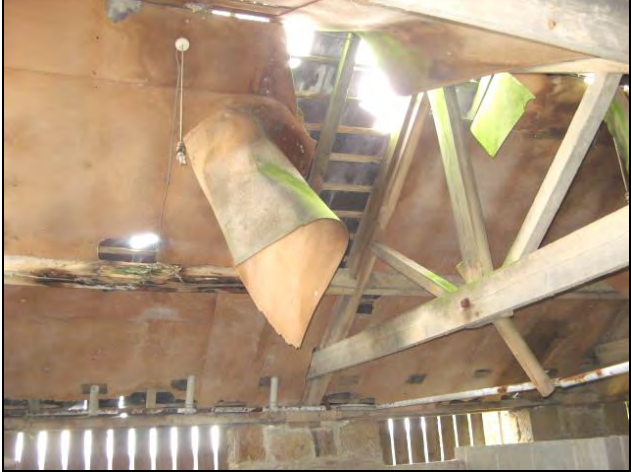
<p>Interior roof. The roof is in a very poor state of repair allowing wind and rain to easily access the building.</p> <p>The holes in the roof have resulted in extensive damp within the building.</p> <p>No evidence of bats were found.</p>

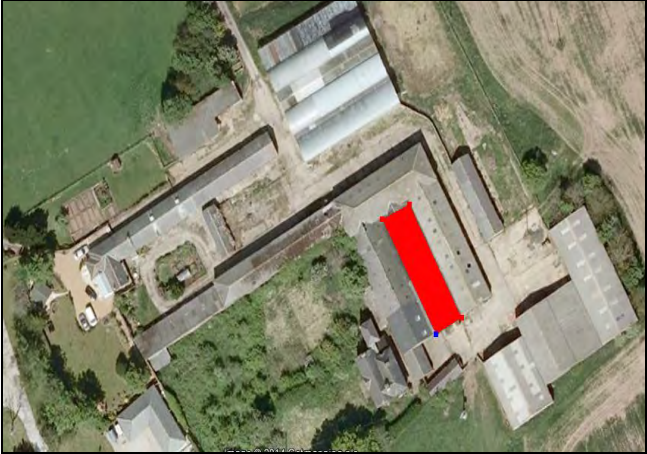
Building 9		
Bat Risk Category:	Moderate	Layout/Photographs:
<p>A large brick built barn adjoining building 8 to the east and building 10 to the west.</p> <p>The building has a pitched corrugated roof which is in a poor state of repair.</p>

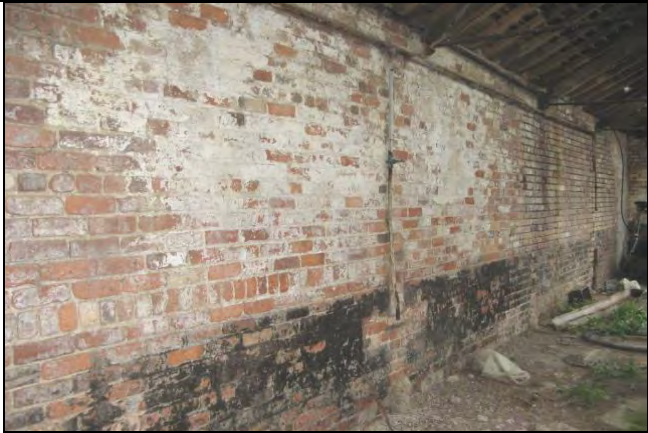
<p>A few bat droppings were found along the edge of this eastern wall beneath five crevices in the wall.</p> <p>Eastern wall separates Building 8 from Building 9.</p>

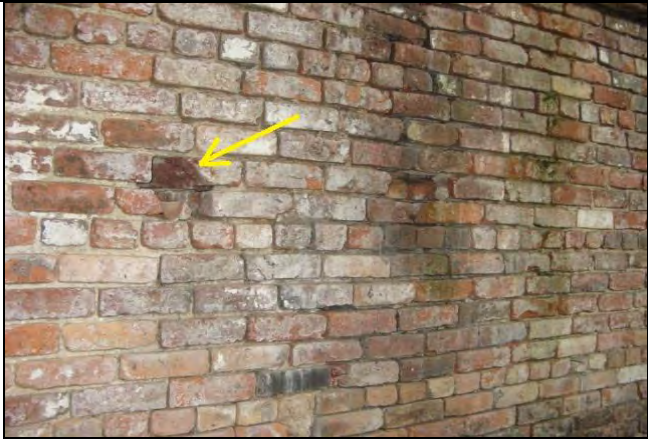
<p>Bat droppings also found at entrance to these five crevices in the wall. Indicated here with yellow arrow.</p> <p>Note: The Bat Activity Surveys found up to five Common Pipistrelle (<i>Pipistrellus pipistrellus</i>) and a probably a Soprano Pipistrelle (<i>Pipistrellus pygmaeus</i>) roosting in this wall.</p>

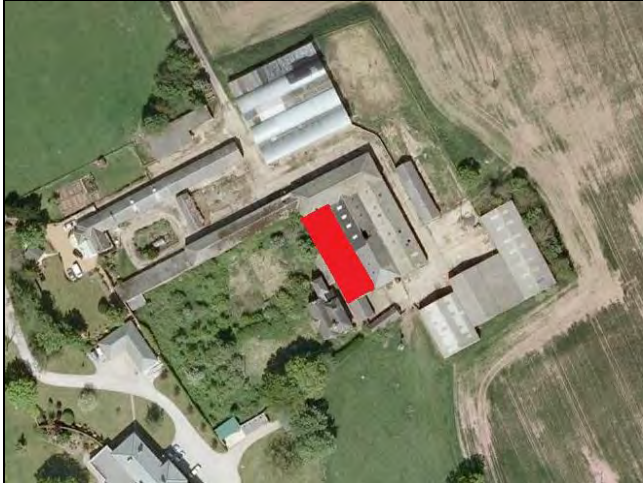
Building 10		
Bat Risk Category:	Moderate	Layout/Photographs:
<p>Large rectangular building that had previously been used to accommodate pigs.</p> <p>Much of the building is rendered and is now in a very dilapidated dangerous condition.</p>

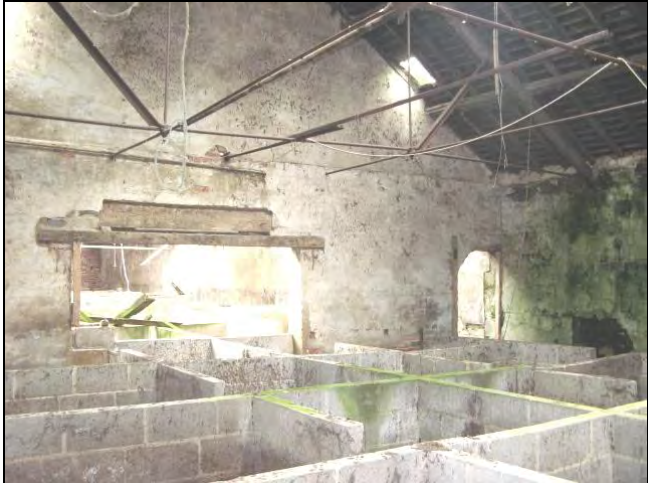
<p>Interior.</p> <p>Very damp interior with dilapidated slate roof supported by slender wooden beams.</p>

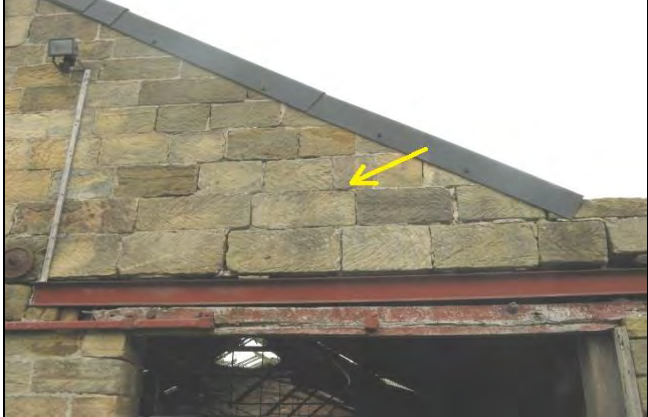
<p>View of south facing doorway.</p> <p>Bat droppings were found beneath crevices in the southern wall over this doorway.</p> <p>Note: The Bat Activity Surveys found up to three Common Pipistrelle (<i>Pipistrellus pipistrellus</i>) leaving the crack in the stone work above the door (indicated by this yellow arrow).</p>

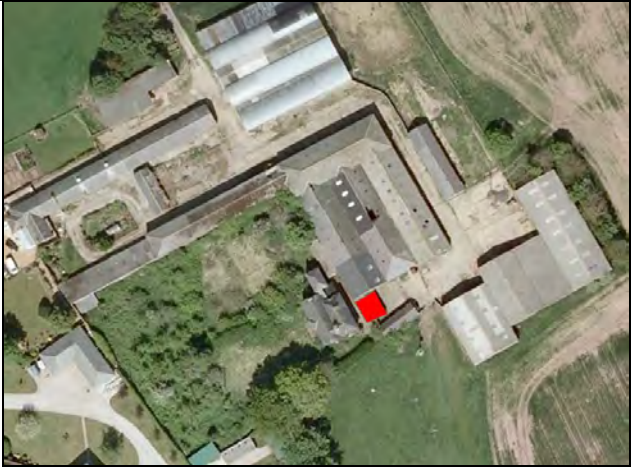
Building 11		
Bat Risk Category:	Negligible	Layout/Photographs:
<p>Stone built single storey stable block with pitched slate roof.</p>

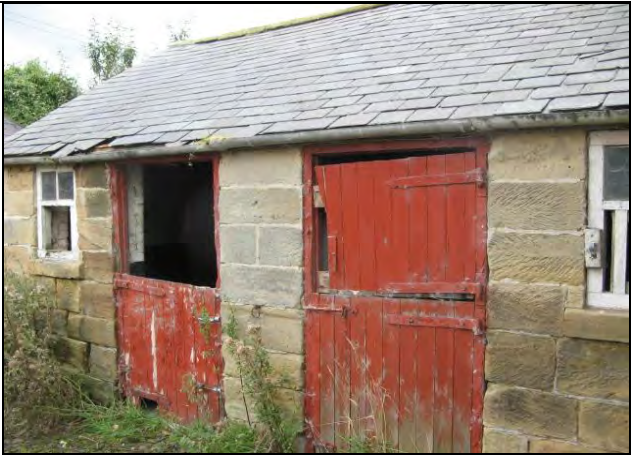
<p>View of west side of the building.</p>

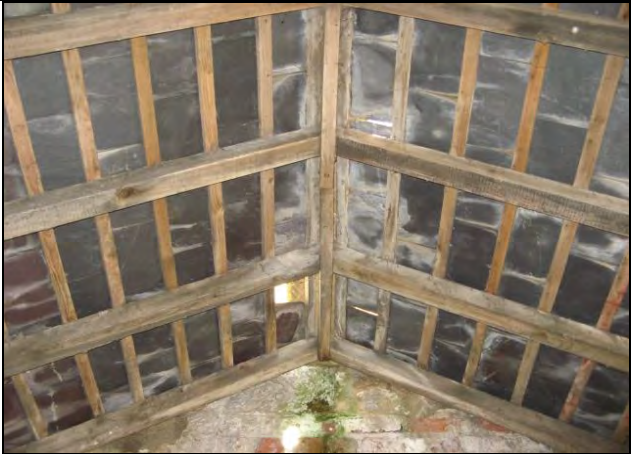
<p>Interior roof along the ridge rafter provides opportunities for roosting bats.</p> <p>No evidence of bats found.</p>

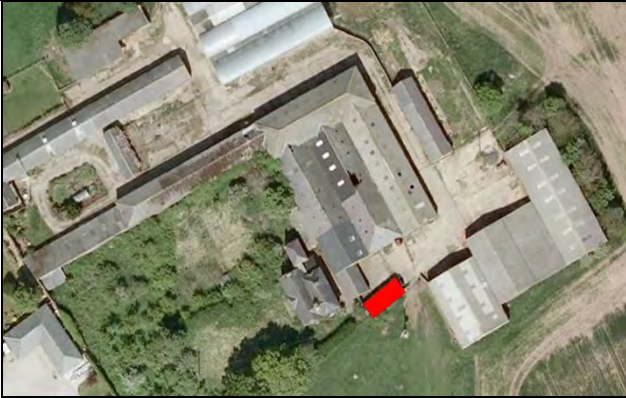
Building 12		
Bat Risk Category:	Negligible	Layout/Photographs:
<p>A brick built storage building with pitched slate roof.</p>

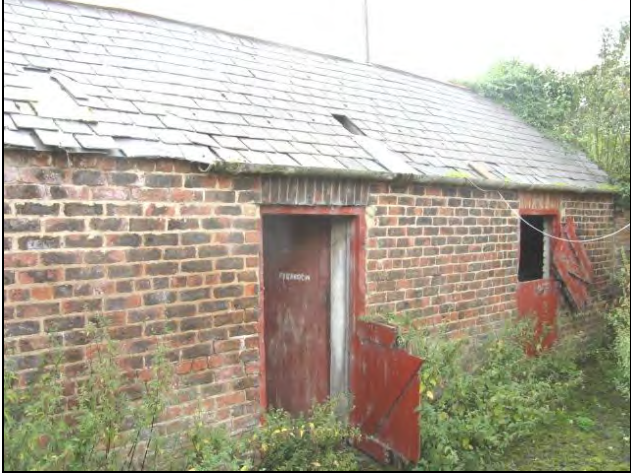
<p>View of the north facing side of the building. Building used to store oil and fumes from this was evident. This will deter bats from using the building.</p>

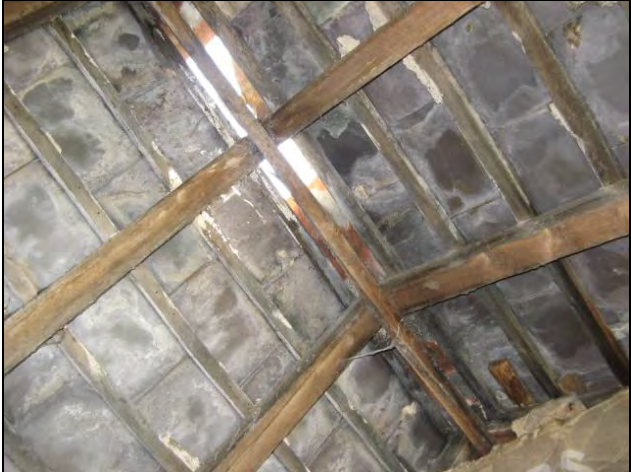
<p>Interior roof showing the ridge rafter. Multiple holes in the roof exposes the building to the weather.</p> <p>No evidence of bats were found.</p>

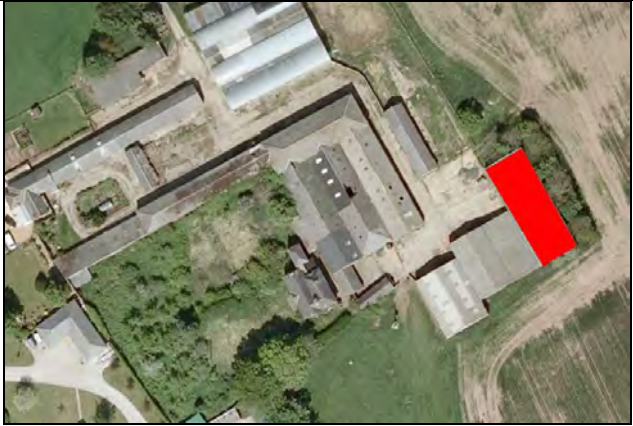
Building 13	
Bat Risk Category:	None
Layout/Photographs:	
<p>This building has been demolished with only piles of rubble existing.</p>

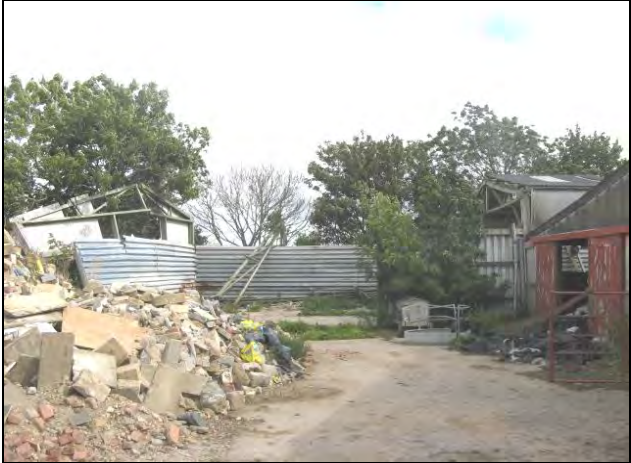
<p>View of the building looking west.</p>
