Design, Access & Heritage Statement Land of Iron Interpretation – Grosmont

REPORT NO: D9255

NORTH YORK MOORS NATIONAL PARK AUTHORITY

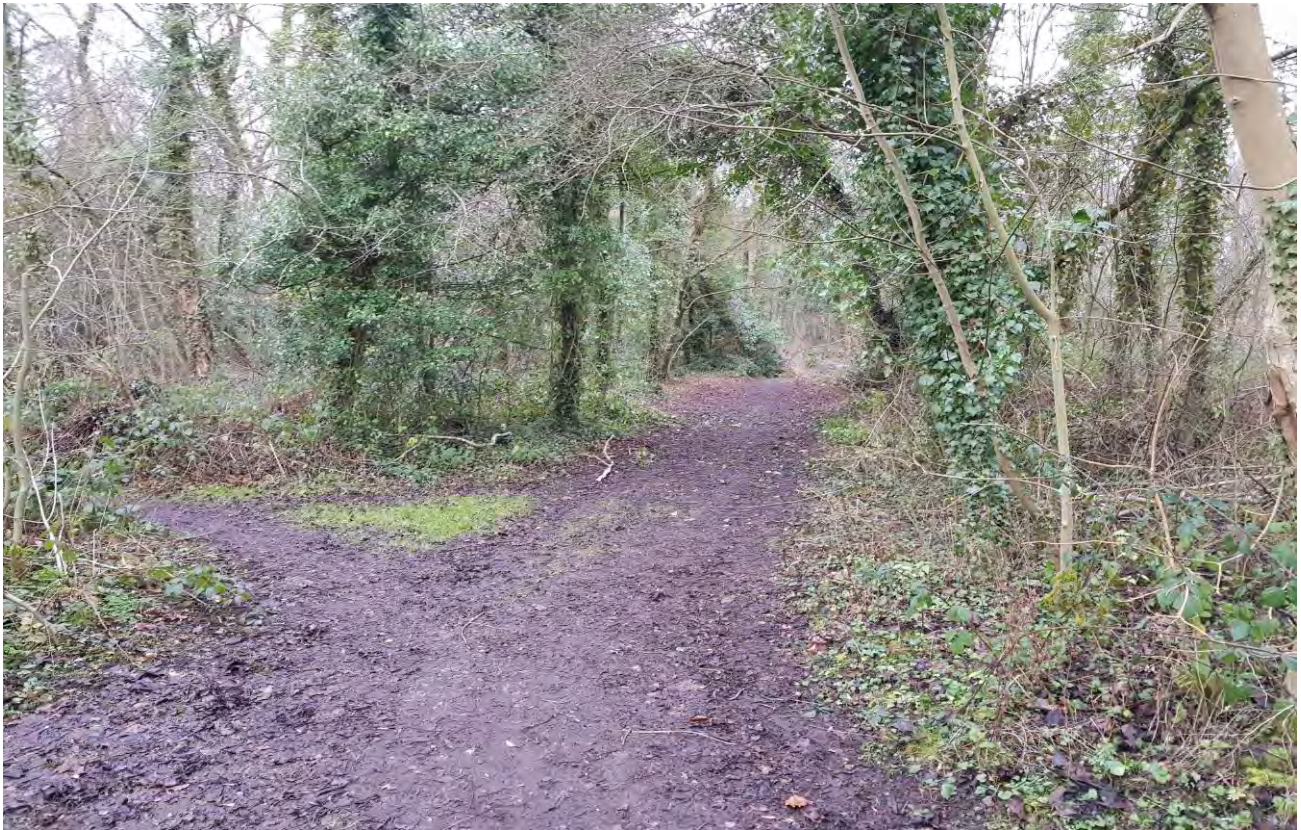
Photograph 1 View of the track in the centre of the site, facing north east.

The north of the site (Photographs 1 and 9) is covered with woodland which is mainly silver birch, in the centre a number of buildings and allotments were noted. Several footpaths were noted which extend beyond the site, one of which leads down to the river bank to the northwest of the site, at the end of the footpath was a disused tramway bridge (Photo 7 and 8) which crosses the River Esk which marks the western boundary of the site.

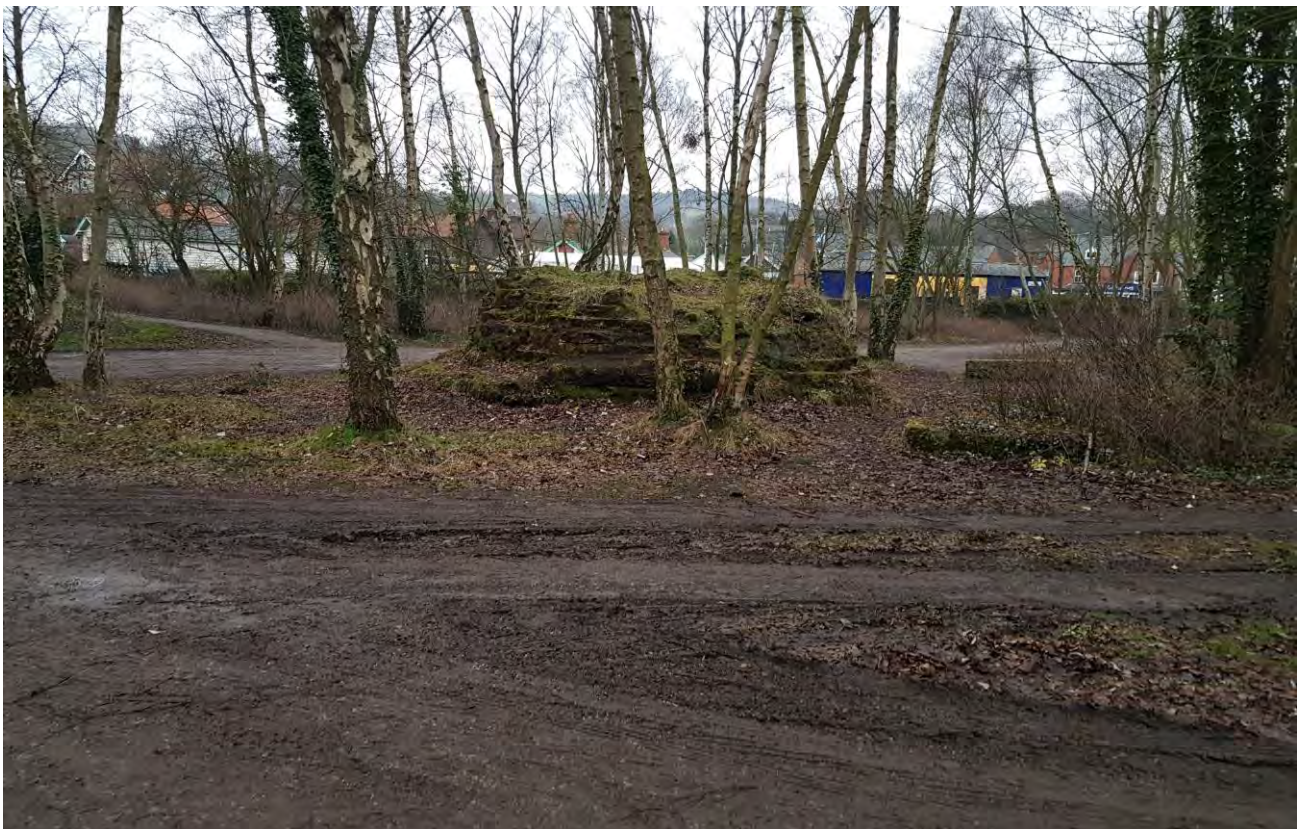
Photograph 2 View of the south east of the site

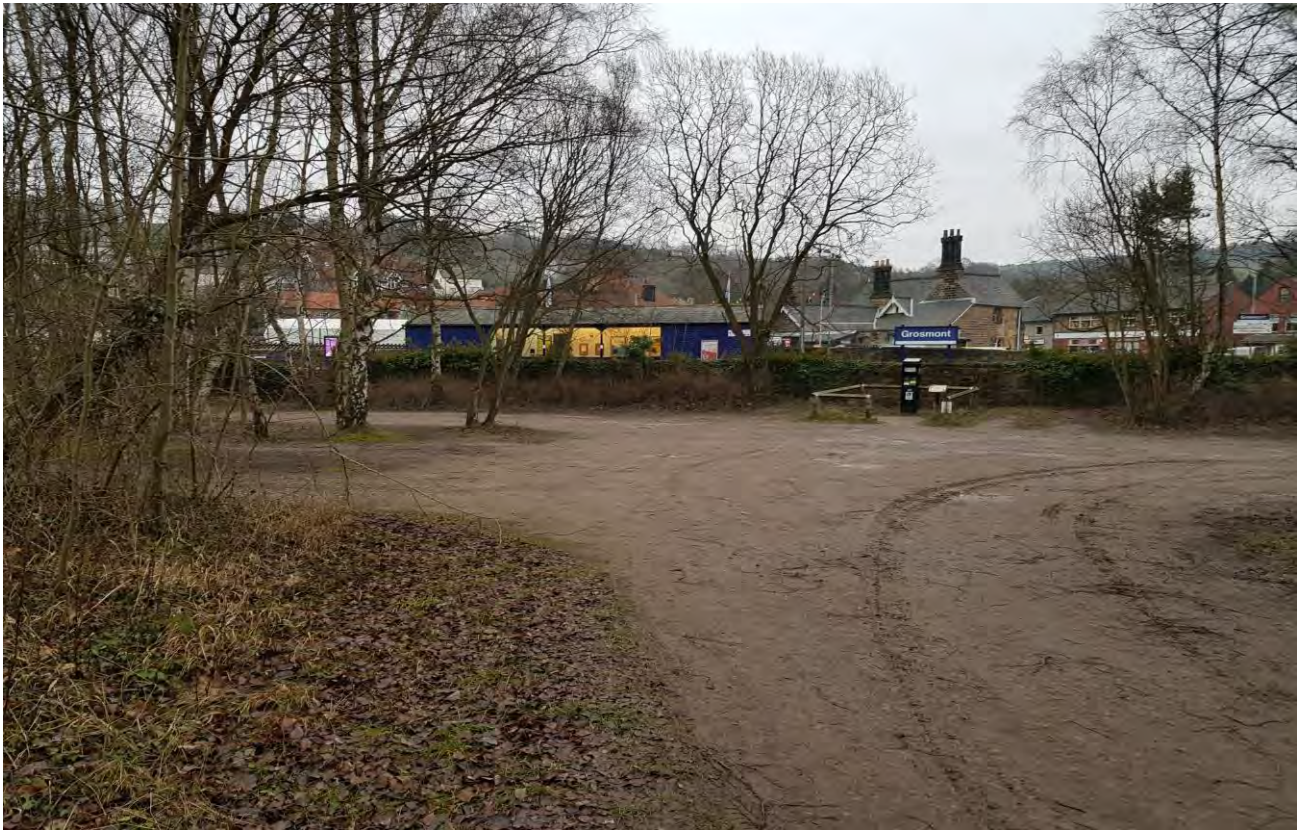
Photograph 3 View of the south eastern boundary of the site facing the railway station

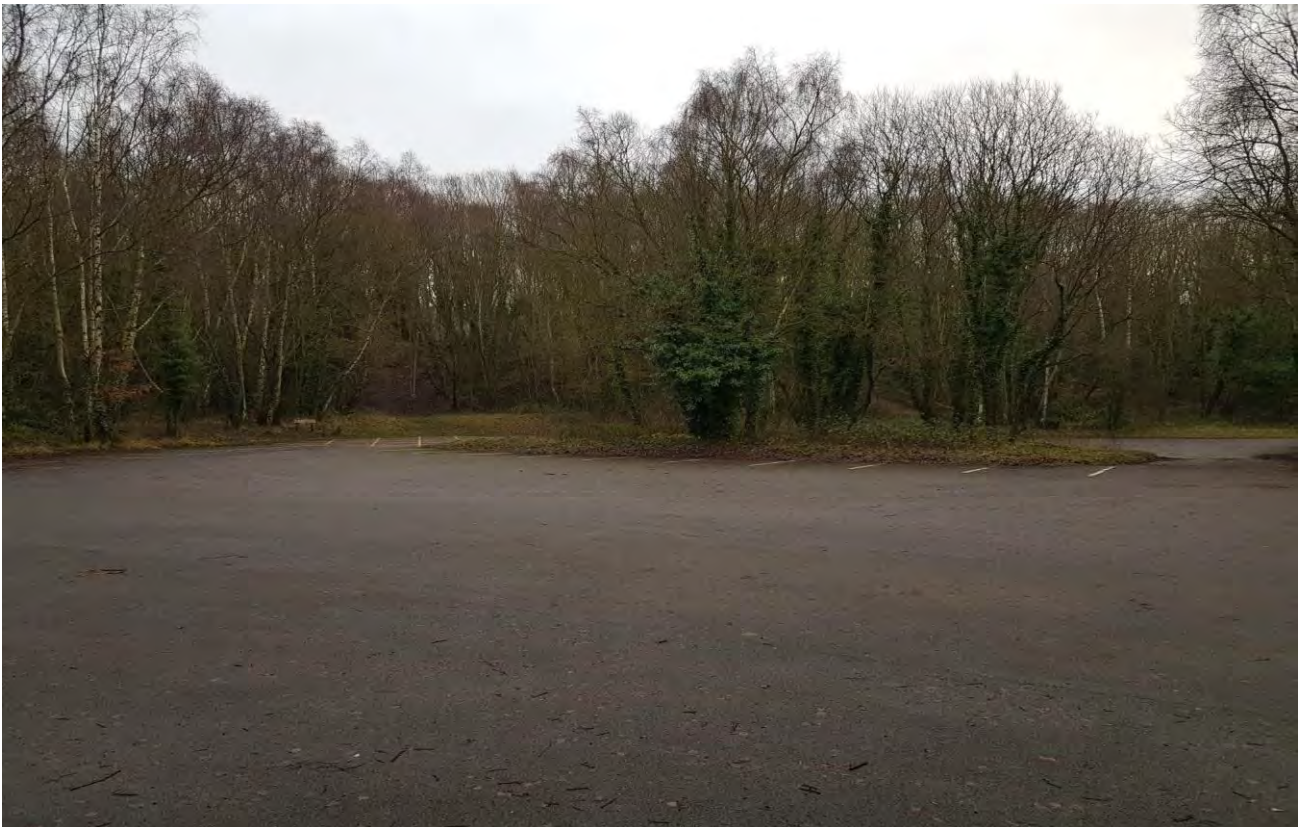
Photograph 4 View of the carpark in the west of the site

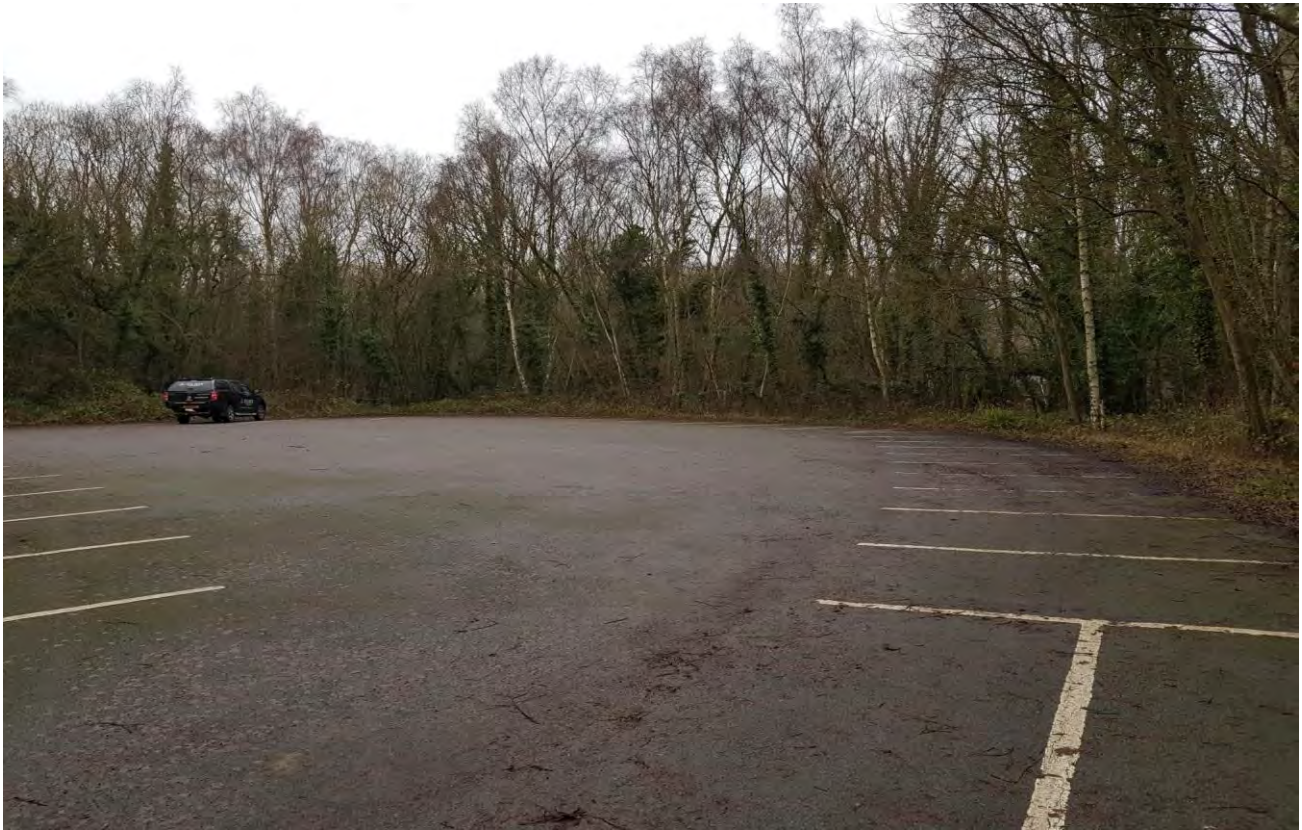
Photograph 5 View of the carpark in the west of the site

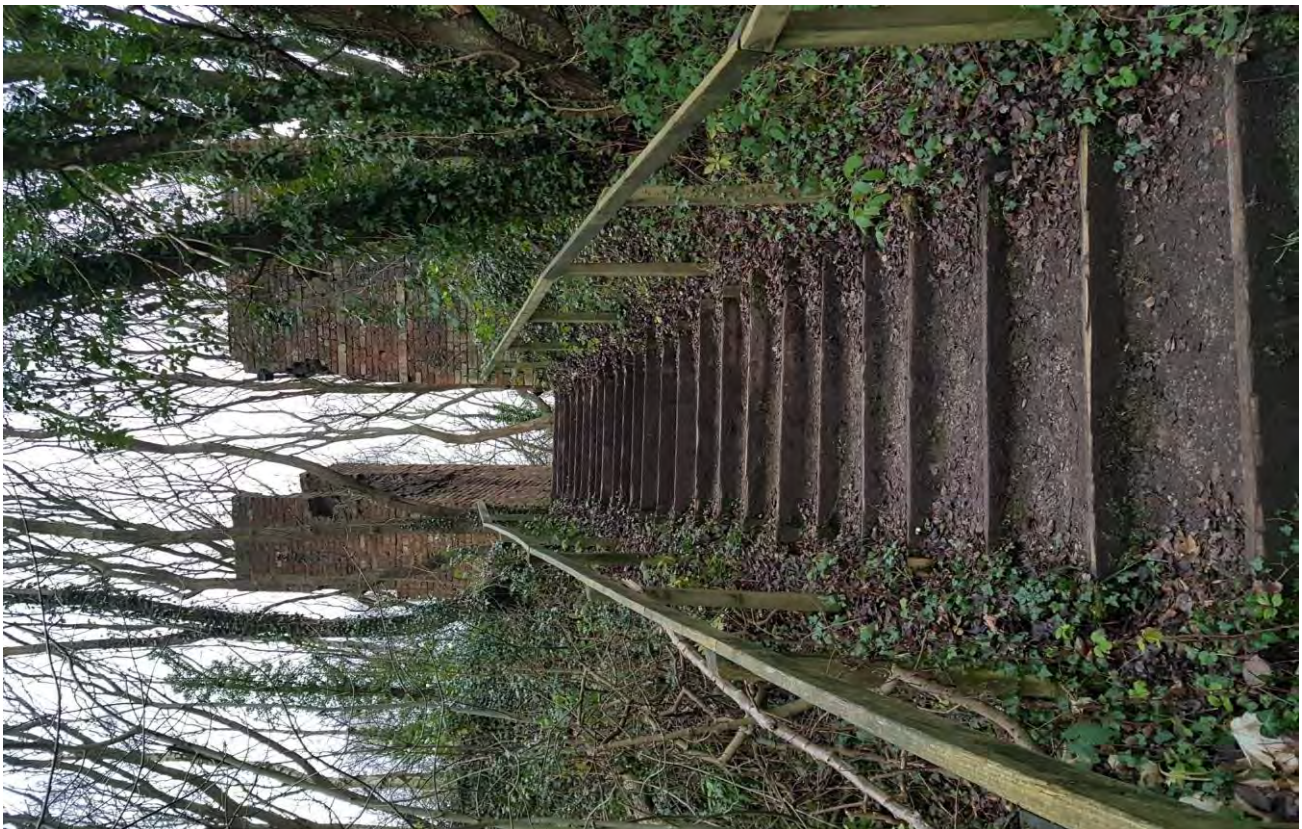
Photograph 6 View of the relict industrial structure in the western area of the site

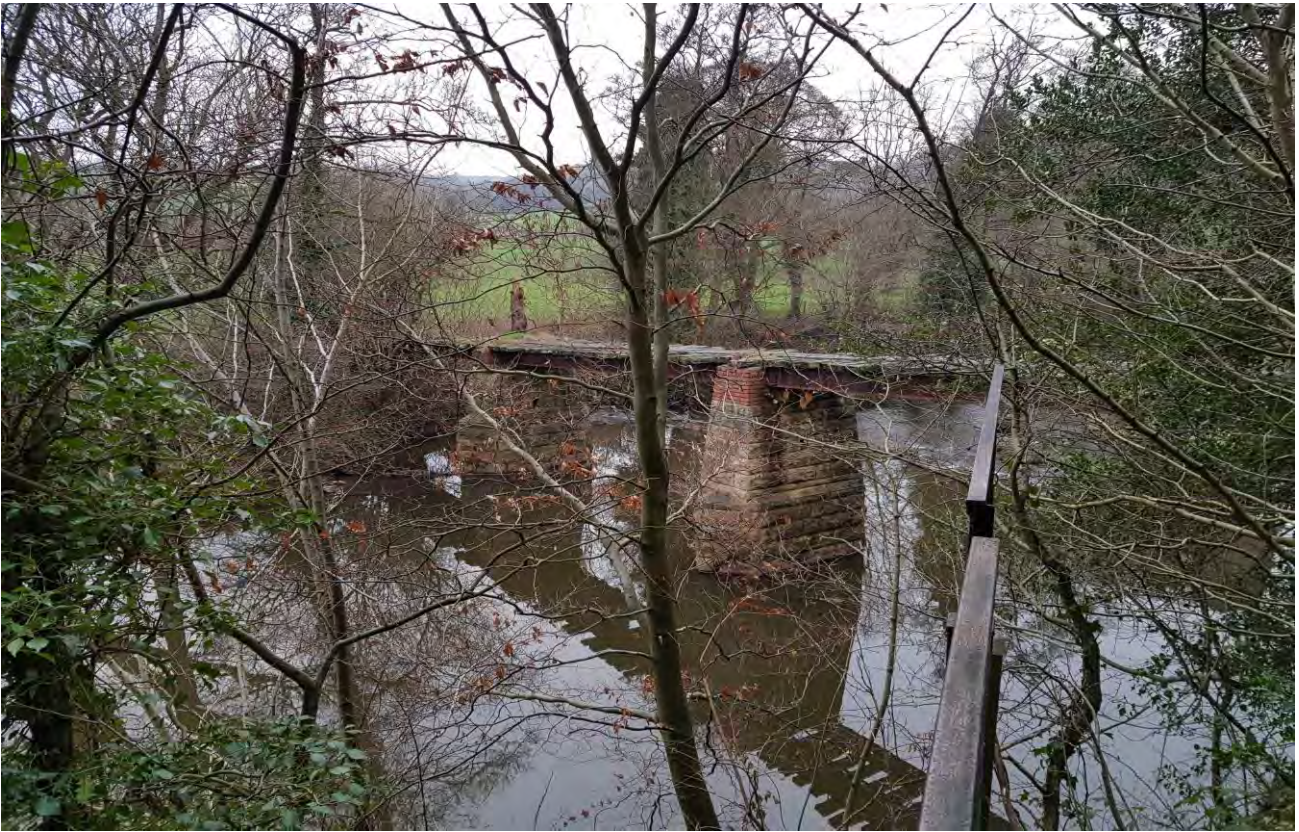
Photograph 7 View of the disused bridge in the north west of the site

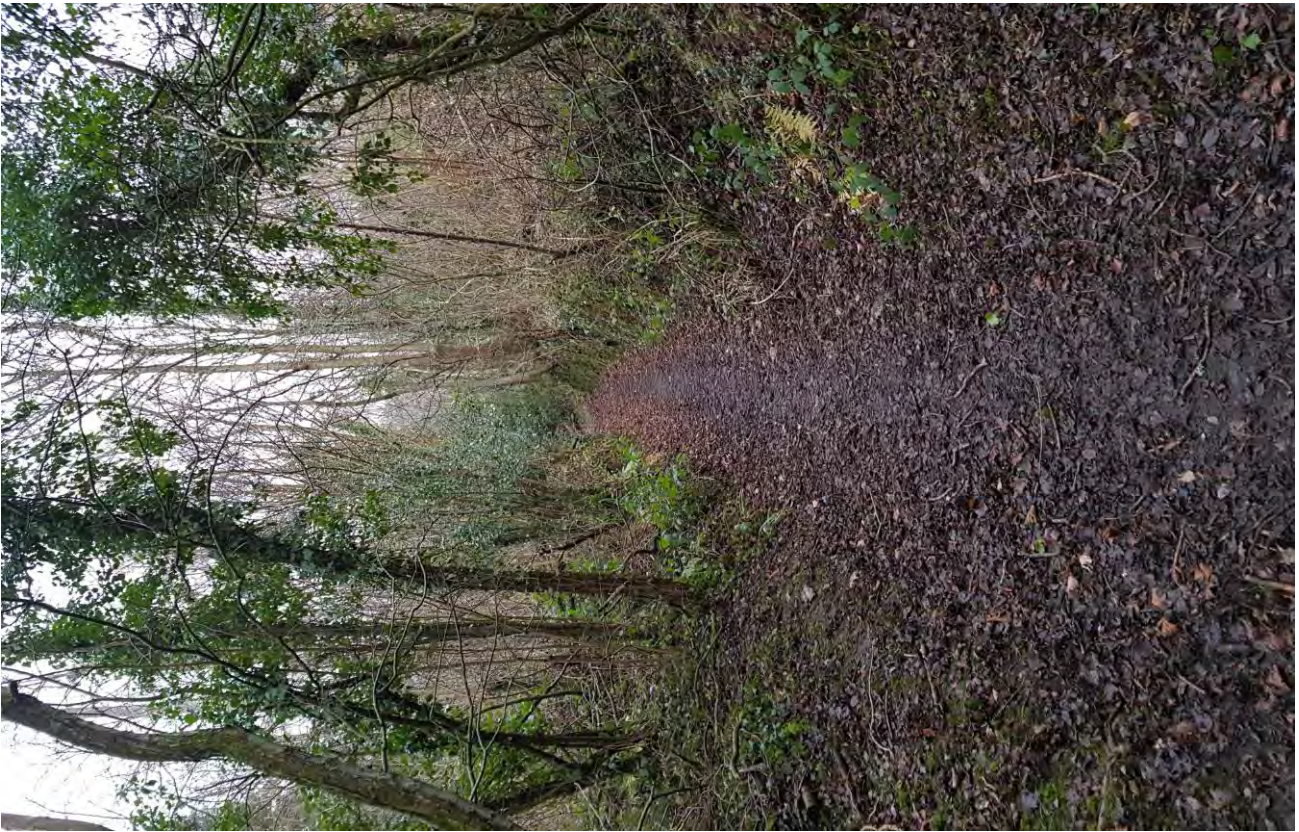
Photograph 9 View of the woodland area in the north of the site
