FRONT STREET, GROSMONT,  
WHITBY, YO22 5QE

FORMER GROSMONT IRONWORKS,  
GROSMONT, NORTH YORKSHIRE

PHASE 1 ARCHAEOLOGICAL SURVEY

Report no: 2007/303.R01  
Version: Final  
Date: July 2007  
Author: Shaun Richardson & Ed Dennison

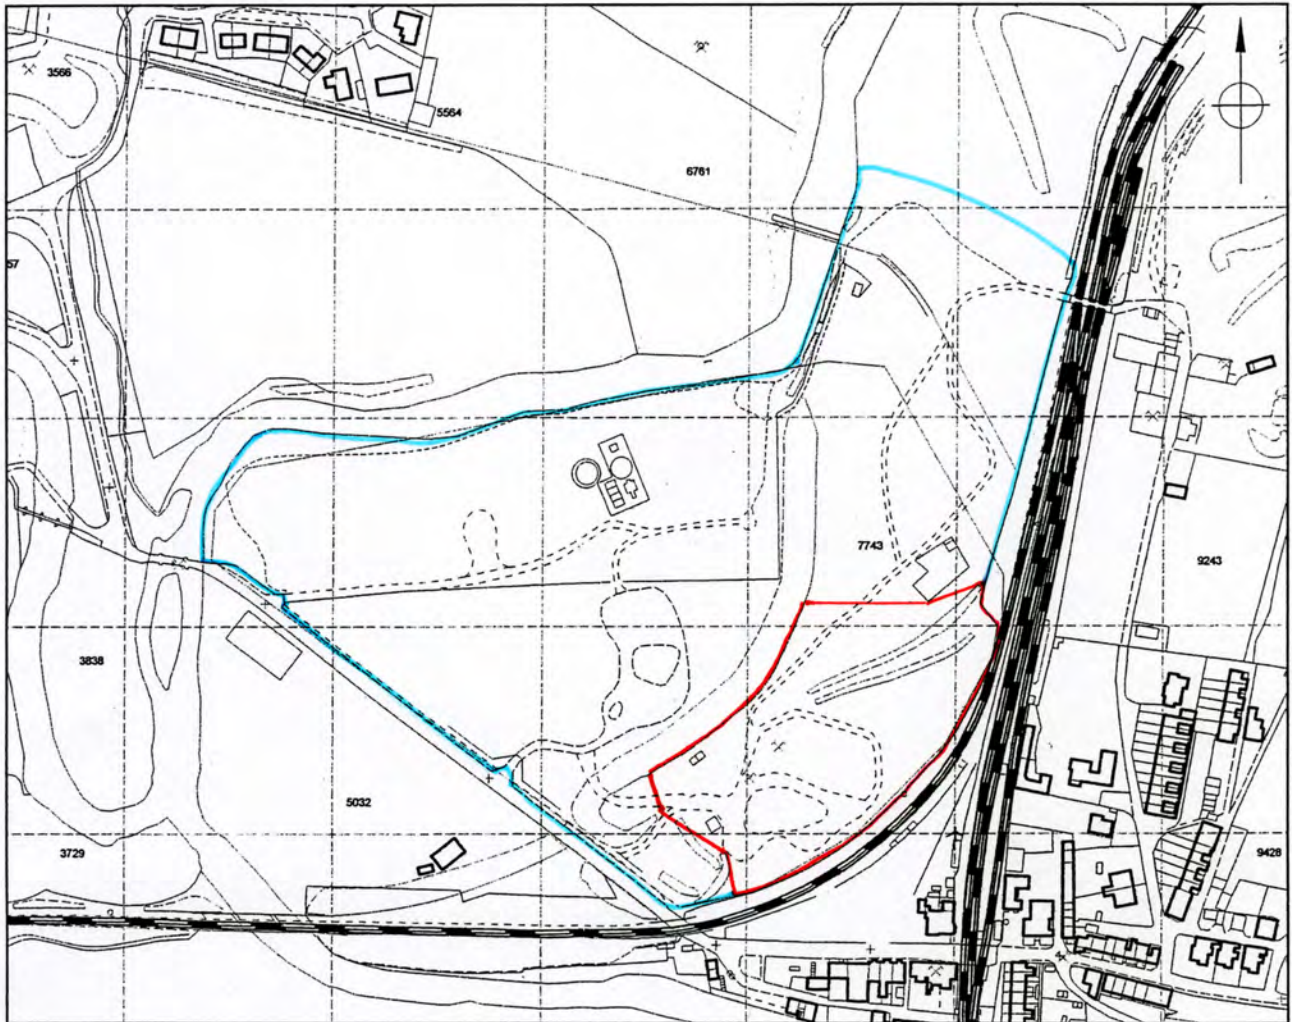
PROJECT		GROSMONT IRONWORKS	
TITLE		SURVEY AREAS	
SCALE	AS SHOWN	DATE	JUL 2007
	EDAS	FIGURE	2

- Detailed survey area
- Walkover survey area

- 1.5 The detailed survey area was sub-rectangular in plan and measured c.150m long (north-east/south-west) by c.76m wide (north-west/south-east) (see figure 2); the area corresponded to the National Park Authority's upper car-park adjacent to the railway station. Following the initial site survey work, it was agreed that a walkover survey would be carried out over an expanded area to the north and north-east, as far as the river Esk and a former bridge crossing the main Whitby to Pickering line. This enlarged area, which included the National Park Authority's lower car-park, covered most of the former ironwork's slag tips as well as a number of other features apparently associated with other industrial enterprises, such as the brickworks formerly located to the east of the railway line.

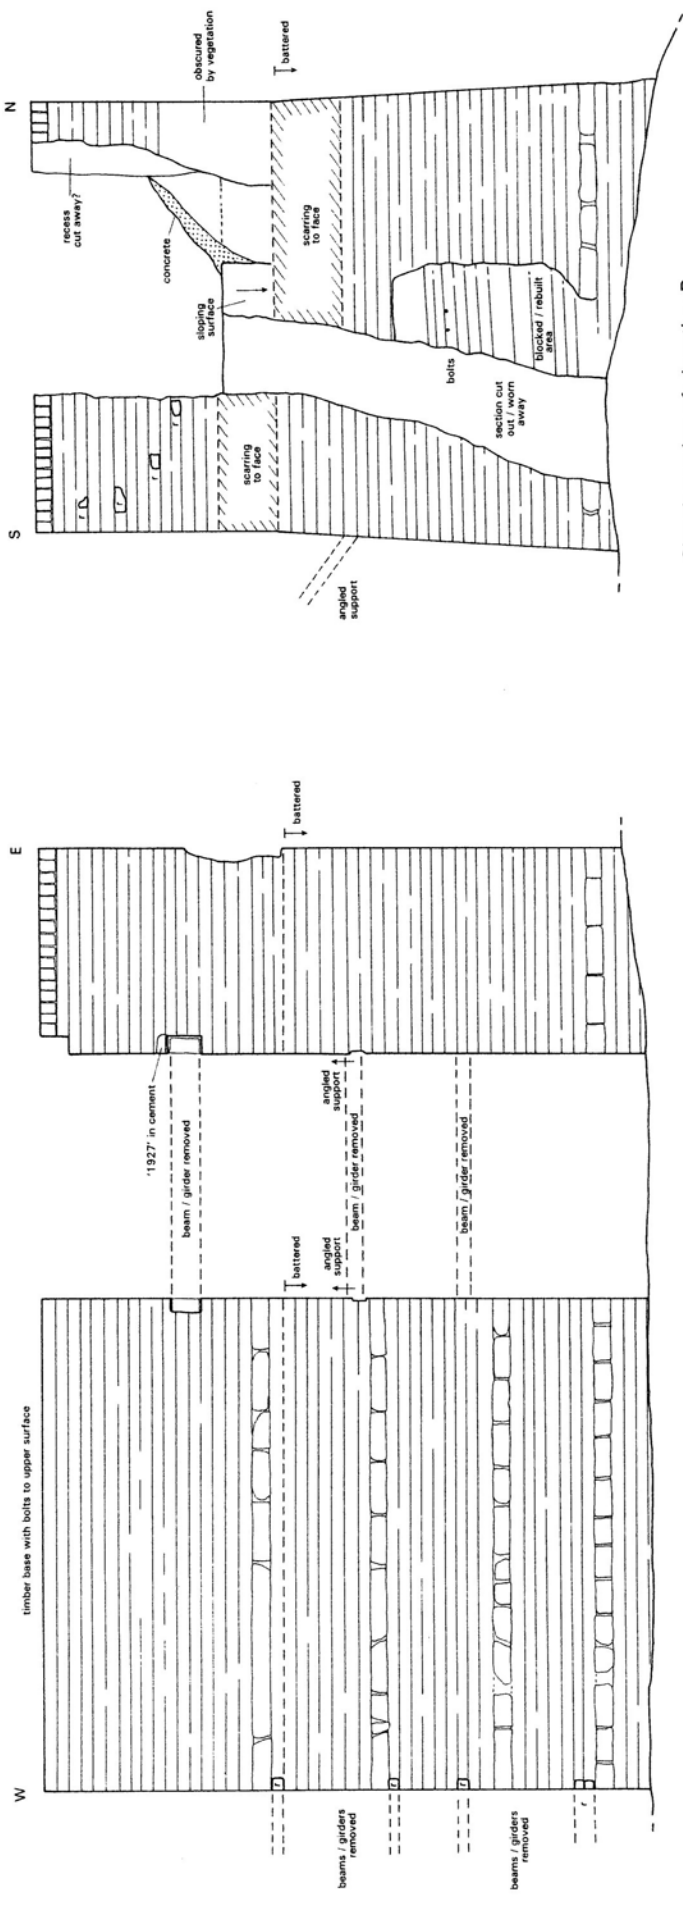
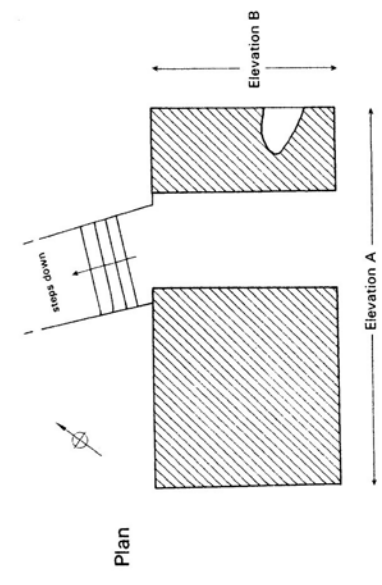
PROJECT	GROSMONT IRONWORKS		
TITLE	SKETCH SURVEY OF HOIST BASE		
SCALE	AS SHOWN	DATE	JUL 2007
	EDAS	FIGURE	7

Sketch section of elevation A

Sketch section of elevation B

Plan

- 3.14 The ruined structure comprises two substantial brick pillars, rising to a maximum height of 4.40m (see plate 7 and figure 7). Both are rectangular in plan, the east pillar being slightly smaller than the west, but both have battered north and south faces and both are built of handmade reddish-brown and yellow bricks, incorporating bands of large refractory bricks. The east pillar has been subject to more alteration than the west, including a large irregularly-shaped area of repair or alteration, crudely carried out in re-used refractory bricks to the east face. To one side of the repair, a sub-oval "shaft" has been cut down through the body of the pillar. The shaft is c.0.60m deep and open to the east side, sloping downwards at a slight angle from north to south. There also appear to be the remains of a circular shaft in the east face. It is difficult to determine exactly how the shaft was cut into the brickwork; it has the appearance of being worn away in several stages by rubbing or friction, but this is not clear. The gap between the two pillars was once crossed by several beams or girders, the uppermost of which was a later insertion, and which bears the date "1927" above its former east end. The ground falls away very sharply to the north of the pillars, with the gap between the two now forming a footpath. A number of features are visible in plan only in the immediate area of the pillars, including concrete bases/beds and ruined structures of machine-made brick.

The hoist/lift base lies in the south-western part of the survey area and was partly overgrown with ivy at the time of the survey. It comprises two substantial brick pillars, rising to a maximum height of 4.40m. The eastern pillar is the smaller of the two, being 3.50m long (north-south) by 1.50m wide (east-west), the north and south faces having a battered profile for approximately two-thirds of their lower height. The pillar has been subject to much repair and patching, but the majority is built of handmade reddish-brown and yellow bricks (average dimensions 230mm by 110mm by 70mm) laid in no particular bonding pattern and set with a lime mortar. There is a single course of large refractory bricks running around the base and the pillar is topped by a course of headers set on edge. The east face preserves much evidence for repair and alteration. Towards the centre of the lower part, there is a large irregularly-shaped area of repair or alteration, crudely carried out in re-used refractory bricks and incorporating two iron bolts which project slightly from the face. On the south side of the repair, a sub-oval "shaft" has been cut down through the body of the pillar. This shaft is c.0.60m deep and open to the east side, sloping downwards at a slight angle from north to south. There appears also to be the remains of a circular shaft in the east face. It is difficult to determine exactly how the shaft was cut into the brickwork; it has the appearance of being worn away in several stages by rubbing or friction, but this is not certain. On both sides of the shaft, there are horizontal bands of shallow scarring to the face of the pillar, four to five courses deep and set at different heights. Above these, there is a wide gap in the centre of the east face, forming a step or recessed area running across the full width of the pillar. This could not be accessed at the time of the current survey but it appears to contain evidence for several phases of brick concrete alteration, as do the parts of the east face which rise above it to either side.

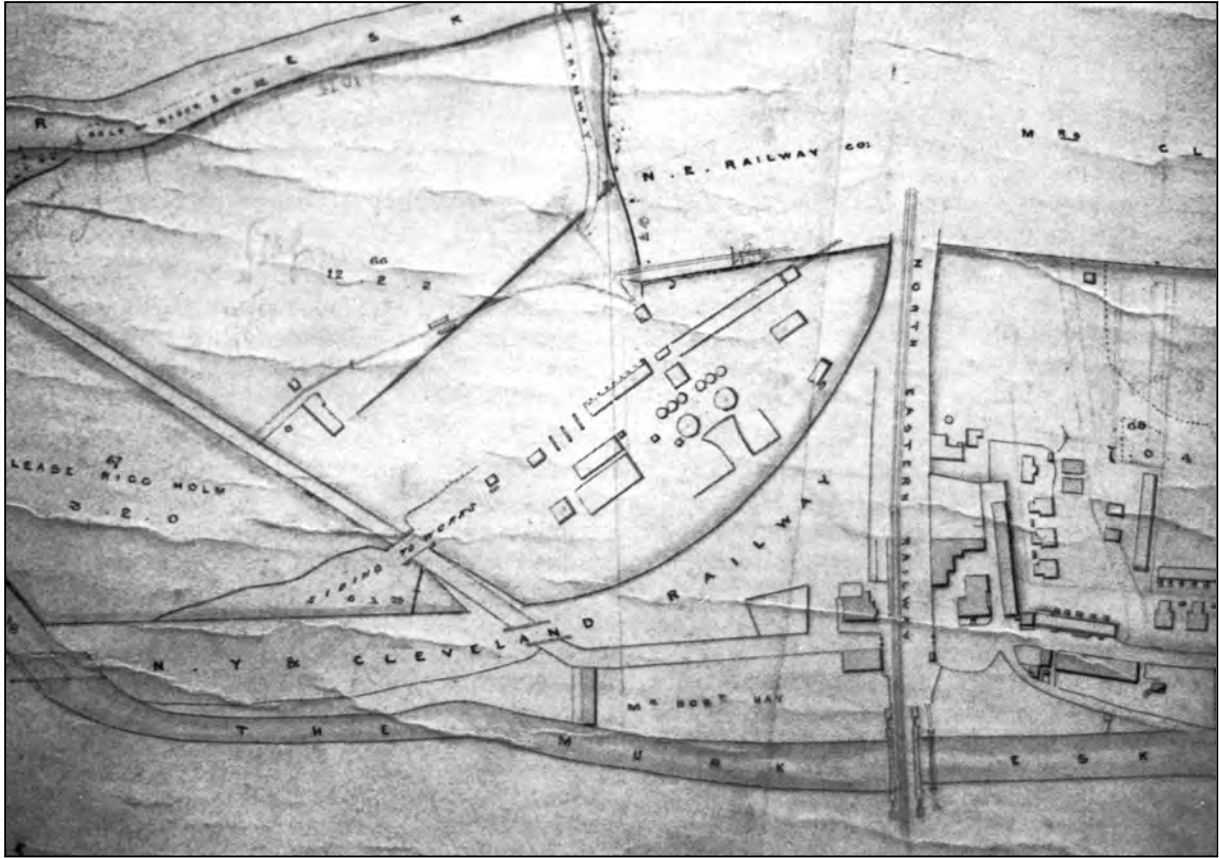
Plate 3: Plan of Grosmont ironworks in 1864 (from Shill & Minter 1994, 290).

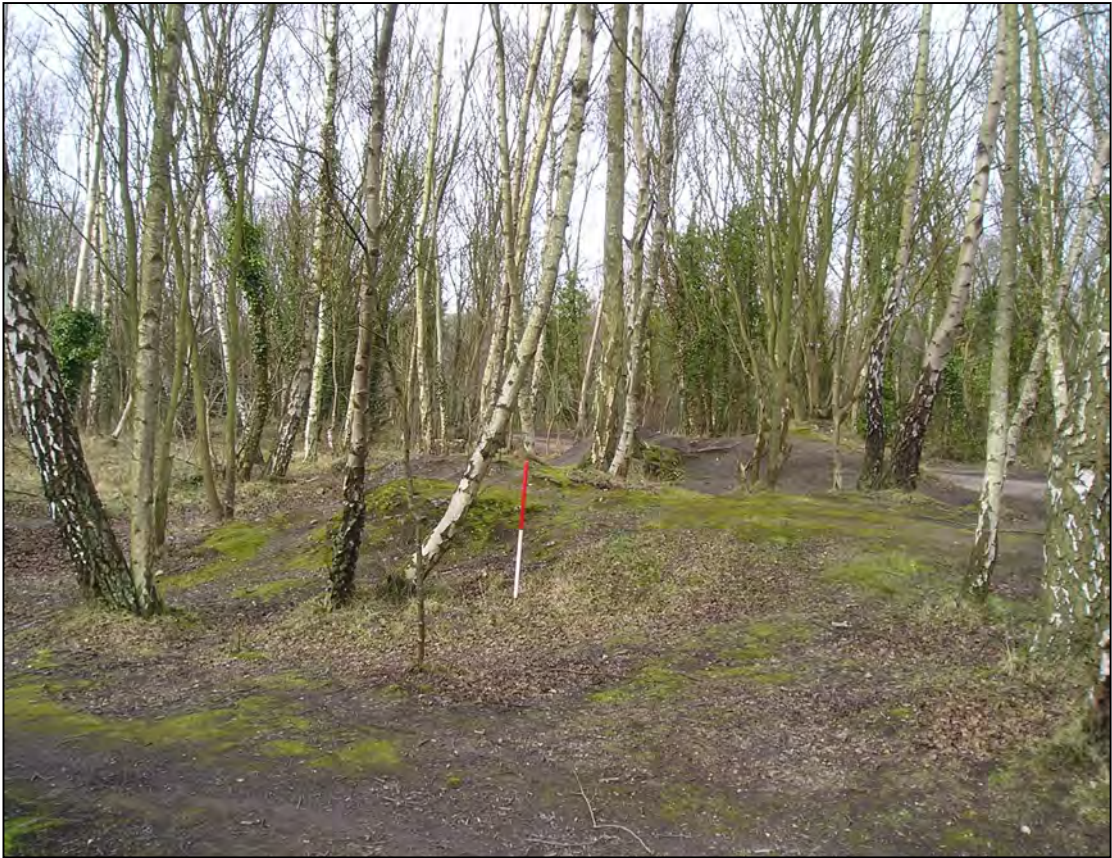
Plate 5: Furnace base (Site 7), looking NW.

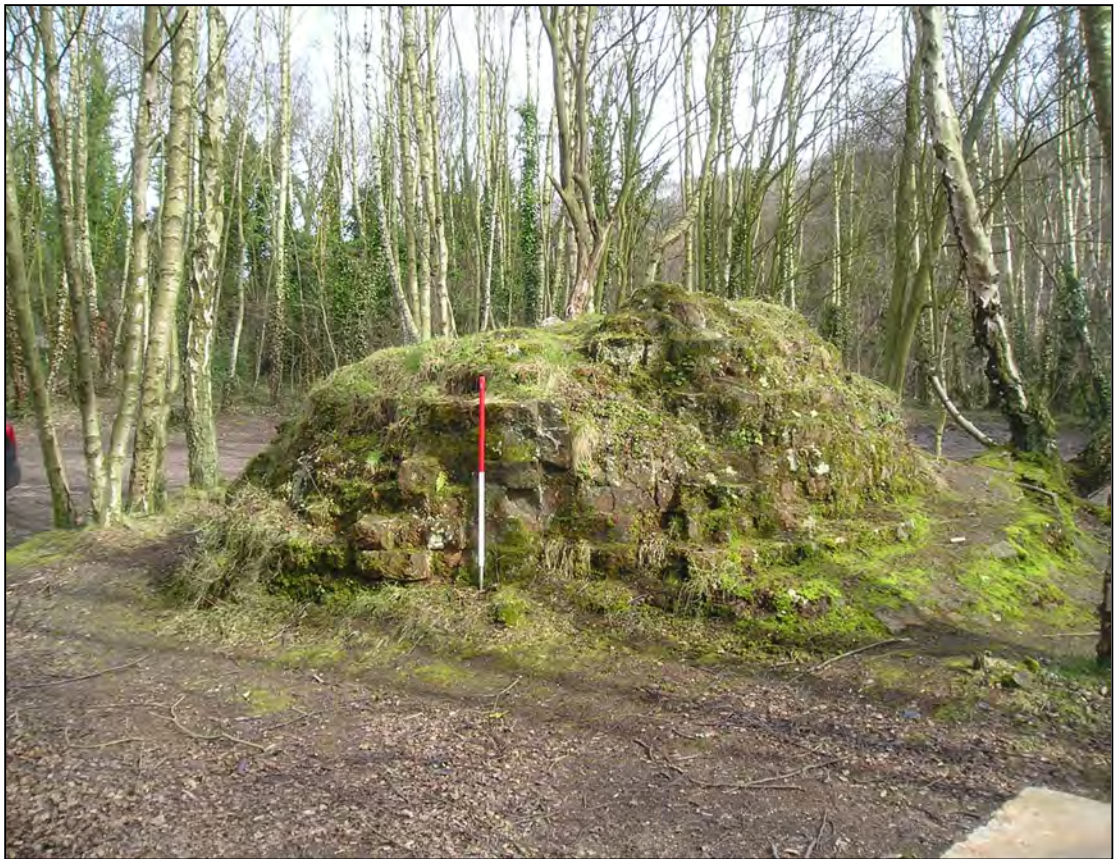
Plate 6: Furnace base (Site 8), looking NE.

- 4.6 As has been previously noted, almost nothing remains above ground of the Grosmont ironworks. The main visible elements are the remnants of the lower part of the third and latest furnace (**Site 8**) and the tramway bridge to the north (**Site 20**) which brought iron ore from the mines located near Priory Farm. However, it is likely that the remains of all three of the blast furnace bases survive below the present NYMNP car-park; the 1863 description of the works describes their substantial nature and depth, together with associated flues and pipes.

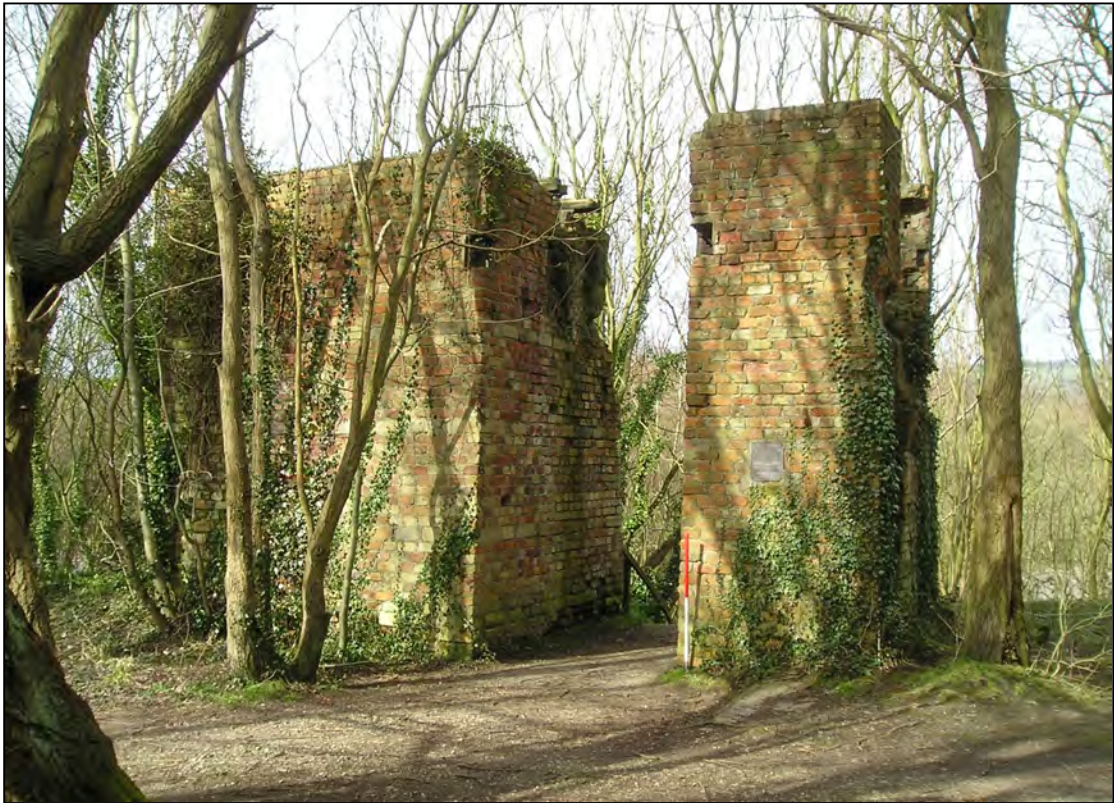
Plate 7: Remains of hoist / lift (Site 2), looking NW.

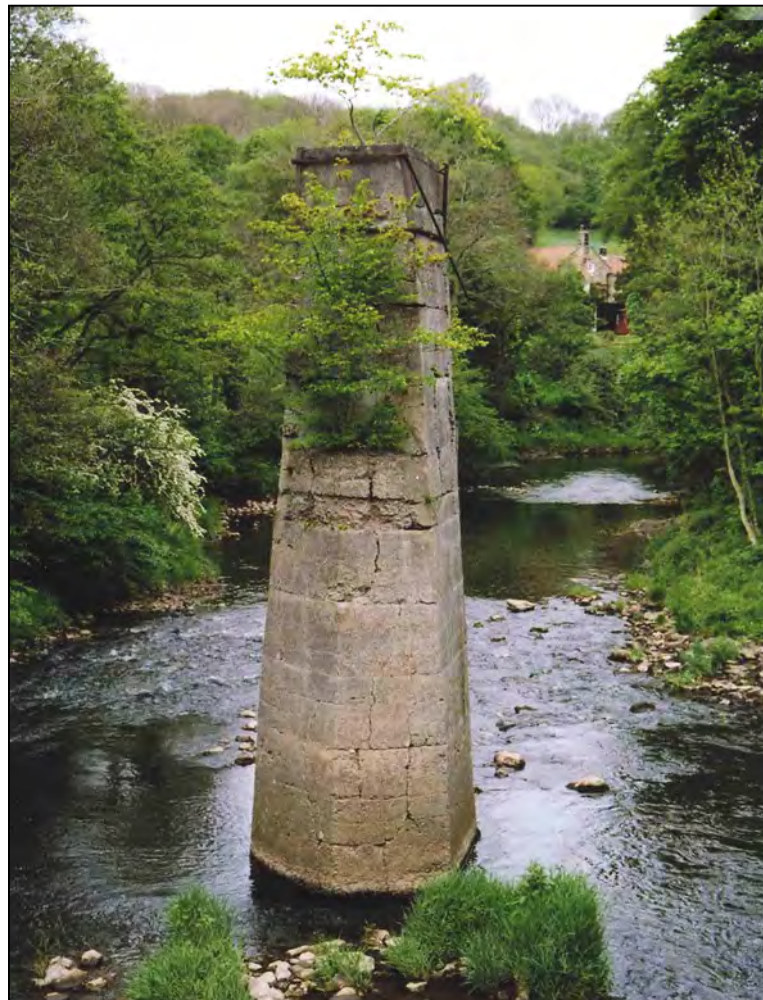
Plate 8: Bridge pier (part of Site 19), looking N.

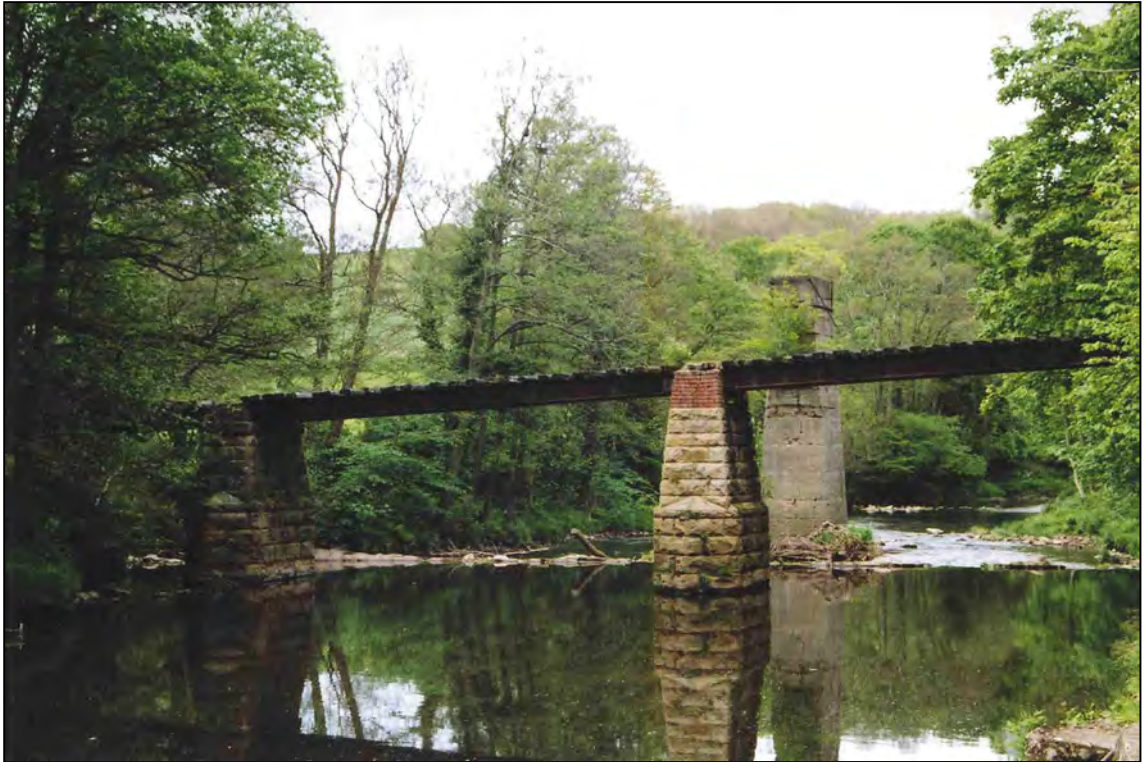
Plate 9: Tramway bridge (part of Site 20), looking N.

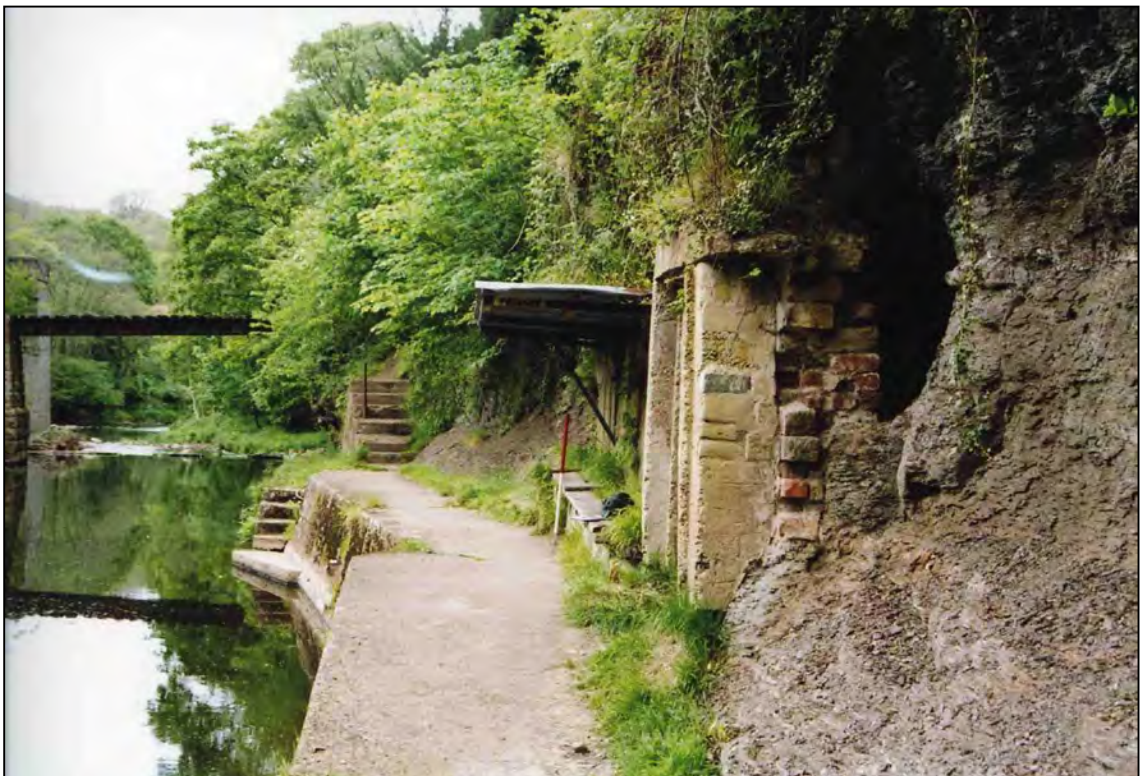
Plate 10: Wharf and related structures (Site 22), looking NE.

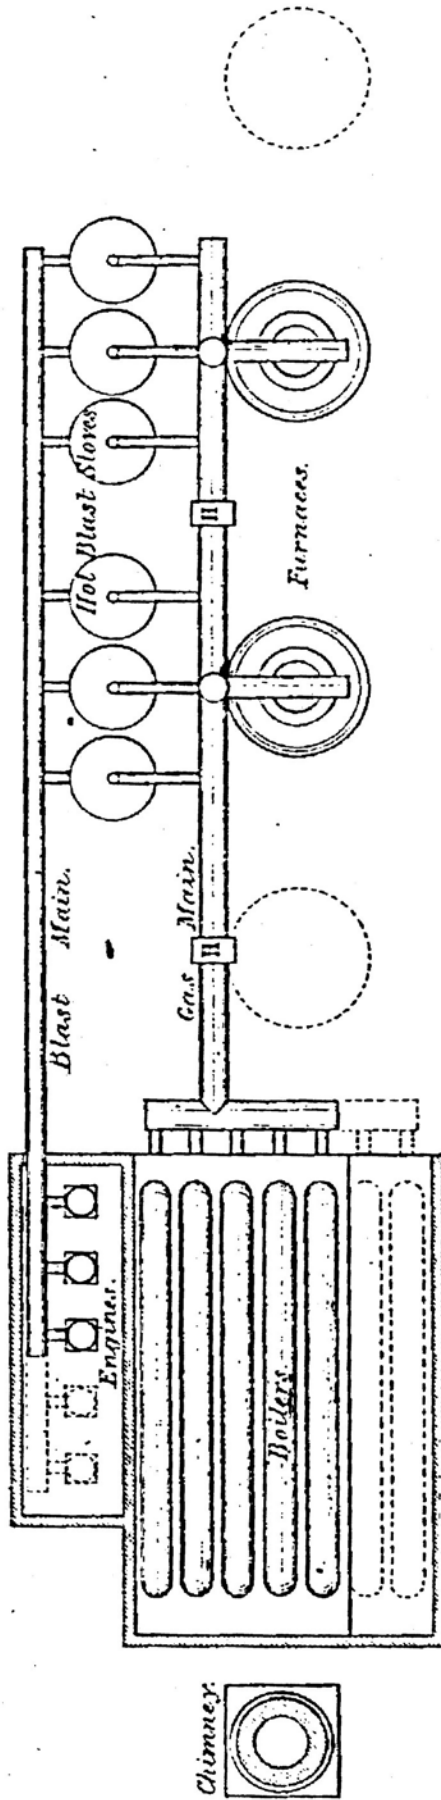
Fig. 1. General Plan of Works.

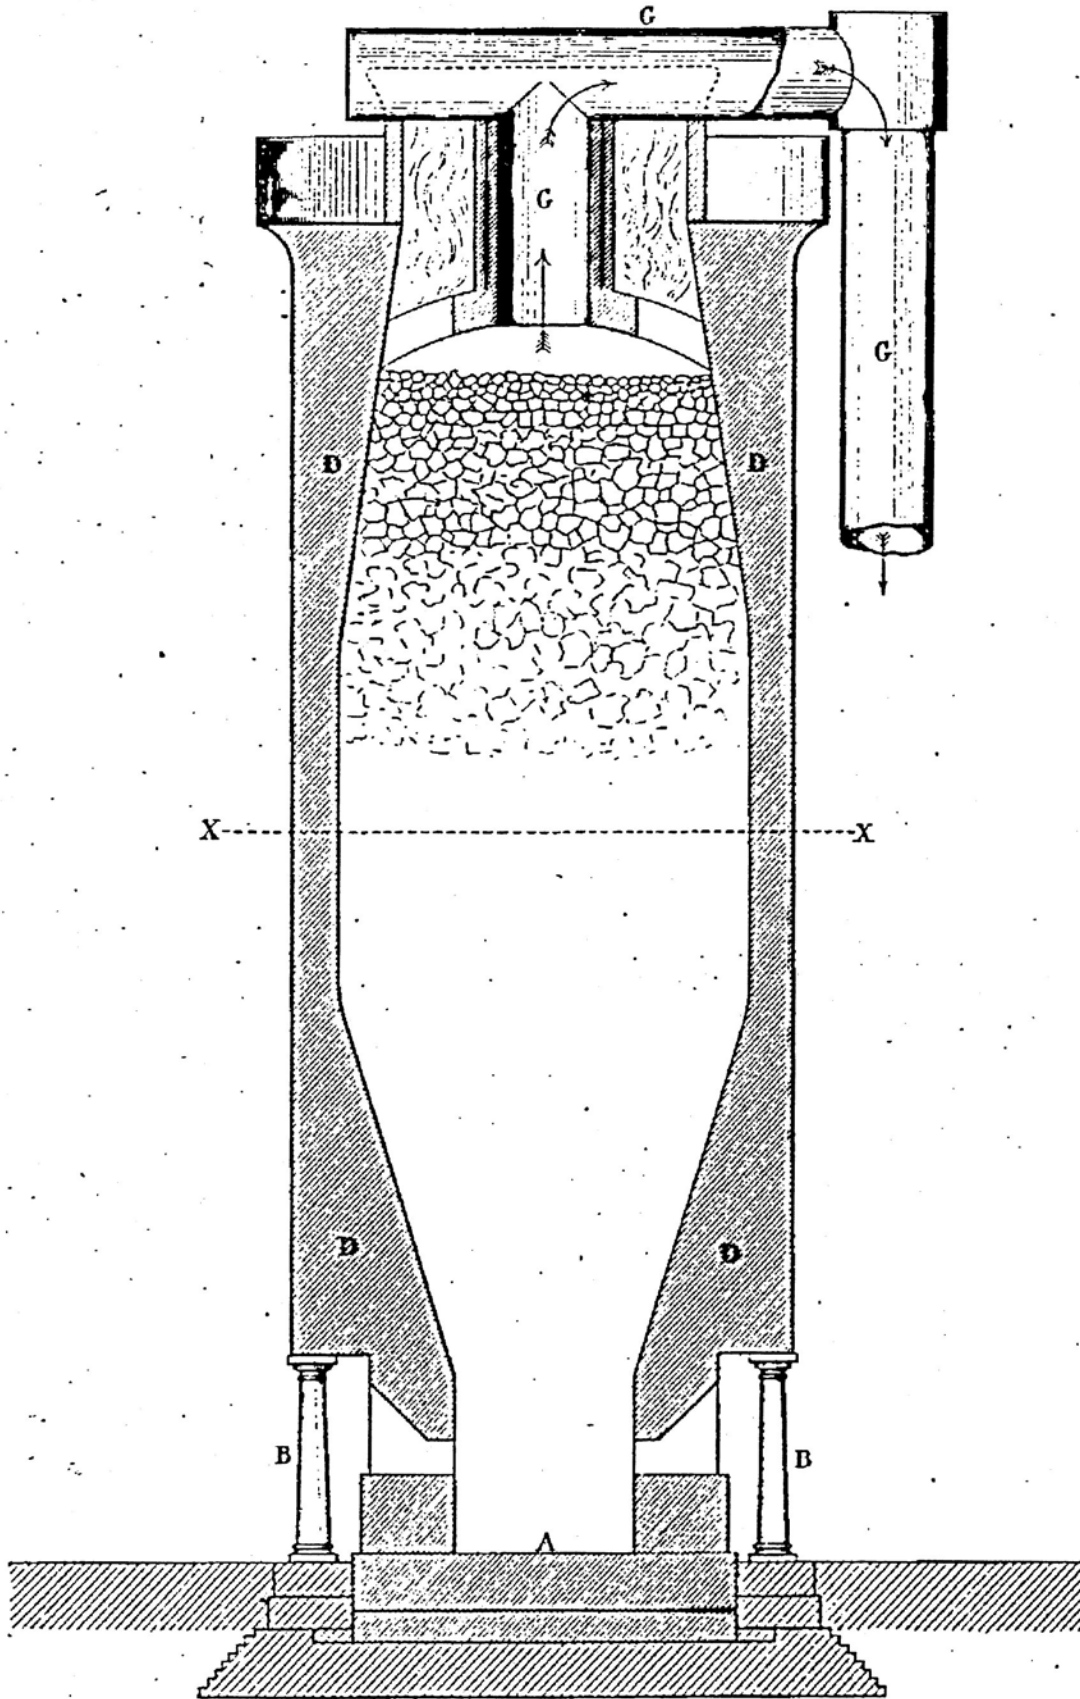
Fig 2. Vertical Section of Blast Furnace.

Each furnace measures 18 feet diameter at the boshes, and a total height of 63 feet from ground line to level of charging floor. The foundations were dug out to a depth of about 9 feet, to rock on one side and hard blue clay on the other, the ground sloping in the direction of the dip of the rock. The stone foundations both for the hearth and casing of the furnace are shown in the vertical sections, Figs. 2 and 3, Plates 62 and 63, and consist of ring courses of masonry built on concrete, about 26 feet diameter, each course being bound by a wrought iron ring, 5 inches wide and  $\frac{7}{8}$  inch thick, Fig. 3. In the interior of the uppermost ring course is built the firebrick hearth A, Fig. 3; the blocks of which this is formed are shown in plan and vertical section in Figs. 6 and 7, Plate 64. These blocks are set in ground fireclay in a moist state, special care being taken to secure a perfectly homogeneous mass, as the whole of the superstructure of the furnace and its contents when in working order, weighing about 1200 tons, rest upon this foundation. On the top course of masonry the foundation plates of cast iron, 3 feet 6 inches square and 4 inches thick, are bedded in fireclay, to which are bolted the cast iron columns BB, Fig. 3, 17 inches diameter, for carrying the superstructure. These columns are united at the top by a cast iron ring or cornice C in segments,  $3\frac{1}{2}$  inches thick, each segment having a semicircular snug cast on its under side, which when the work is joined together fits into the top of the column B, thus binding the whole of the segments into one ring.

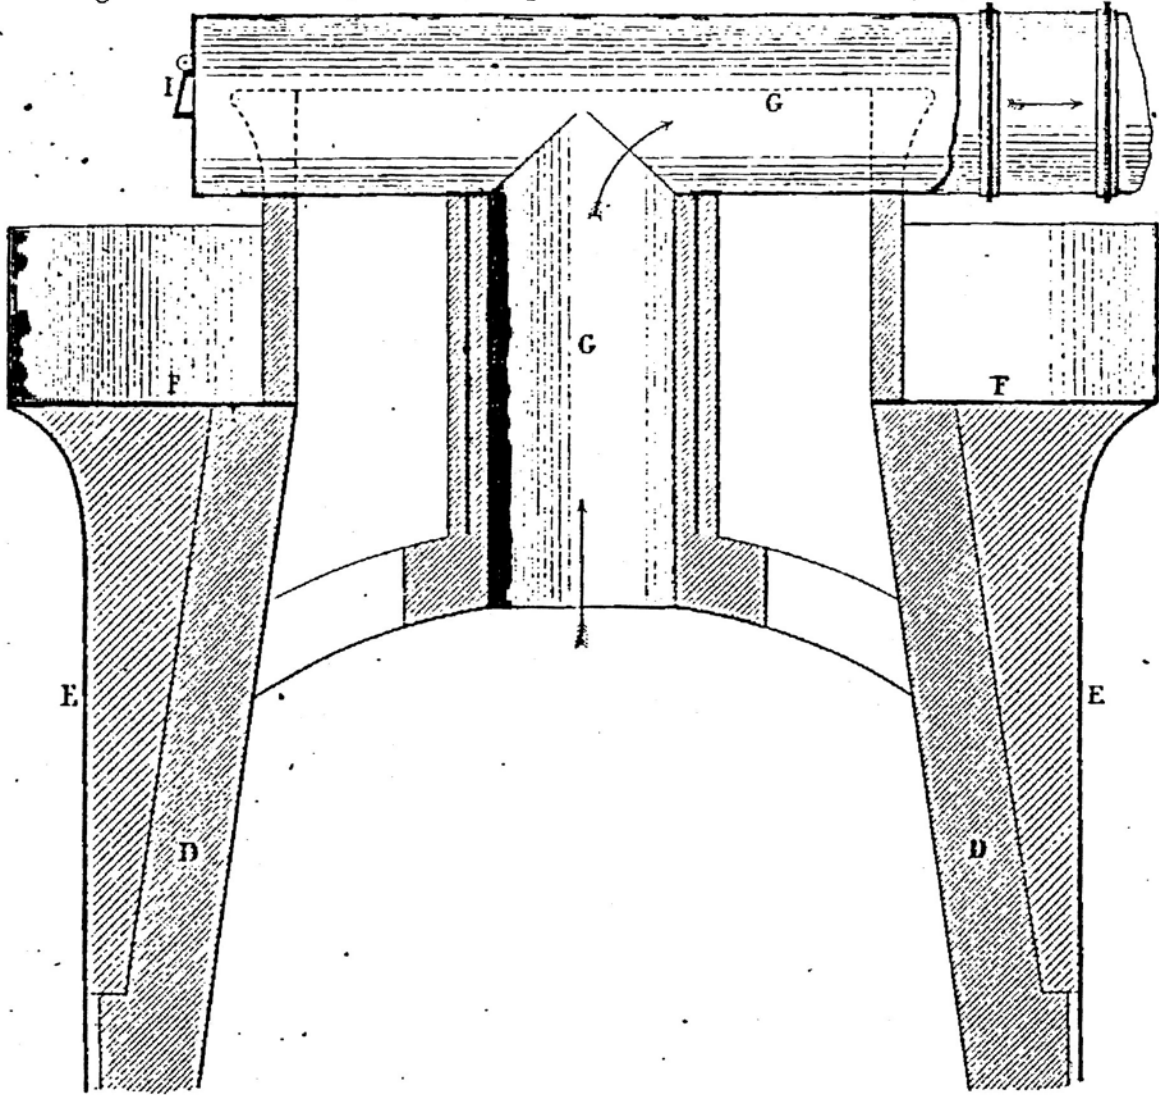
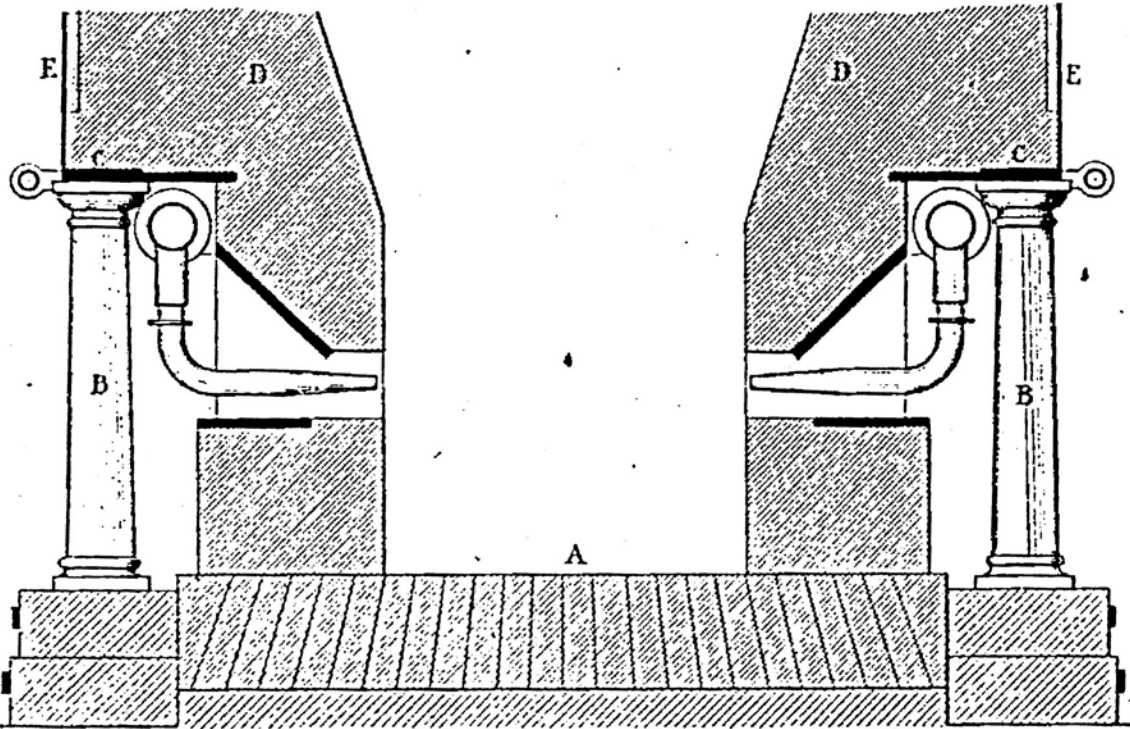
Fig. 3. Vertical Section of top and bottom of Blast Furnace.

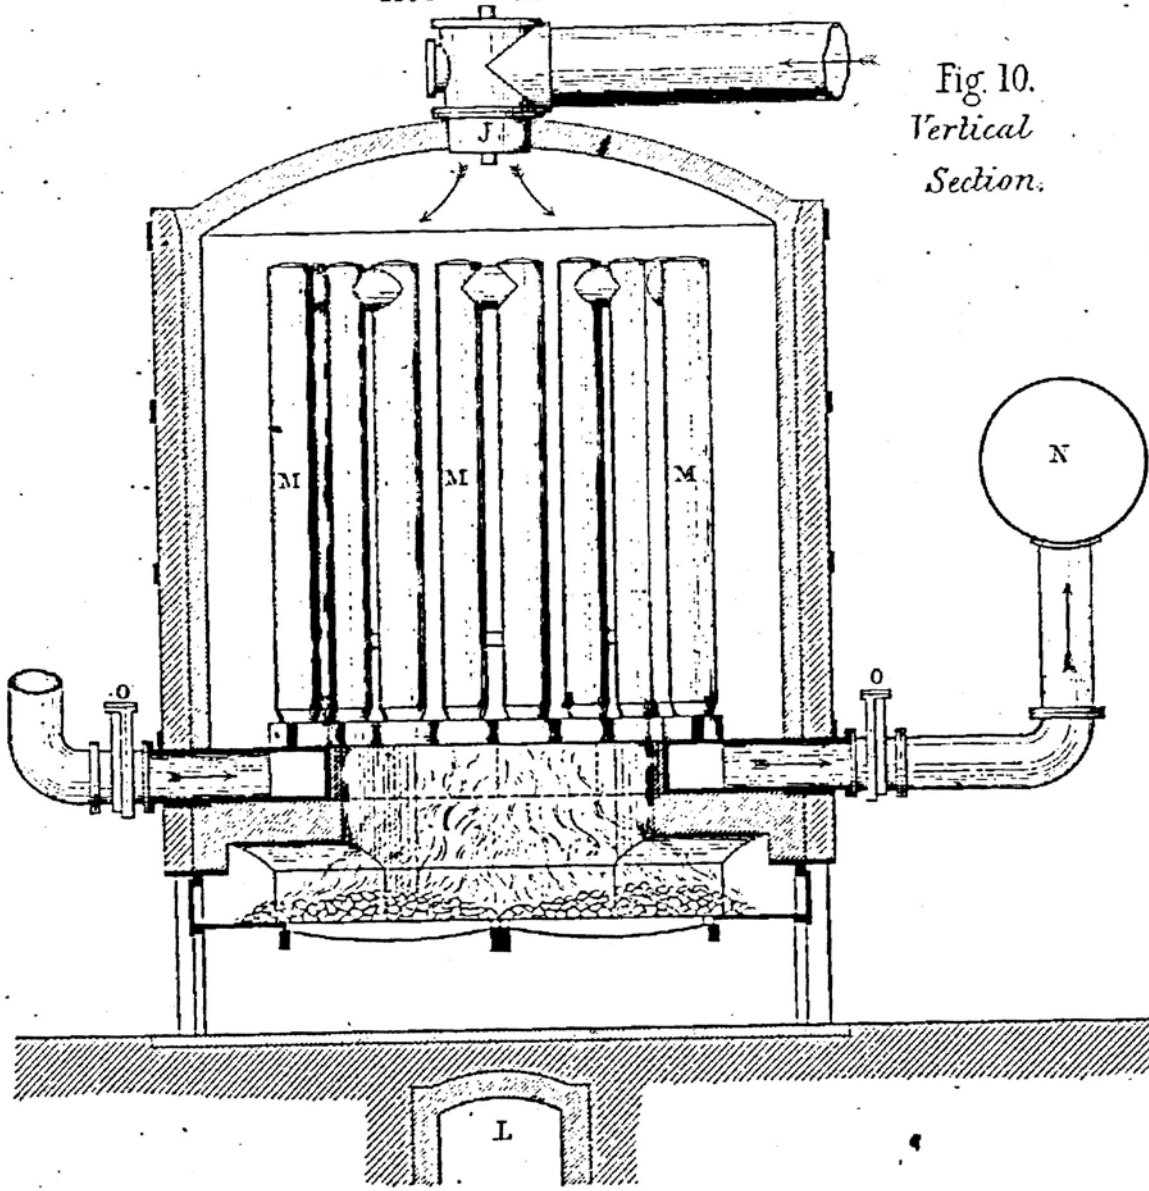
Fig 10.  
Vertical  
Section.

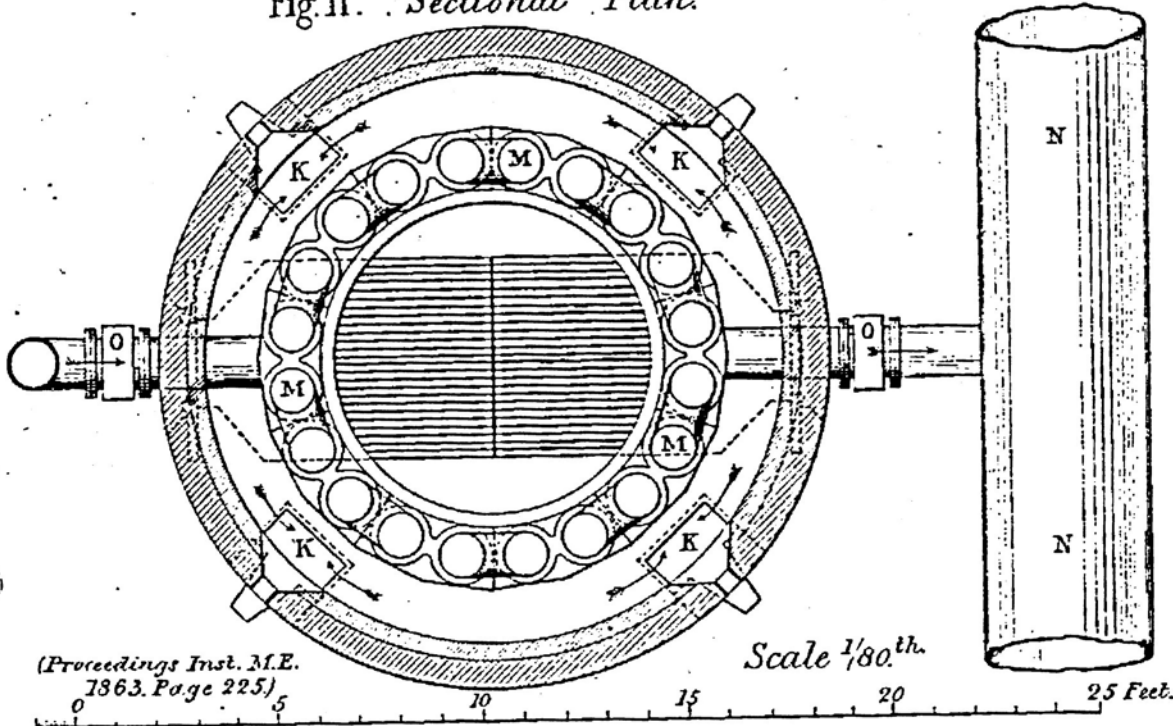
Fig 11. Sectional Plan.

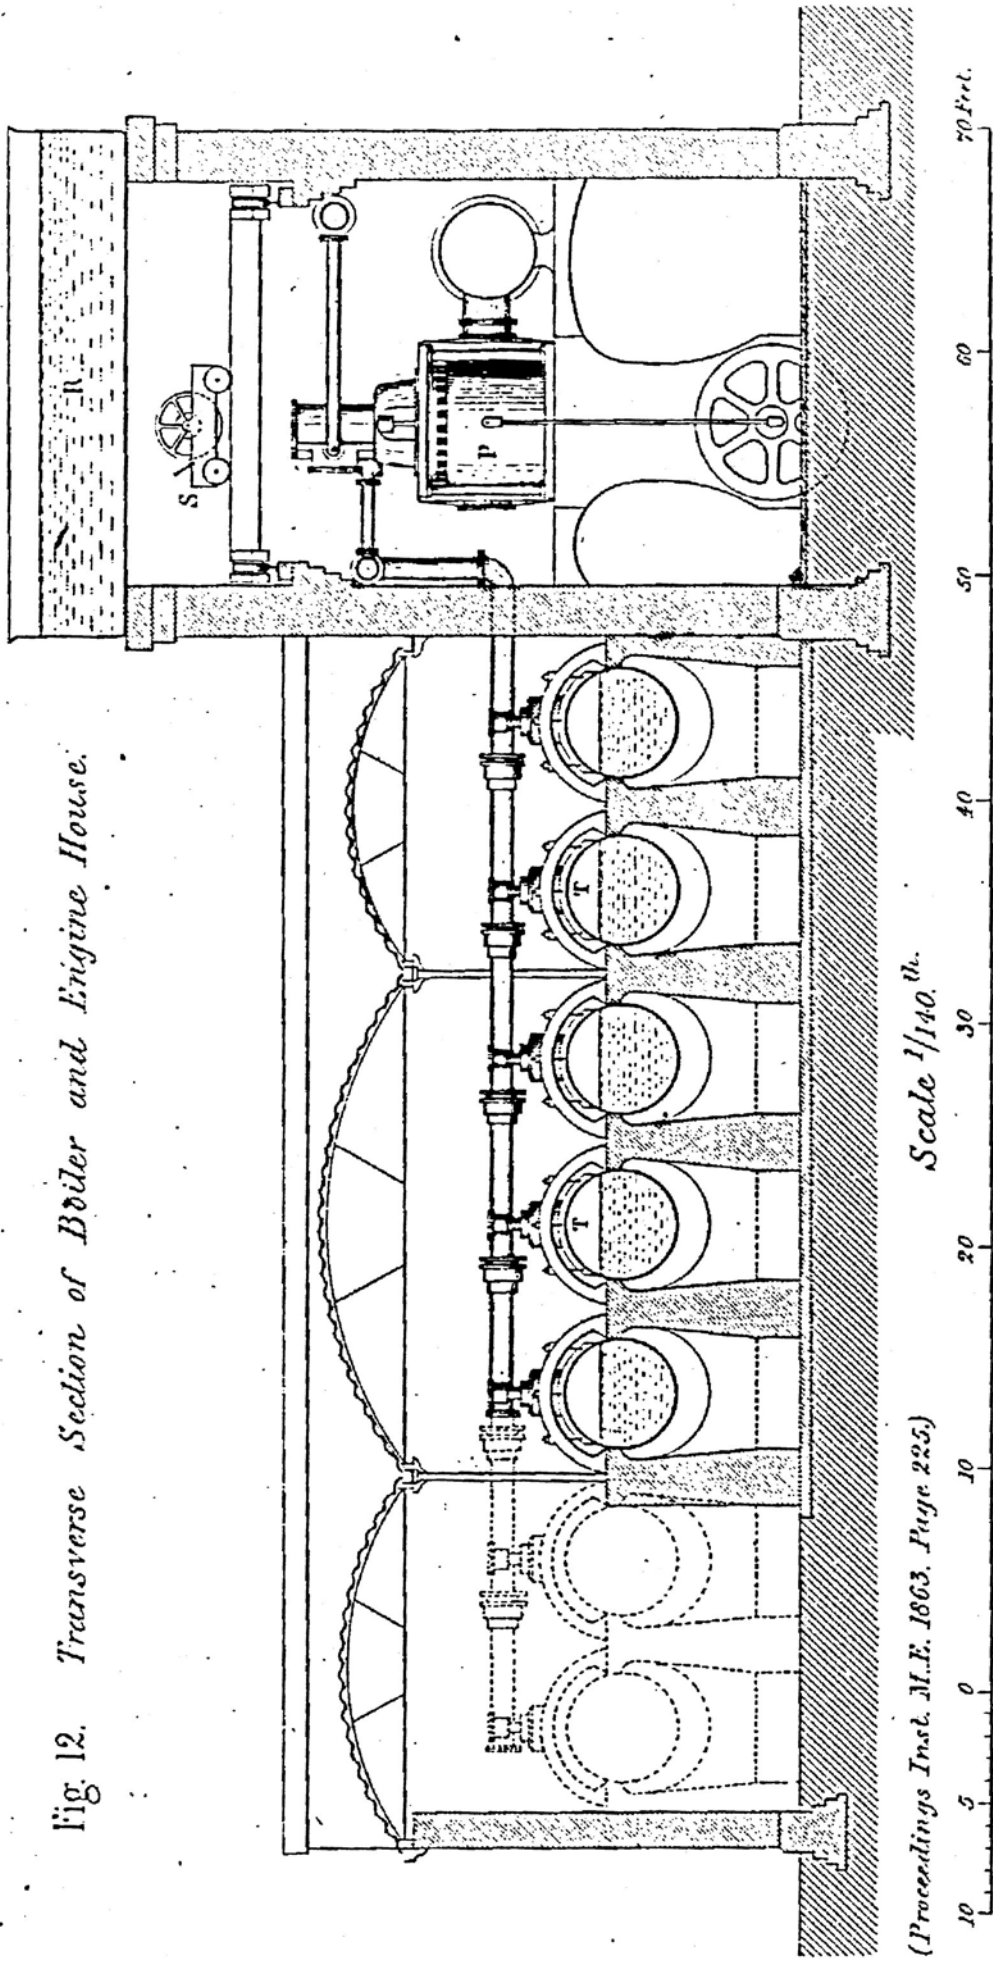
Fig. 12. Transverse Section of Boiler and Engine House.

The engine house is of red brick with mouldings of white brick, and presents a good appearance; the roof is formed by the water tank R, Fig. 12, Plate 66, which contains the water supply for the tuyeres, pig beds, &c. In the engine house is fixed a travelling crane S for the convenience of examining any portion of the engines; this is found a most useful appendage. The water supply is derived from the river Esk by two lift pumps having trunk cylinders  $7\frac{1}{4}$  inches diameter. The boilers T, Fig. 12, Plate 66, are five in number, each 73 feet long by 5 feet diameter, of the plain egg-ended form, heated by the waste gas from the blast furnaces. They are suspended by means of cast iron bridges from the top of the boiler seats, and are fed by three donkey engines, all connected to one pipe over the boilers. The steam pressure is 60 lbs. per square inch above the atmosphere.
