Thirley Cotes Farm, Harwood Dale

Bat Survey, June 2018.

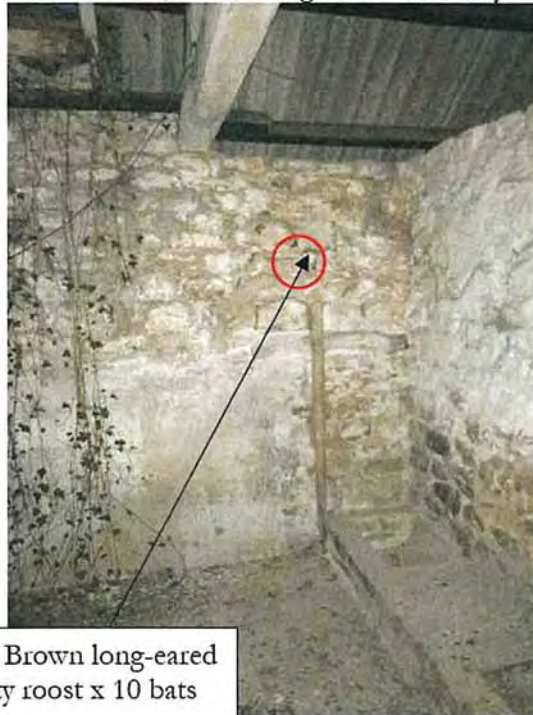
Plate 8 – Barn 1, brown long-eared maternity roost

Brown long-eared	Maternity x10	Barn 1 Roost 3	Located in a gap in the internal stonework	Internal roost x 1 access point via the missing ridge	Missing mortar in the stonework approximately 60mm x 40mm.
23/03/18	Hibernation	No hibernating bats were observed during the endoscope inspection.

**Roost 3 - Brown long-eared
maternity roost x 10 bats**

7.2.3 The brown long-eared maternity roost in barn 1 (**Roost 3**) is of medium conservation significance, however a maternity roost of a common and widespread specie requires 'more or less like for like' replacement with constraints on timing (Bat Mitigation Guidelines, 2004). Bat boxes are inappropriate substitutes for maternity roosts in buildings in the case of the brown long-eared maternity roost, do not constitute 'like for like' replacement.

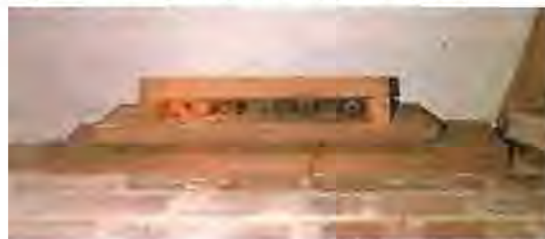
Plate 12 - Example of an open bottomed slot box (Norfolk Bat Group)

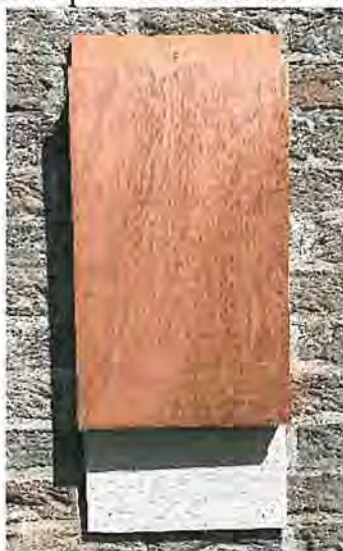
Plate 13 - Example of an open bottomed slot box (Wold Ecology Ltd)
