WOLD ECOLOGY LTD

Thirley Cote Farm, Harwood Dale

Bat and Barn Owl Survey, August 2010.

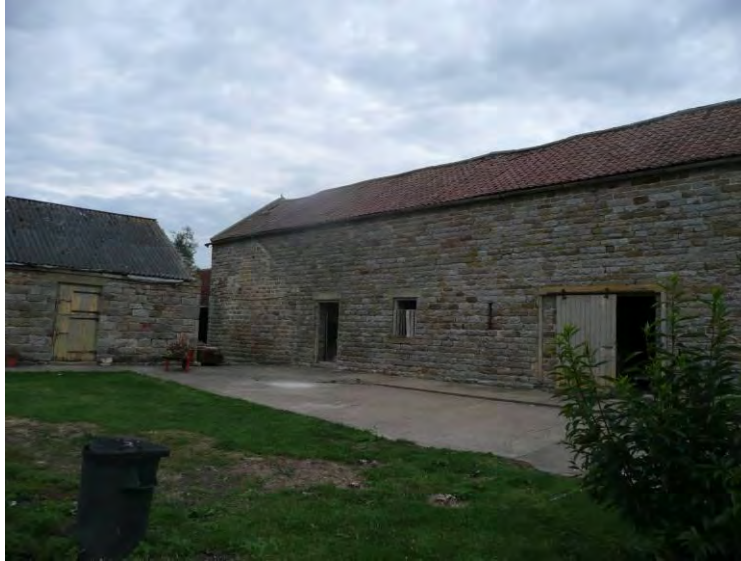
Figure 1 – Barn, south elevation.

- 2.7.1.1 The barn was built in the 1830's and consists of two storeys built from local stone with a pitched roof; it is currently used for storage. The roof is in poor condition with loose and missing pan tiles on the north pitch. The roof deteriorated significantly during the winter of 2010. The ridge is intact with no obvious gaps but numerous gaps are present beneath the gable coping stones.

There are subsidence cracks on the north and south elevation and adjacent to the east gable; there are numerous gaps in the mortar and above the wall plate. There are also gaps adjacent to the timber window frames and doors. The western part of the barn is single storey and an open fronted barn in an 'L' shape. The red pan tile roof has gaps beneath the tiles. The single storey section is supported by smooth sawn timbers, brick pillars and steel girders; there are gaps in the brickwork and in the timber joints throughout.

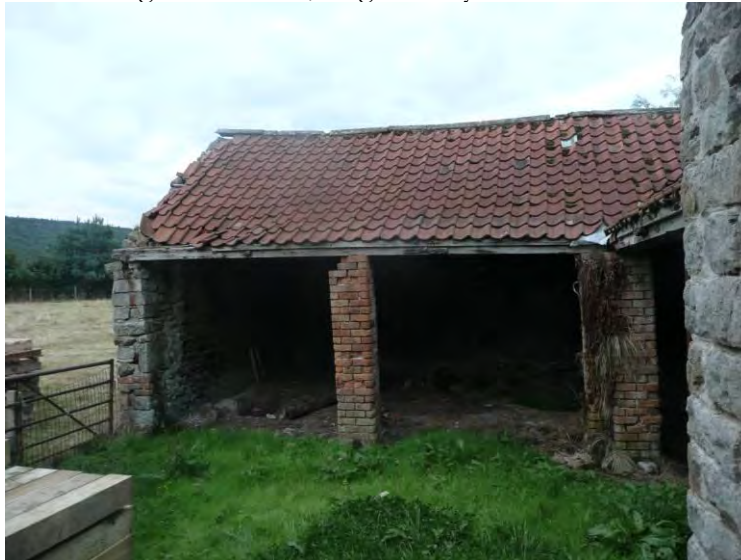
Figure 2 – Barn, single storey west section.

5.7.1 Barn owl pellets, were found on the floor of the open fronted, single storey section at the western end of the barn. A barn owl was observed during the bat emergence survey and it returned to the roost in the single storey section of the barn during the dawn survey.

5.9.1 As conversion of the barn would destroy a barn owl roost site, **Wold Ecology highly recommend the provision of 2 barn owl nest boxes on the borders of the site, away from the proposed development.** Both boxes should be erected on poles or trees and work should be completed prior to any work being started on the hayloft. Two boxes are usually recommended because during the breeding season the male bird is often driven from the nest site by the female. The male is forced to roost elsewhere whilst still providing food for both the female and the chicks. A second box would make provision for nesting and the roosting male.

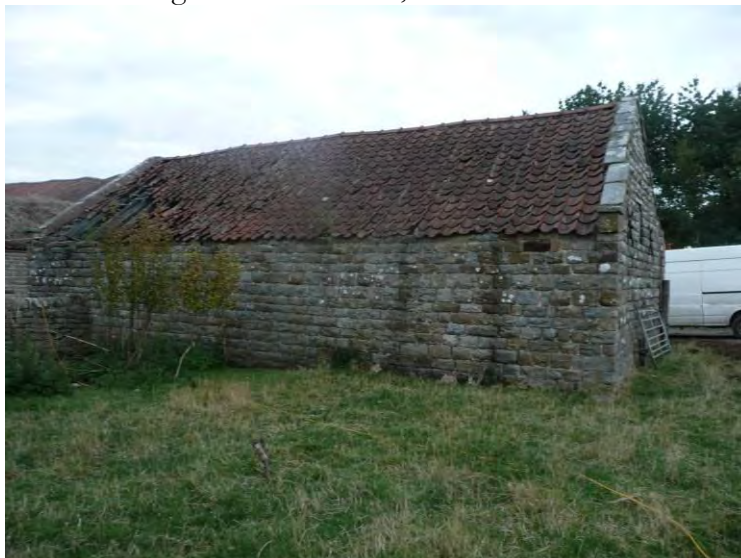
Figure 3 – Cart shed, south elevation.

- 2.7.1.2 The cart shed is a single storey building with a pitched roof and local stone walls, it is currently empty. The red pan tile roof is in a poor state of repair with missing and slipped tiles, gaps are present beneath. Brick pillars support the roof with gaps present in both the brickwork and stone elevations. There are also gaps beneath the coping stones on the gable ends and adjacent to the timber window frames. Internally, the roof is supported by smooth sawn timber beams, there are gaps above the beams and mortise joints. The roof is not felt lined but gaps are present above the timber sarking. There were no signs of roosting bats or bat activity inside the building, but due to the presence of features with potential to provide roosting opportunities for bats i.e. gaps underneath the tiles, ridge tiles and ivy. The building has been assessed as having a MEDIUM POTENTIAL to support bats (see 2.10 figures 3 and 4).

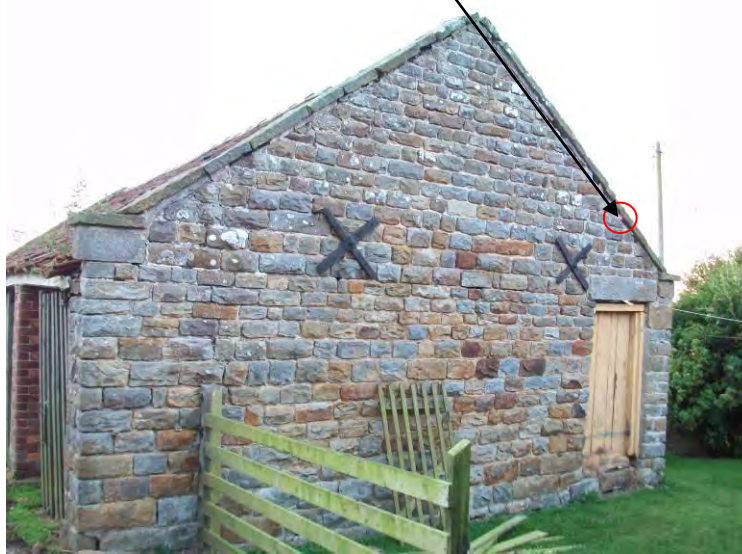
Figure 4 – Common pipistrelle roost 1, west gable of cart shed.

- **Roost 1** – common pipistrelle (x 1 bat) summer roost is located on the west gable of the cart shed, in an external crack in the stonework. The roost will be lost as part of the proposed development (see 2.9.3 and 2.10, figure 4).

- 4.3.12 Two lead tiles (4 in total) will be sited on the north and south facing pitches of the cart shed. The exact locations of the tiles will be determined on site by the bat ecologist.

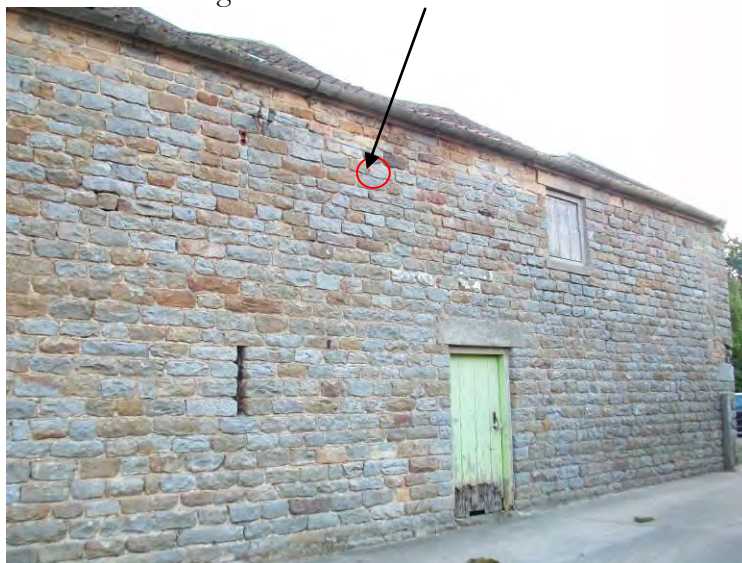
Figure 9 – Natterer's roost 13.

- **Roost 13** – Natterer's (x 1 bat) summer roost is located on the south elevation of the barn, in an external crack in the stonework. The roost will be lost as part of the proposed development (see 2.9.3 and 2.10, figure 9).

- 4.3.12 The walls of the barn and the cart shed will remain intact, therefore a similar variety of crevices to those on the existing stone walls will be provided. Crevices must be maintained at a minimum of 150mm deep by approximately 20 x 20mm wide. At least 8 gaps and crevices will remain post development and suitable crevices will be determined by the bat ecologist. Scaffolding and an endoscope will assist with determining suitable crevices for roosting bats and will include existing roosts or crevices close to the existing roosts.

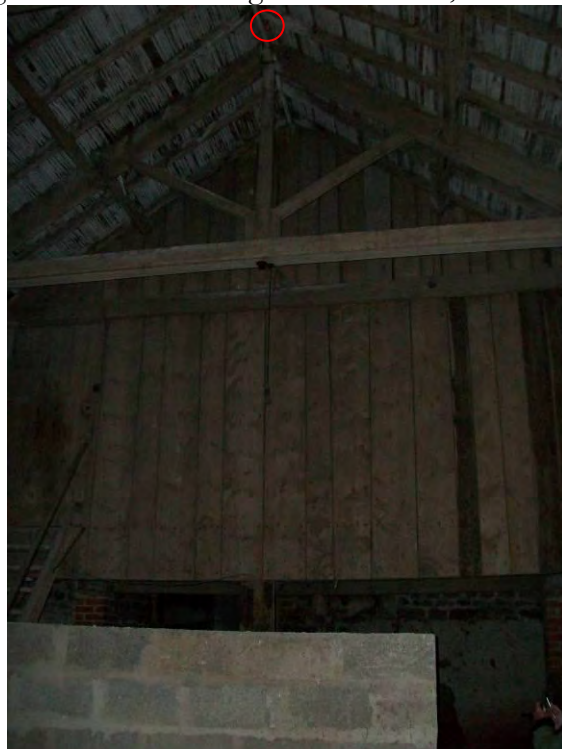
Figure 11 – Brown long-eared roost 16, inside barn.

- **Roost 16** – Brown long-eared (x 1 bat) summer roost is located inside the barn, above a timber roof support. The roost will be lost as part of the proposed development (see 2.9.3 and 2.10, figure 11).
