**Bat, Breeding Bird and Barn Owl Scoping Survey**

**Burgate Farm, Harwood Dale**

**April 2016**

**MAB Environment & Ecology Ltd**

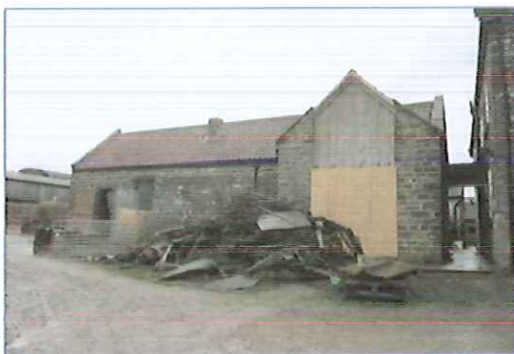
**Photo 1 - Western elevation.**

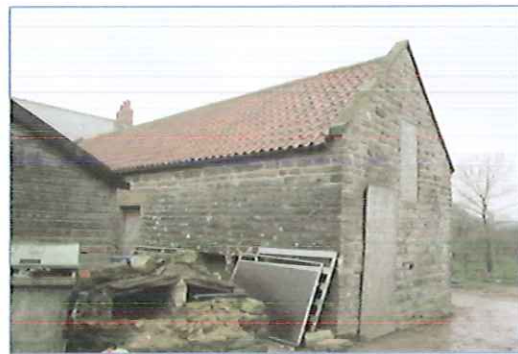
**Photo 2 - View of the building from the north.**

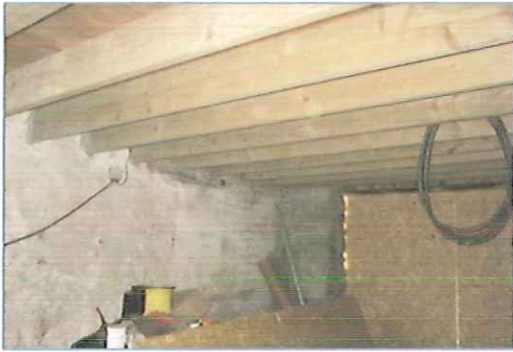
There is an upper floor which has been put in fairly recently. Crevices are present around these timbers where they meet the internal walls. The main ridge beam is steel

Photo 3 - Upper floor timbers. Crevices are present where timbers meet the internal walls.

There is some suitable crevice roosting habitat due to gaps along the eaves and around floor timbers of the upper floor, where these meet the internal walls. The roof is also lined, but is in very good condition having been re-roofed and re-lined in recent years, with no missing or raised tiles providing access into the cavity between the tiles and lining. Due to the location of some features, not all could be comprehensively inspected for signs of use by bats, and the amount of debris and animal manure on the lower floors may also obscure some evidence of use, especially by low numbers. For this reason, and to take account of this low risk bat habitat, it is recommended that a summer emergence survey is carried out in order to complete the impact assessment.

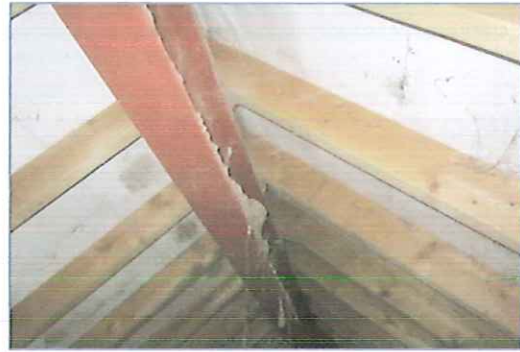
and the roof has a modern breathable roofing membrane. No bat droppings were found on the upper floor.

Photo 4 - Lined roof and steel beam with swallows nesting along beam.

Overall, the building has been assessed as providing low bat roosting potential. There is no evidence of use of the building by void dwelling bat species. The roof is supported by modern smooth sawn timbers and the main ridge beam is steel; therefore there are very limited opportunities for void dwelling bat species such as brown long-eared and Natterer's bat, and a lack of evidence internally, despite dry and undisturbed conditions on the upper floor, confirms absence of any bats roosting along the ridge.

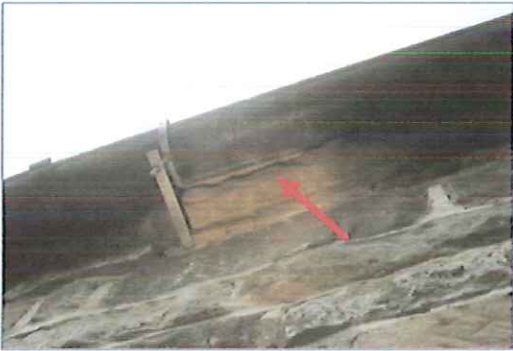
Photo 5 - Gaps along eaves on eastern elevation.

Emergence surveys should be carried out during the period May - August in order to gain a full understanding of the use of the site by bats and to assess the extent to which they may be affected by the proposed development.

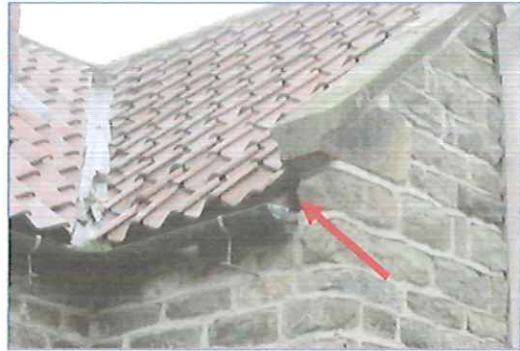
Photo 6 - Gap at corner at eaves level.

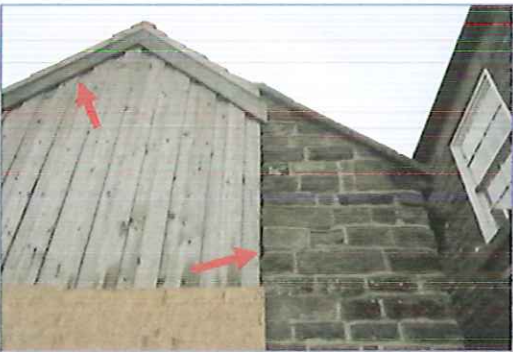
External walls are well-pointed. The roof is also in very good condition having been re-roofed recently. The tiles are in place and tightly fitted. All the lead flashing around chimneys is sealed with no gaps and the concrete ridge line is well mortared. There are gaps all along the eaves and at one corner on the western elevation (photo 6). There are also some small gaps where timber cladding meets the external stone walls on the western gable, and behind a timber fascia board, but this area does not appear to lead into any void and was cobwebby (photo 7).

Photo 7 - Timber fascia and cladding to western gable, with crevices between timbers and stone work.
