**Bat Emergence/Re-entry Survey at  
Manor House Farm, Troutdale**

**May/June 2016**

**Survey of Farm Buildings  
at Manor House Farm, Troutsdale.**

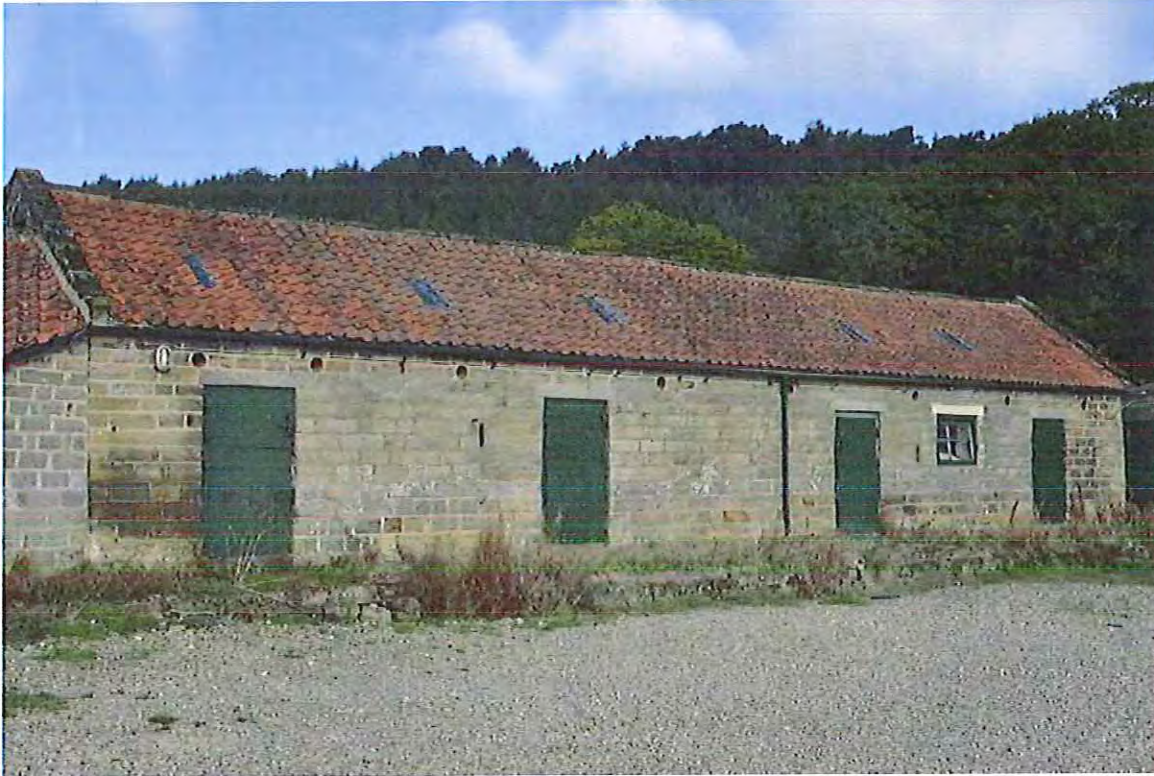
Photo 1: Disused Stable Block/Cow Byre

The survey site consists of a dis-used stable block/cow byre (Appendix 4, Photo 1) and adjoining stores (Appendix 4, Photo 2). The buildings are located within Manor House Farm complex, on Snainton Lane, Troutdale as shown in appendix 1. A number of buildings within the farm complex have already been converted in to holiday accommodation, with the remaining buildings being a mixture of agricultural buildings of varying construction.

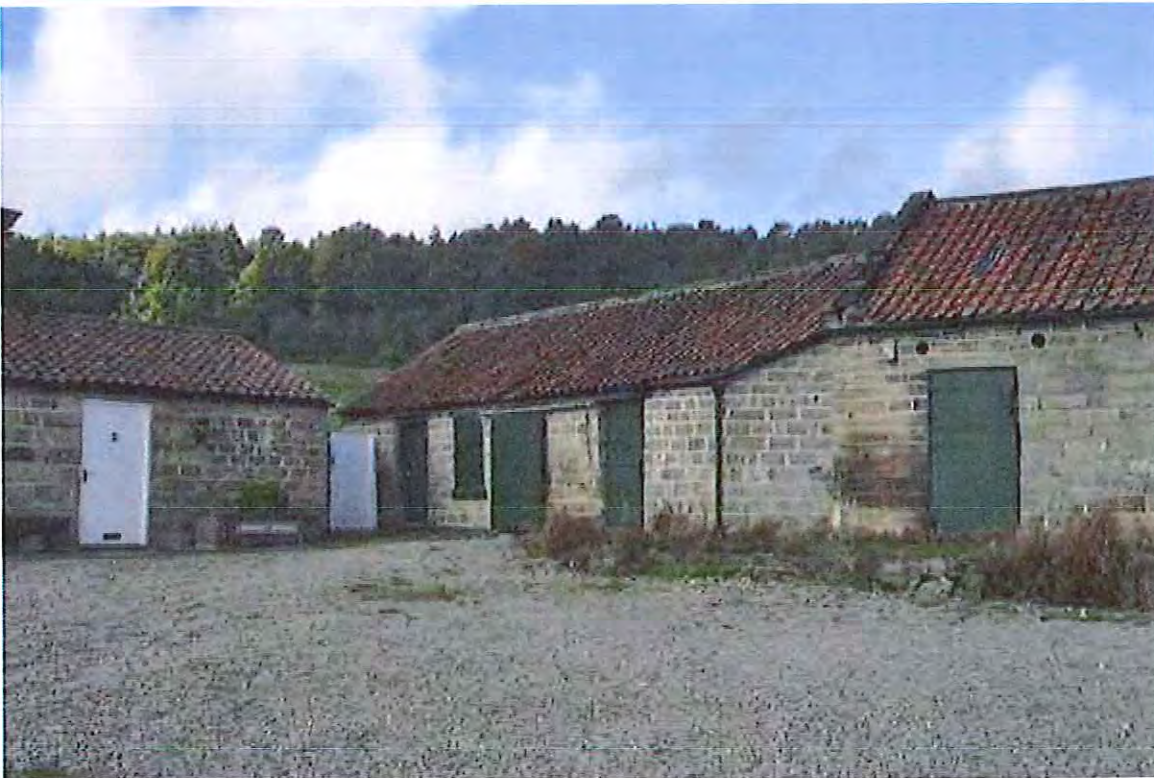
Photo 2: Adjoining Stores

Adjoining the stable block/cow byre is a series of three store rooms (Appendix 4, Photo 2). These rooms were also given a full inspection. The building is of a similar construction to the main building; dressed sandstone, with a clay pantile roof.

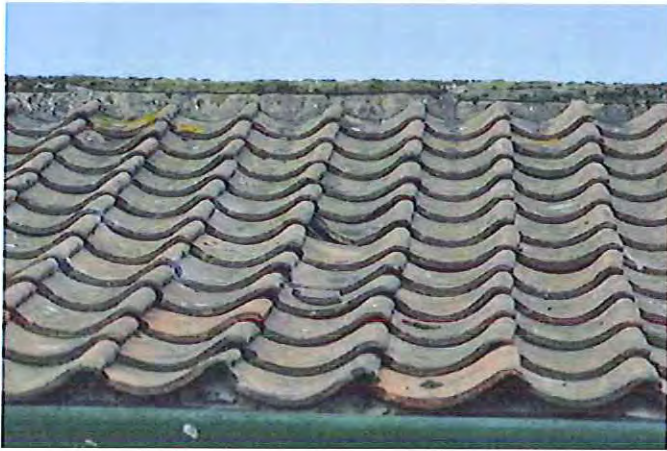
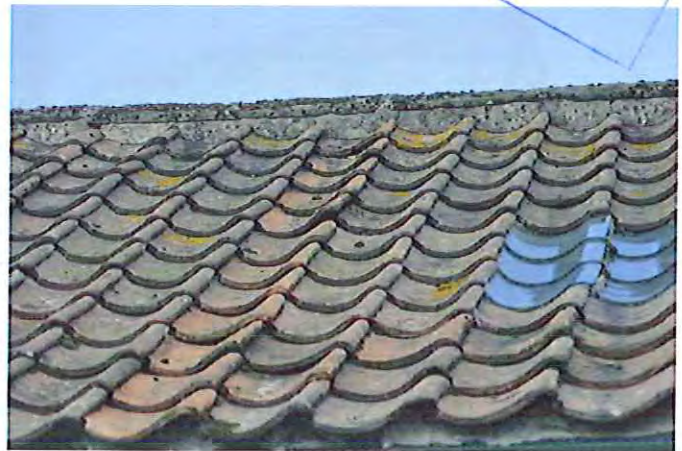
The building is constructed of dressed sandstone with a felt lined, close fitting, clay pantile roof that is in generally good repair however there are some gaps caused by raised and broken tiles (Appendix 4, photos 3 and 4). The ridge tiles are well fitted and the mortar is intact for the length of the ridge. The current condition of the roof suggests it has been reroofed at some point in the past.

Photos 3 and 4: Photos of roof showing some raised and broken tiles, but intact ridge tiles and pointing.

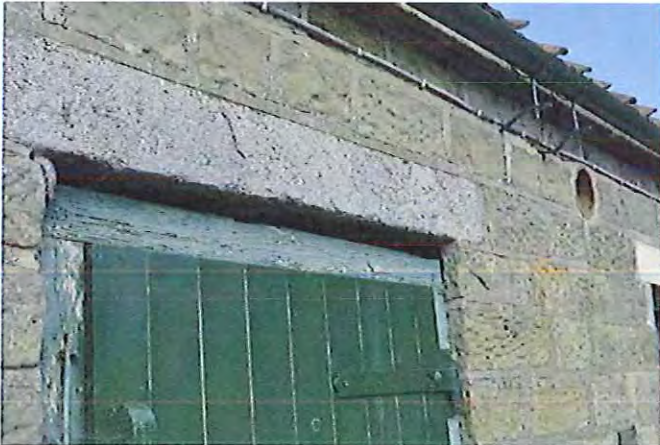
The south east aspect of the building is in a good state of repair, with very little damage to the mortar. There are 4 doorways into the building, each of which has a poorly fitting door and doorframe, with some large gaps between the wood and stone work (Appendix 4, photo 5). There is also a number of ventilation pipes (Appendix 4, Photo 6) just below the eaves and a six pane window, two of the panes are missing.

Photo 5: Gaps above doorframe

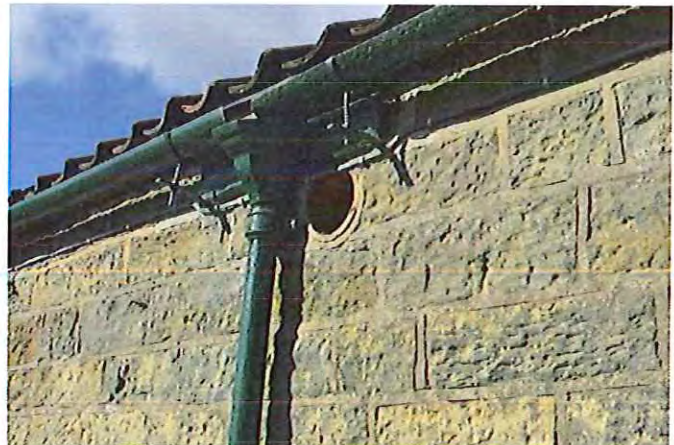
Photo 6: Ventilation holes

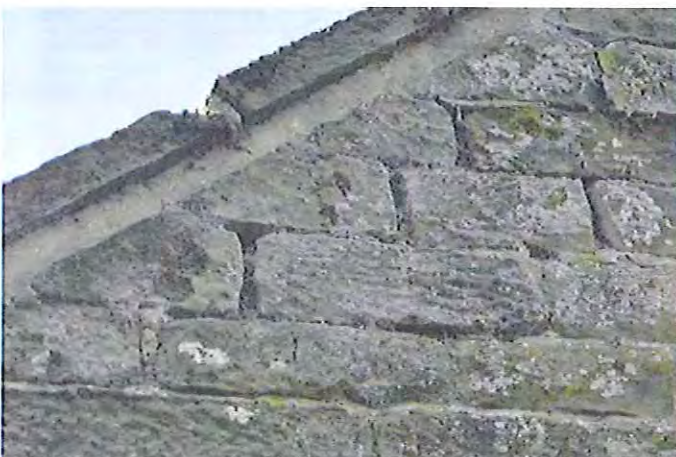
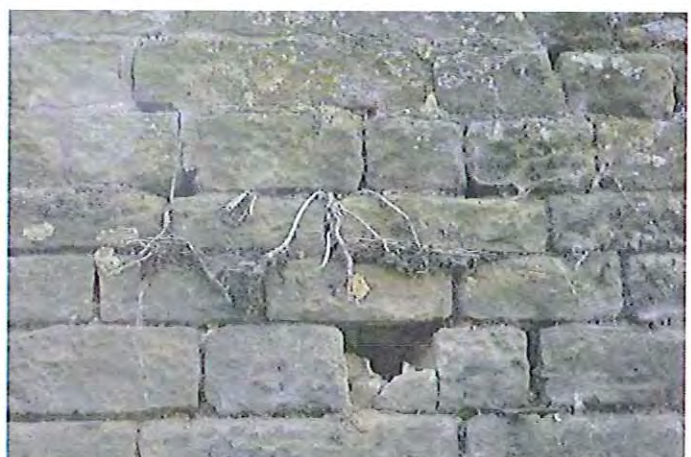
The gable end wall is in much poorer condition, with some large cracks developing (Appendix 4, photos 7 and 8); the northern corner of the building has the largest cracks with some areas of the wall failing as shown in appendix 4, photos 9 and 10. The rear wall of the building is generally in good condition, however there are some places where the mortar has failed and stones have collapsed (Appendix 4, photo 11).

Photo 7 and 8: Cracks and holes in gable end wall.

Any repairs to the interior of the gable end wall will also be conducted during this time to ensure that no disturbance to the roost will occur during the period that females may be using maternity roosts.

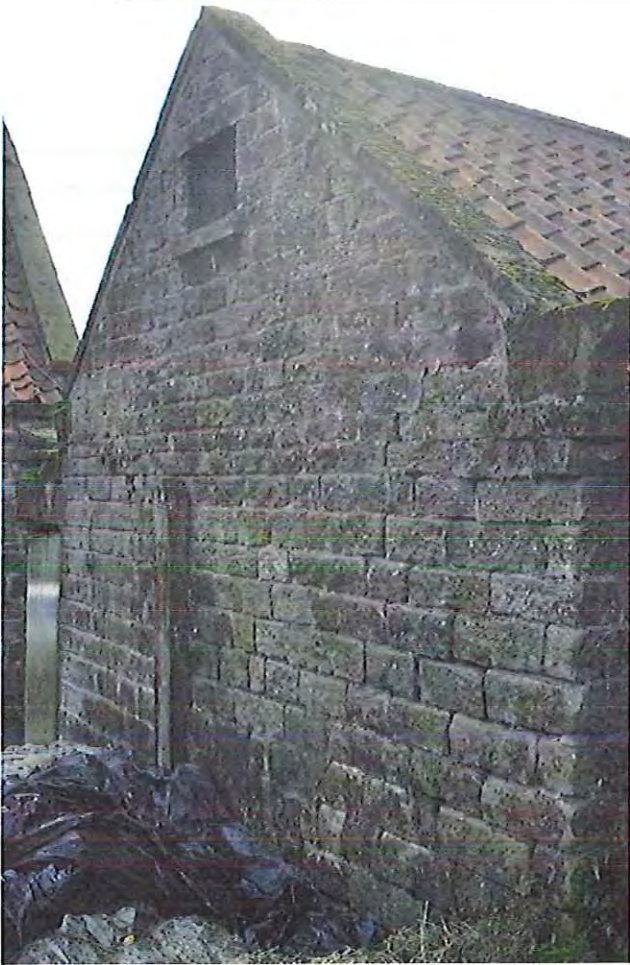
Photo 9: Poor condition of gable end wall

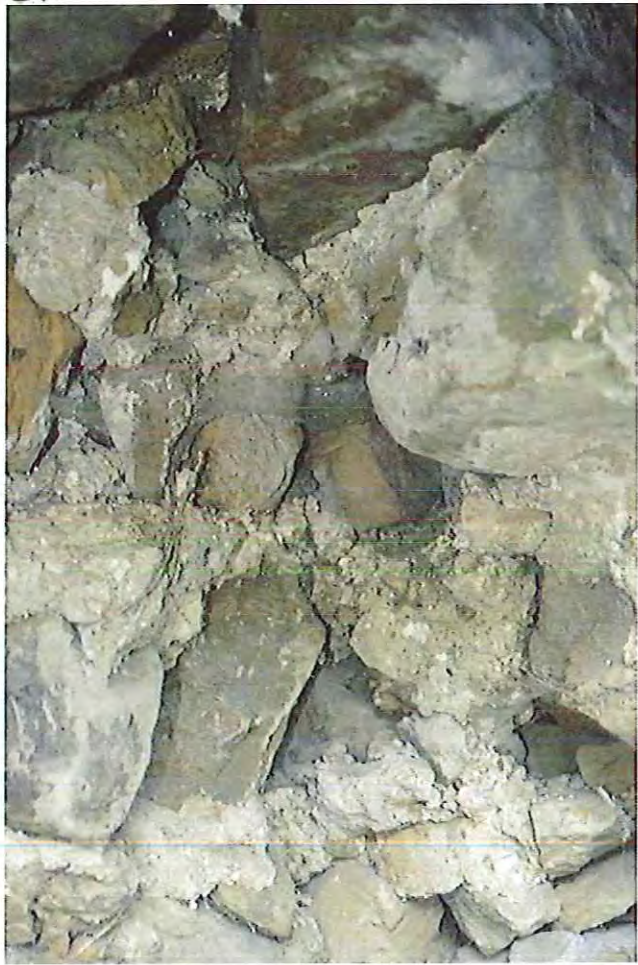
Photo 10: Collapsed area of wall

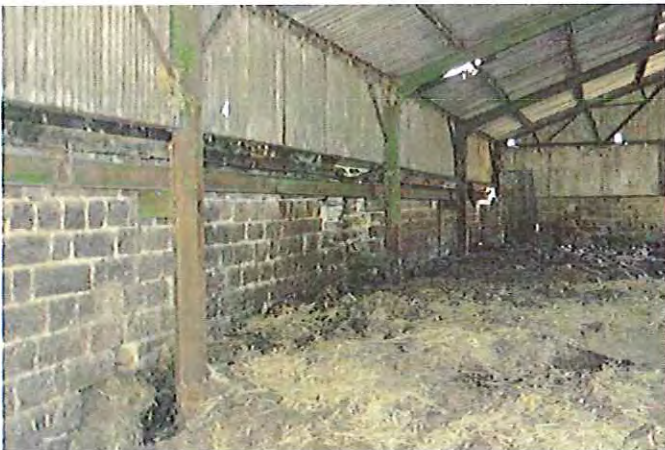
Photo 11: Rear wall of stable block.

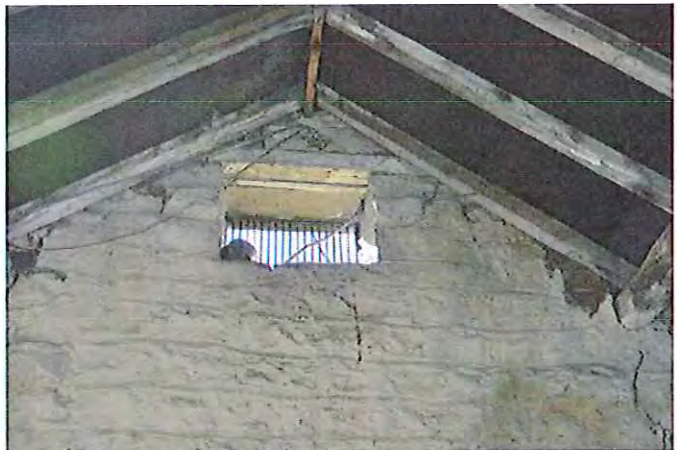
Photo 12: Aperture in gable ed wall with close gapped grill.

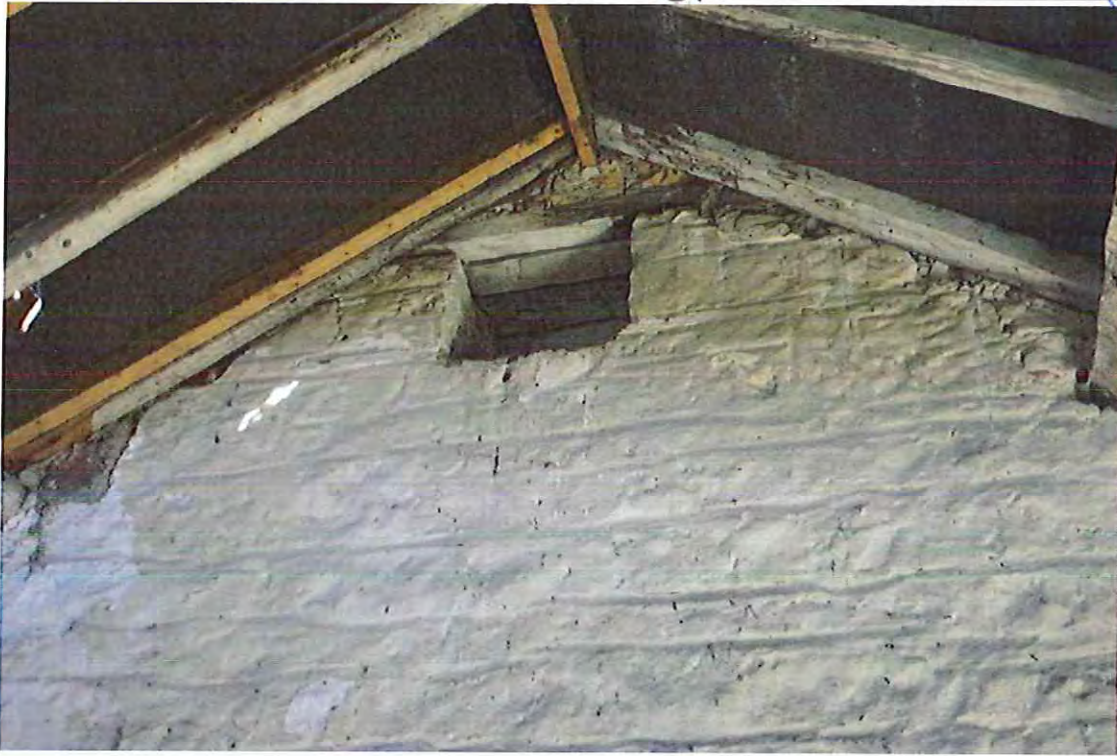
Photo 13: Opening through internal wall

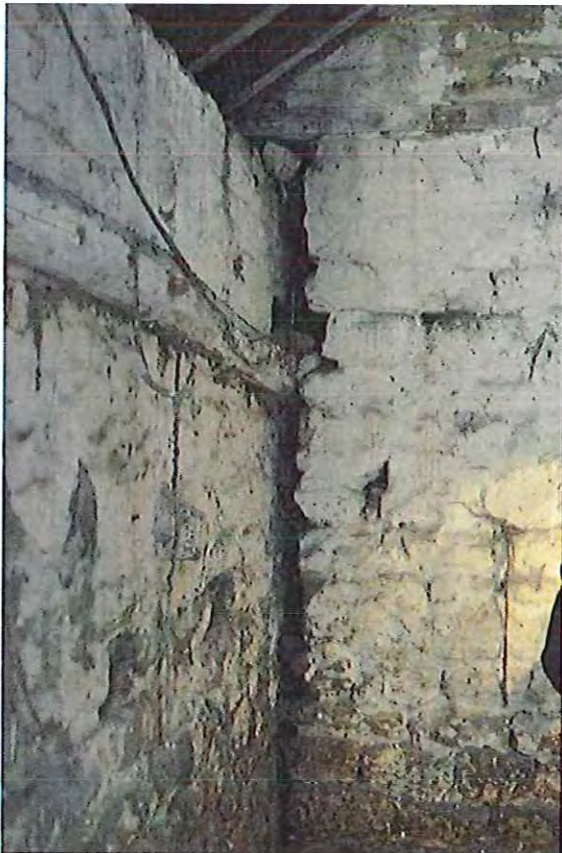
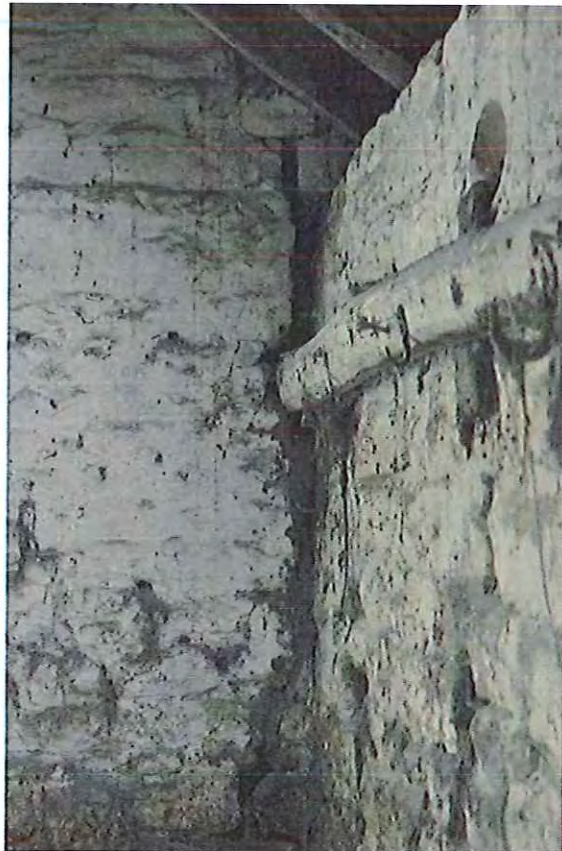
Photo 14 and 15 Cracks between internal and external walls.

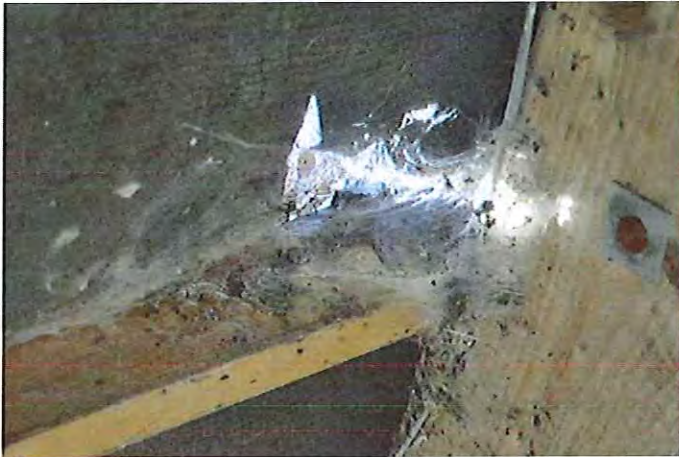
The interior of the stable block/cow byre has been split in to three different rooms. The first room has been used as a kennel in the recent past. The walls are painted white and there is a concrete floor. There is a window aperture with a close fitting grill in the apex wall (Appendix 4, photo 12) and an aperture through the internal wall the adjacent room (Appendix 4, photo 13). There are some large cracks and gaps at the joints between the external and internal walls (Appendix 4, photo 14 and 15). The room is open to the sarking, with some holes through to the tiles (Appendix 4, photo 16)

Photo 16: Hole in sarking

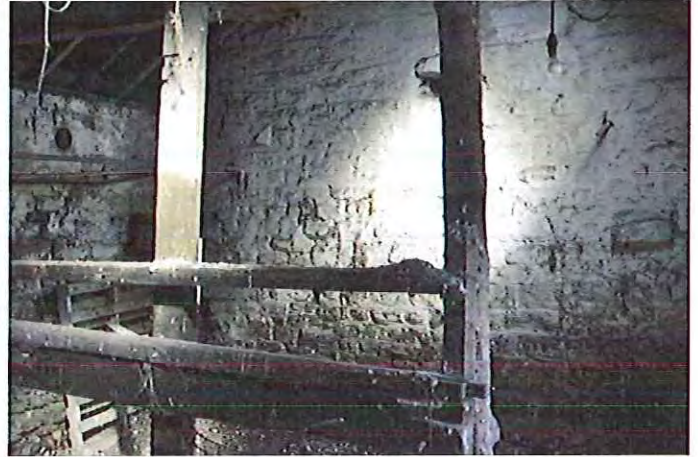
The second room is similar to the first, with painted white walls, apertures through to the adjacent rooms and cracks between the internal and external walls (Appendix 4, photo 17). The floor is concrete however it is covered in leaked effluent from the adjacent cow shed. There are also some holes in the sarking in this room (Appendix 4, photo 18).

Photo 17: Interior of second room

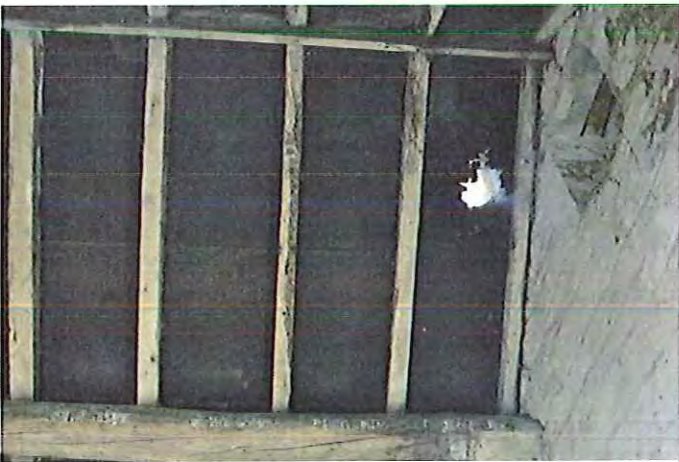
Photo 18: Hole in sarking and aperture through to adjacent room.

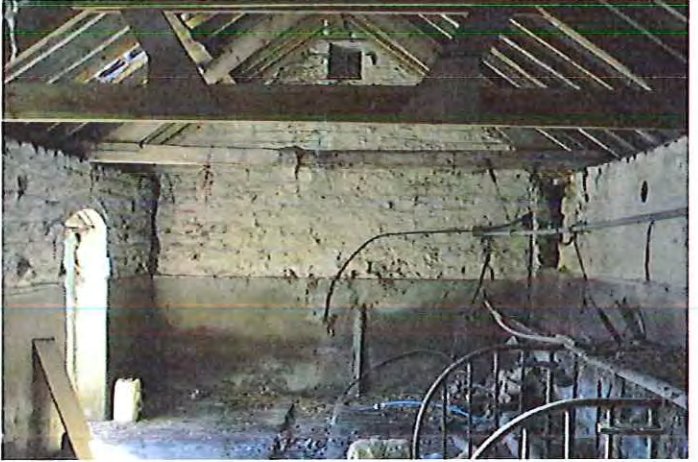
The third area is the largest space within the structure. It is very similar in nature to the other two rooms, with white painted walls and a concrete floor, however the lower area of the walls has been rendered in the past (Appendix 4, Photo 19). This room has one window with two missing panes and also contains a window aperture on the gable end that is fitted with a close gapped grill.

Photo 19: Interior of main area.

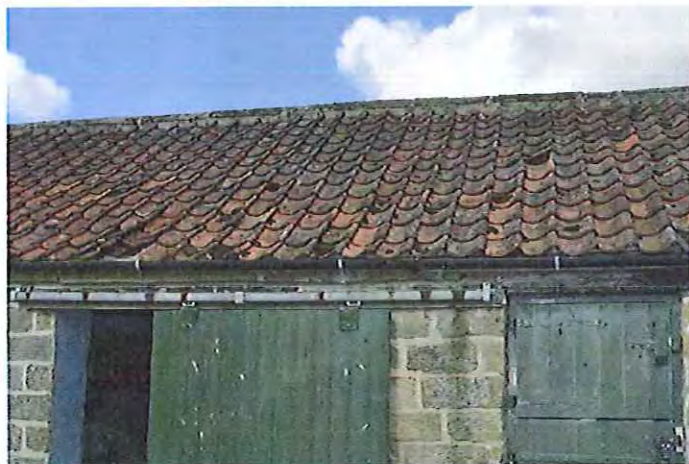
The roof is in generally good condition; however there are some occasional lifted and broken tiles (Appendix 4, Photo 20). The stone work is in good repair the pointing is all sound (Appendix 4, photo 21). The rear of the building is in slightly poorer condition, with some degradation to the mortar and the lower three rows of tiles on the roof being displaced (Appendix 4, photo 22).

Photo 20: Roof of adjoining stores

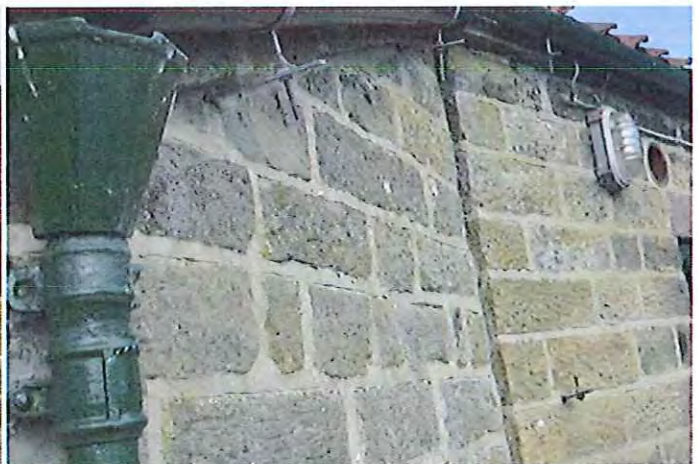
Photo 21: Walls and guttering

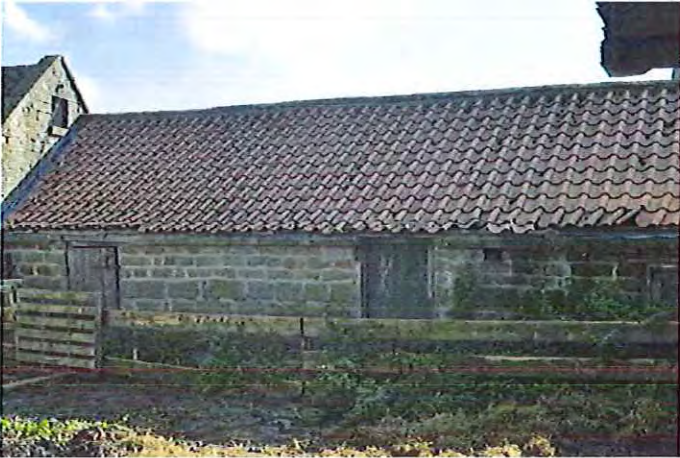
Photo 22: Rear Wall of adjoining stores.

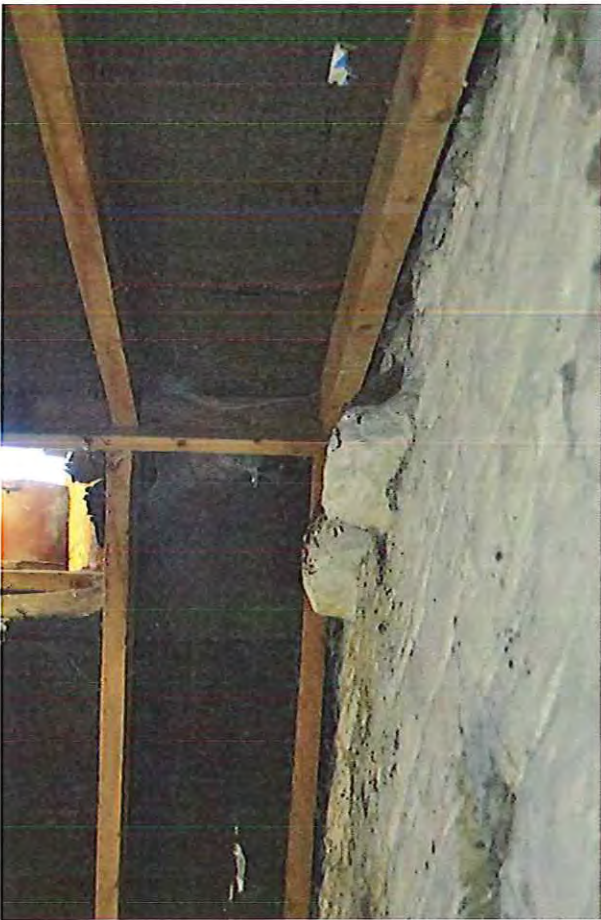
The first of the store rooms contains garden machinery and tools. The walls are whitewashed and in generally good repair. There are some close gaps formed by rafters and the gable end wall (Appendix 4, photo 23).

Photo 23: Gaps between rafter and gable end wall.

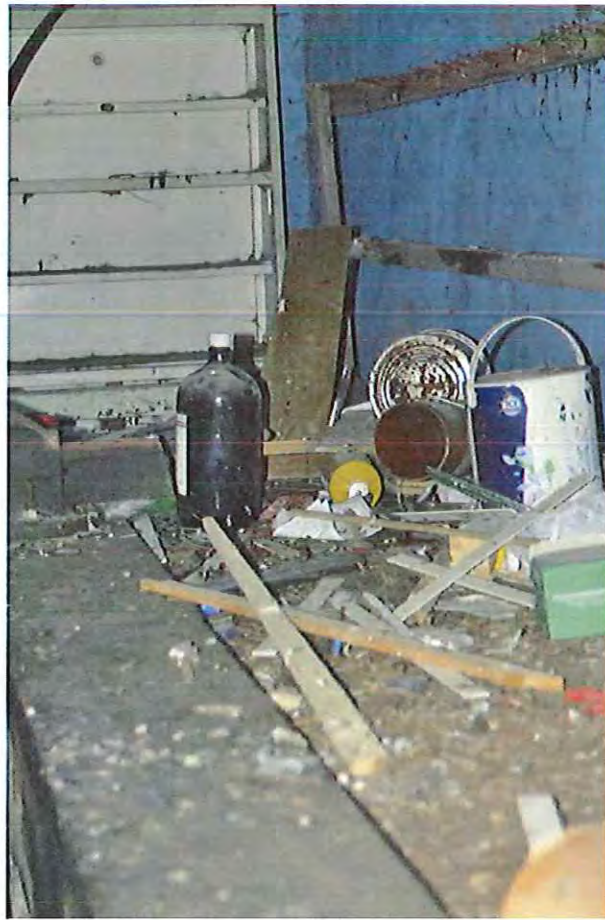
The second store room is disused and mostly contains old furniture and accumulated debris (Appendix 4, photo 24).

Photo 24: Workbench.

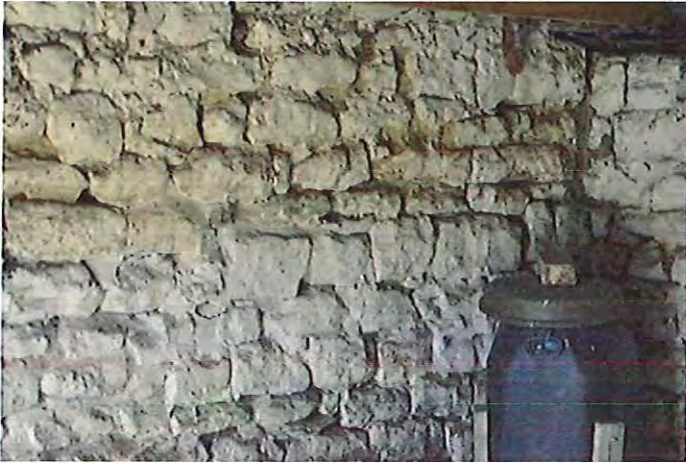
The final store room is used for the storage of game bird feeders, but is currently mostly empty (Appendix 4, photo 25).

Photo 25: 3<sup>d</sup> store room.

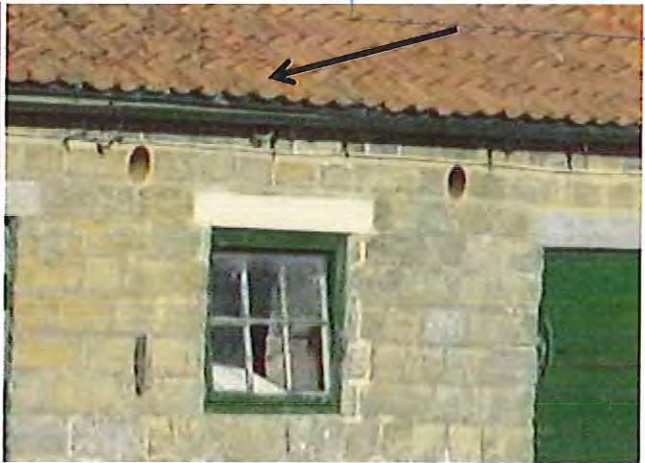
A total of 8 Common Pipistrelle were recorded emerging from the targeted building; 1 from the eaves above the window at the northern end of the disused stable block/cow byre (Appendix 4, photo 26) and 7 from the gable wall end of the adjoining store room from beneath the 2 pan tiles on the stone buttress (Appendix 4, Photos 27 and 28).

Photo 26: Emergence point form above window.

The repairs to the roof structure will impact upon a roost of a singular male or non-breeding female Common Pipistrelle. During the replacement of the roof a dedicated bat access point will be provided to allow continued access to the roost site. In addition a further 4 access points will be spaced along the south easterly roof slope, enhancing the building for use by bats.

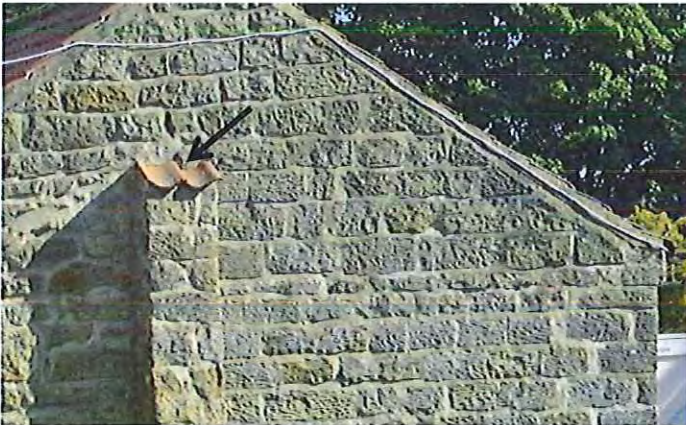
Photo 27: Gable end wall showing buttress topped with two pan tiles

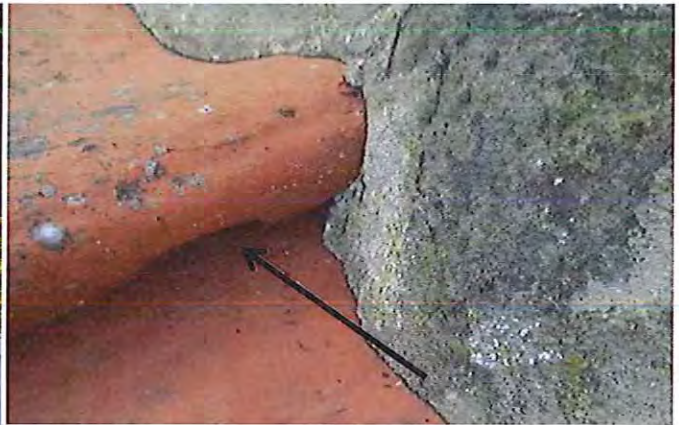
Photo 28: Emergence point for 7 common pipistrelle.

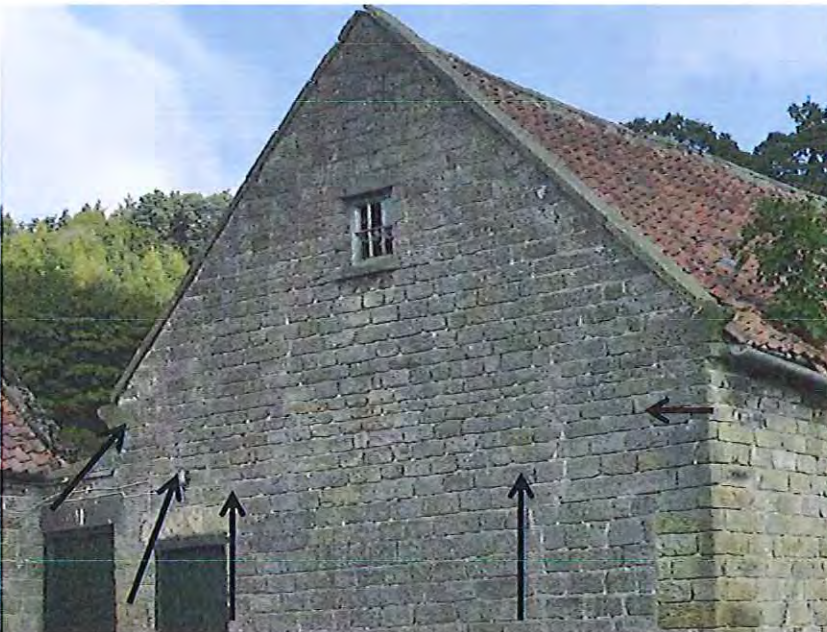
the adjoining store gable wall end. 6 bats were recorded returning to the gable end wall of the adjacent two storey stone barn in 5 different locations (Appendix 4, Photo 29).

Photo 29: Points at which bats returned during dawn survey
