Replacement Shooting Lodge -Thimbleby Shooting Ground Thimbleby Estate **Thimbleby**

Photographs of Existing Lodge - Ecology

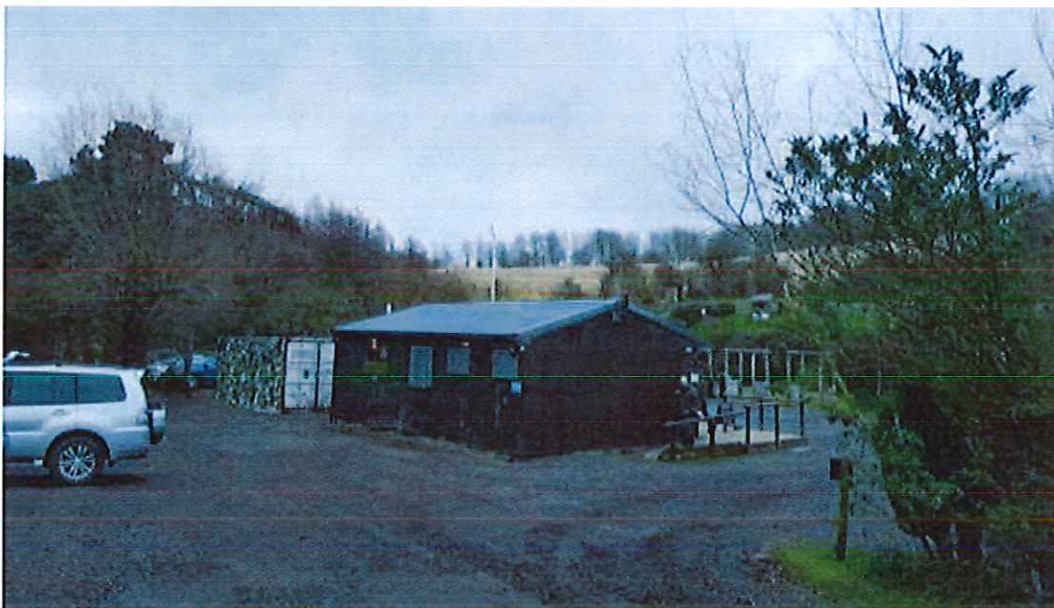
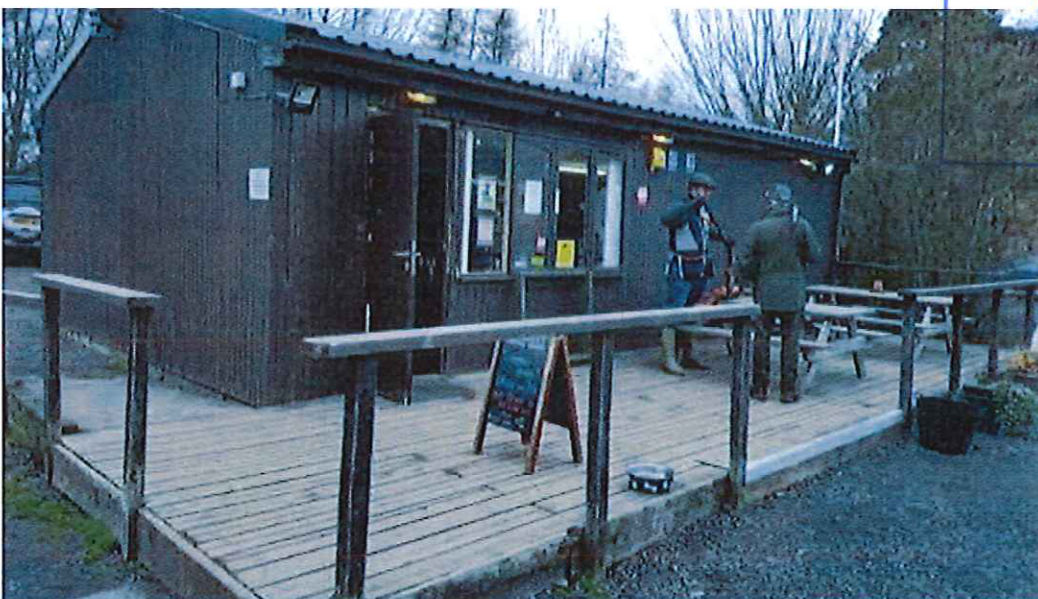
The lodge building to be removed is constructed of timber cladding and the roof of profile metal sheeting at a low pitch. The attached photographs demonstrate that there is no requirement for a bat scoping survey at the site as the form, shape, materials and construction of the existing lodge means there is no potential for bats to access, or roost in the building.

Internally the ceiling is fully enclosed and sealed.
