Location:  
**Chapel Garth  
Egton Bridge**

Report Type:  
**Arboricultural Survey  
Arboricultural Impact Assessment  
Arboricultural Method Statement  
Tree Protection Plan**

Ref:  
**ARB/AE/1604**

Date:  
**August 2017**

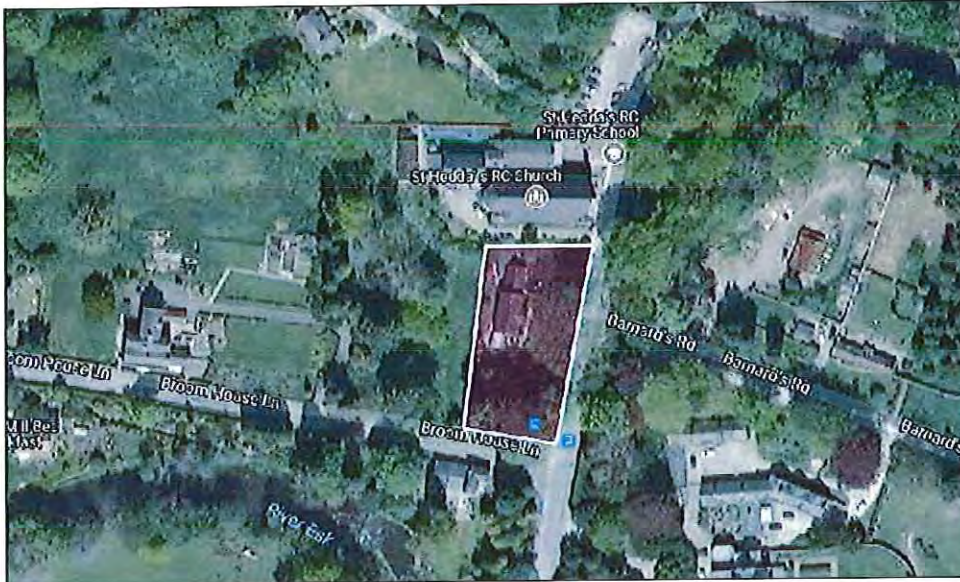
Figure 1: Site extent highlighted

- 2.1 Chapel Garth is located within the village of Egton Bridge and is a detached residential dwelling set within mature gardens. Figure 1 shows the extent of the site:

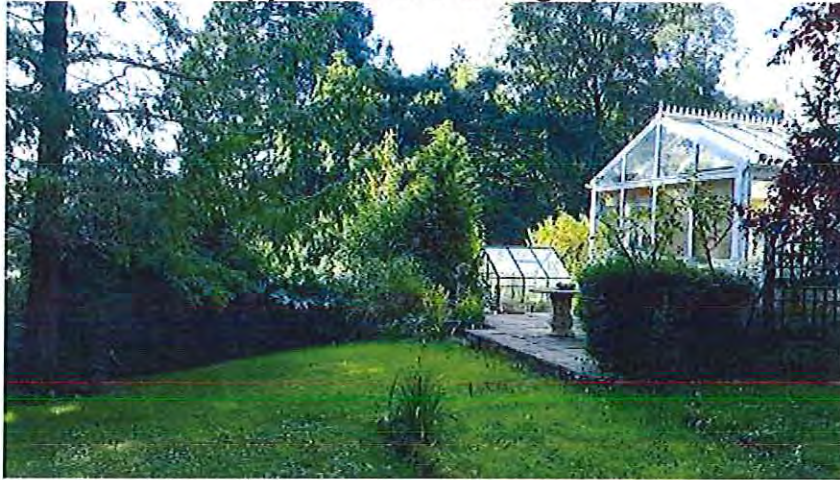
Figure 1: Current conservatory. Tree 9 to left

| No. | Species | Age | DBH | Stems | Height | Crown Spread | | | | CH | EstD | General Observations | EstCont | BS Cat | Recommendation |
|---|---|---|---|---|---|---|---|---|---|---|---|---|---|---|---|
| 9 | Dawn Redwood | SM | 42 | 1 | 12 | 5 | 3 | 5 | 3 | 1 | N | | 40+ | A1 | No work required |

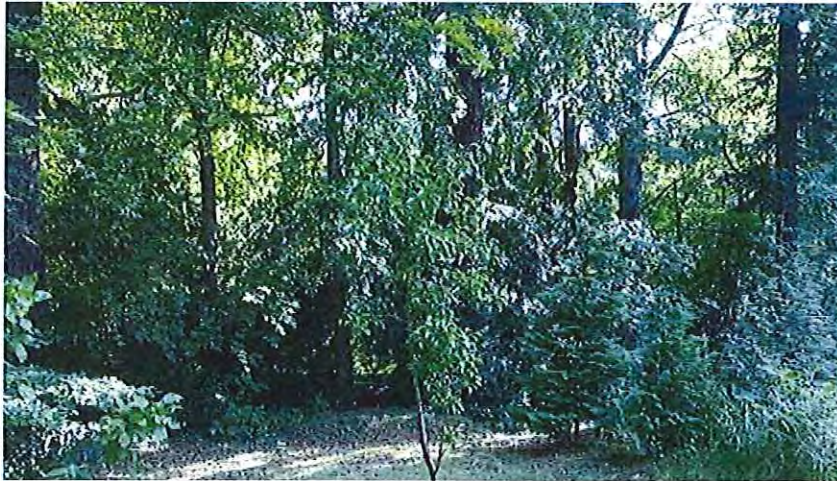
Figure 2: Looking south towards Group 1

| Group Number | Dominant Species | Lesser Species | DBH | Average Height | Age | Average Spread | Condition/Comments | Recommendations | EstCont | BS Cat |
|---|---|---|---|---|---|---|---|---|---|---|
| 1 | Beech<br>Pine spp<br>Lime spp<br>Turkey Oak | Holly<br>Yew<br>Cypress spp | 70 | 20 | M | 6 | Group at southern end of garden - trees 4-8 are also part of this group but highlighted individually due to stature and location closest to construction zone. Evergreen understorey. | No work required | 40+ | A1 |

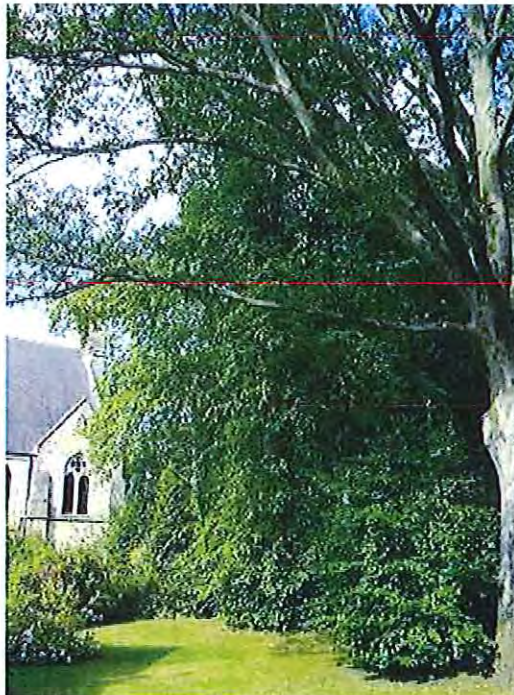
Figure 3: Eastern boundary looking north (Tree 2 in foreground)

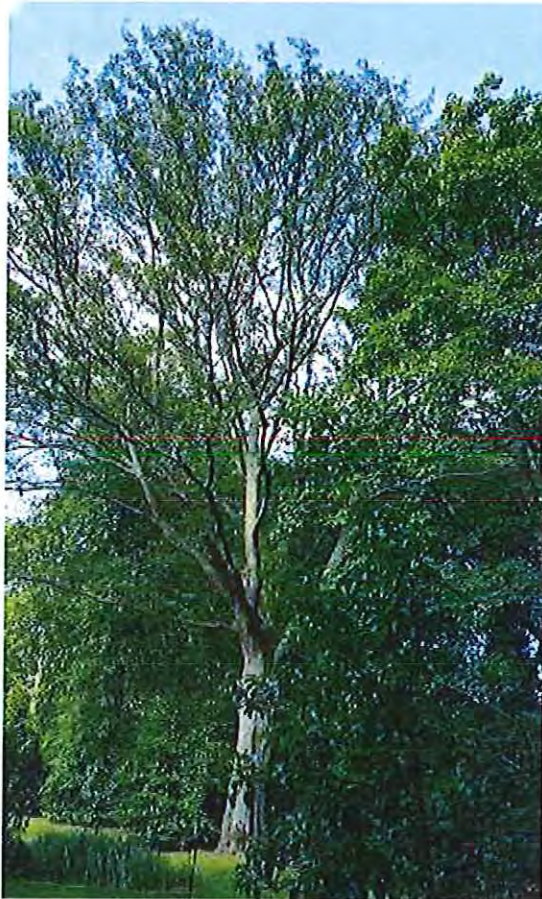
| No. | Species | Age | DBH | Stems | Height | Crown Spread | | | | CH | EstD | General Observations | EstCont | BS Cat | Recommendation |
|---|---|---|---|---|---|---|---|---|---|---|---|---|---|---|---|
| 2 | Turkey Oak | M | 118 | 1 | 25 | 10 | 8 | 9 | 12 | 6 | N | Moderate deadwood in crown (Characteristic of species) - some over adjacent road. | 40+ | A1 | Remove deadwood over road. |

Figure 3: Tree 2

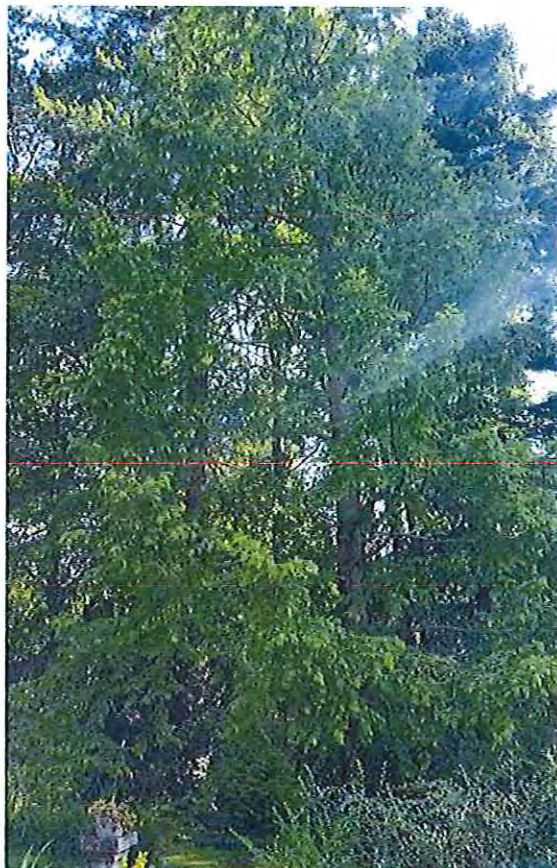
| No. | Species | Age | DBH | Stems | Height | Crown Spread | | | | CH | EstD | General Observations | EstCont | BS Cat | Recommendation |
|---|---|---|---|---|---|---|---|---|---|---|---|---|---|---|---|
| 5 | Corsican Pine | M | 83 | 1 | 25 | 6 | 5 | 5 | 5 | 15 | N | x4 co-dominant stems at 8m - union appears in reasonable condition. | 40+ | A1 | No work required |
| 6 | Douglas Fir | M | 97 | 1 | 28 | 7 | 5 | 5 | 6 | 7 | N | Small snapped branch at 7m - low target potential. | 40+ | A1 | No work required |

Figure 4: Trees 5 & 6

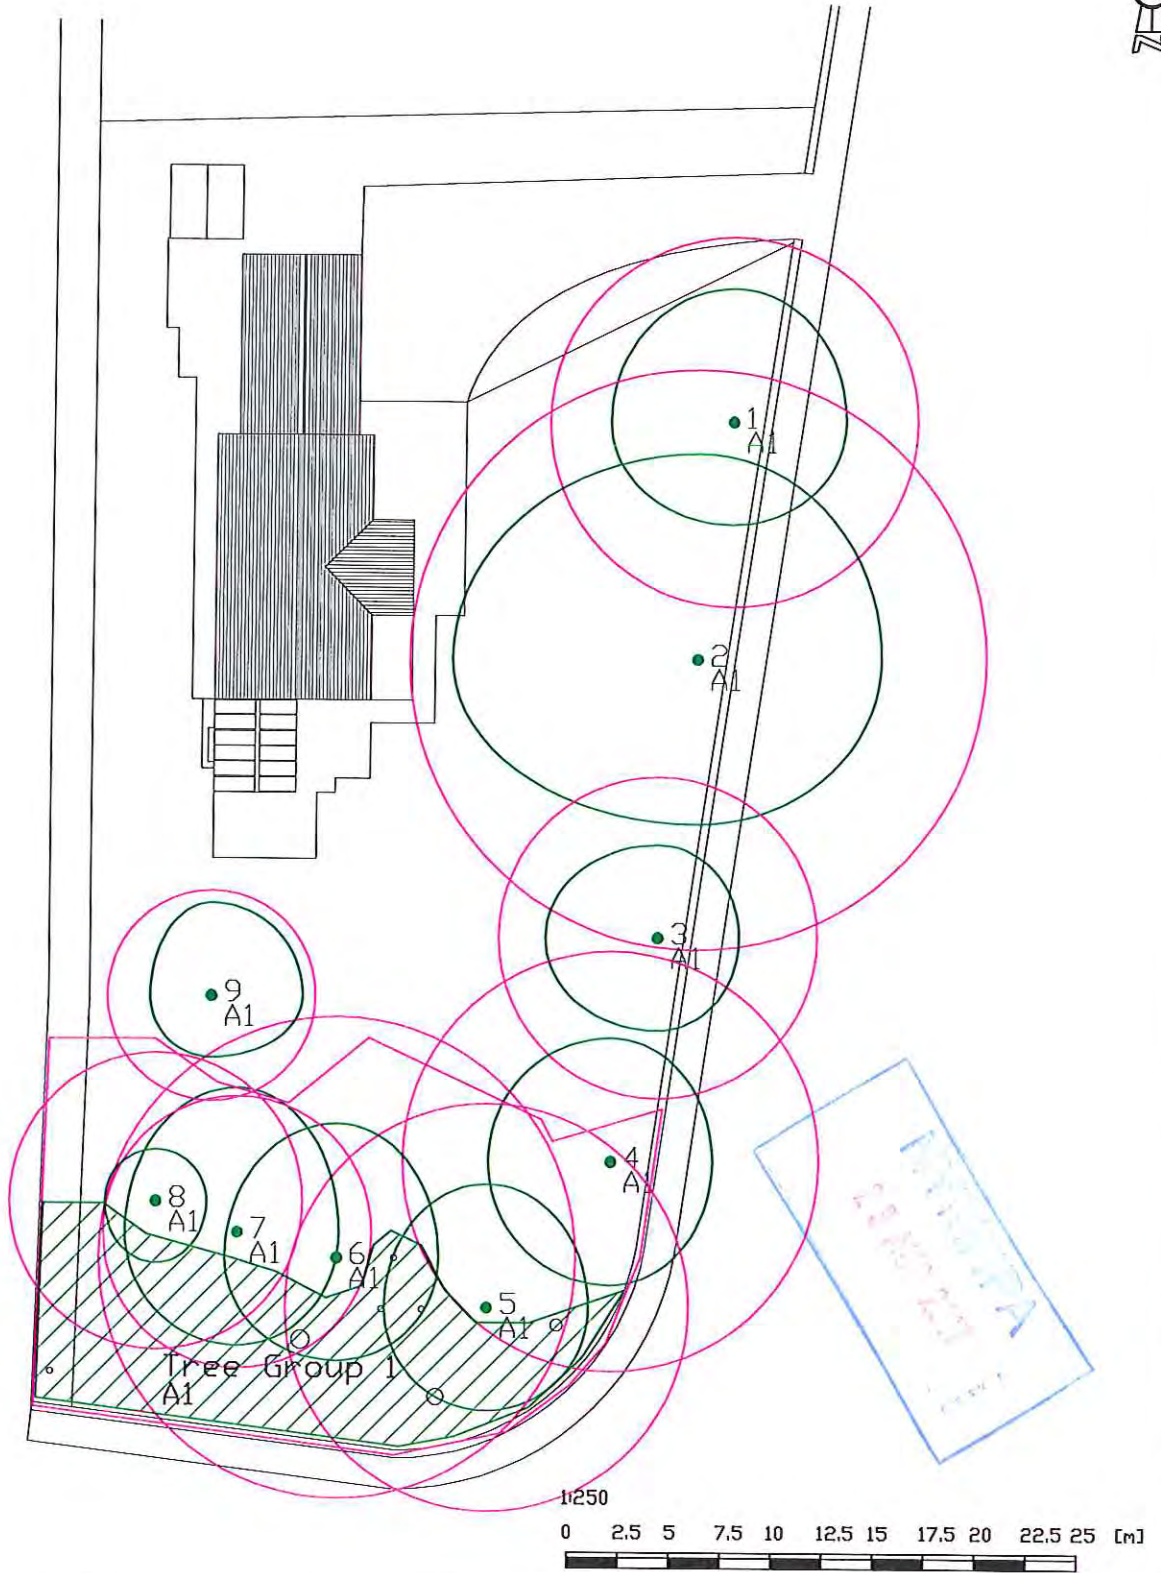
**APPENDIX 6**

Drawing Title: Tree Constraints Plan  
 Project: Chapel Garth, Egton Bridge  
 Drawing Number: ARB/AE/1604/TCP  
 Date: August 2017  
 Scale: 1:250 @ A3
