## Hern Head House

Troutsdale, Snainton  
YO13 9PS

Design & Access Statement  
& Heritage Asset Assessment  
& Flood Risk Assessment

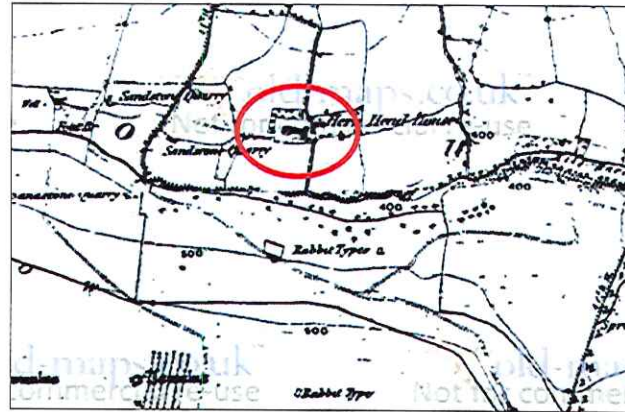
Fig. 3: Extract from 1854 OS

2.1 The building to be extended appears to be present on the 1854 Ordnance Survey map (Fig. 3), and is clearly visible on the 1892, 1911 & 1973 Ordnance Survey maps in their current form (Fig. 4, 5 & 6). There are no signs that the building has been significantly altered to the front elevation. The rear elevation shows signs of modernisation and alterations.

3.1 Although the building is not Listed it is recorded on the 1854 first edition Ordnance Survey. It contains some traditional features and we have therefore assessed the building as a nondesignated heritage asset.

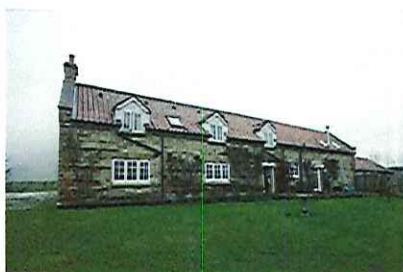
Fig. 7: View of South West / front elevation

Notwithstanding the inconsistent dormer windows, this is a traditional isolated farmhouse with adjacent range of agricultural buildings to the East located in Troutdale within the National Park. Traditionally built in stone with a red clay pantile roof covering, low eaves height and water tabling to gables, the house is typical of the local vernacular. Another characteristic of this type of building is the fact that the front / South elevation is proportioned and considered whereas the rear / North has been extended and altered to accommodate the owners and various functions of the building across its lifespan. As a result the North elevation is a collection of modern extensions and alterations. Whereas the original house is constructed in large dressed stonework, later extensions are in lesser quality random stonework highlighting the significance of the main elevation.

Although the South elevation is the most significant, it too has been altered with additional rooflights and a steel flue pipe.

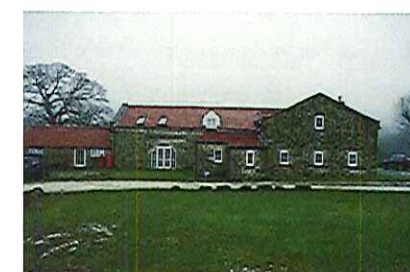
Fig. 9: View of the North elevation with lean-to kitchen extension in the centre to be removed

2.3 The kitchen extension is the most recent to the North of the existing dwelling. Although constructed in stone with a red clay pantile roof covering, the roof is constructed with low eaves and a very low pitch to the horizontal. Although it is typical that roof pitches do not always match across a building of this age, such a shallow pitch compared to the remaining dwelling is a clear statement of its age.

The proposals remove the small kitchen lean-to extension from the rear / North and replace it with a new extension which will extend further East. Rather than extending the low pitch roof which is an unsympathetic combination of modern and traditional styles, our proposals are for a modern green flat roof extension over stone walling to match the existing house.

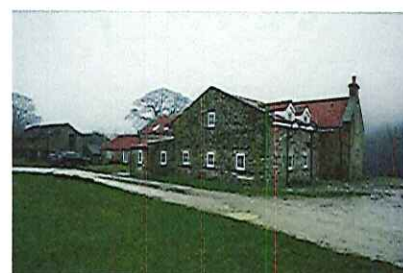
Fig. 11: View of rear / North West elevation of dwelling with agricultural buildings beyond

Stonework on rear elevations is more coursed rubble than hammer-dressed, although slightly dressed quoins and shaped kneelers are evident on the two-storey gable.

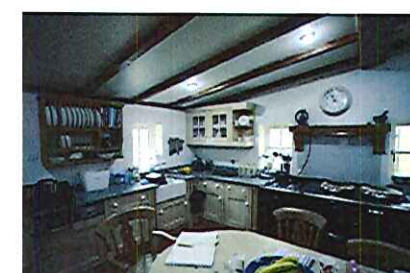
Fig. 12: Internal view of kitchen extension - proposed to be removed / replaced. Image shows low roof pitch and eaves height.

4.1 The kitchen to the ground floor of the existing building is located within an existing lean-to structure adjacent to the modern gabled extension on the North West corner of the house. The existing structure has a red clay pantile roof which is considerably below the minimum recommended pitch for their effectiveness. The stone walling shows signs of significant alteration.

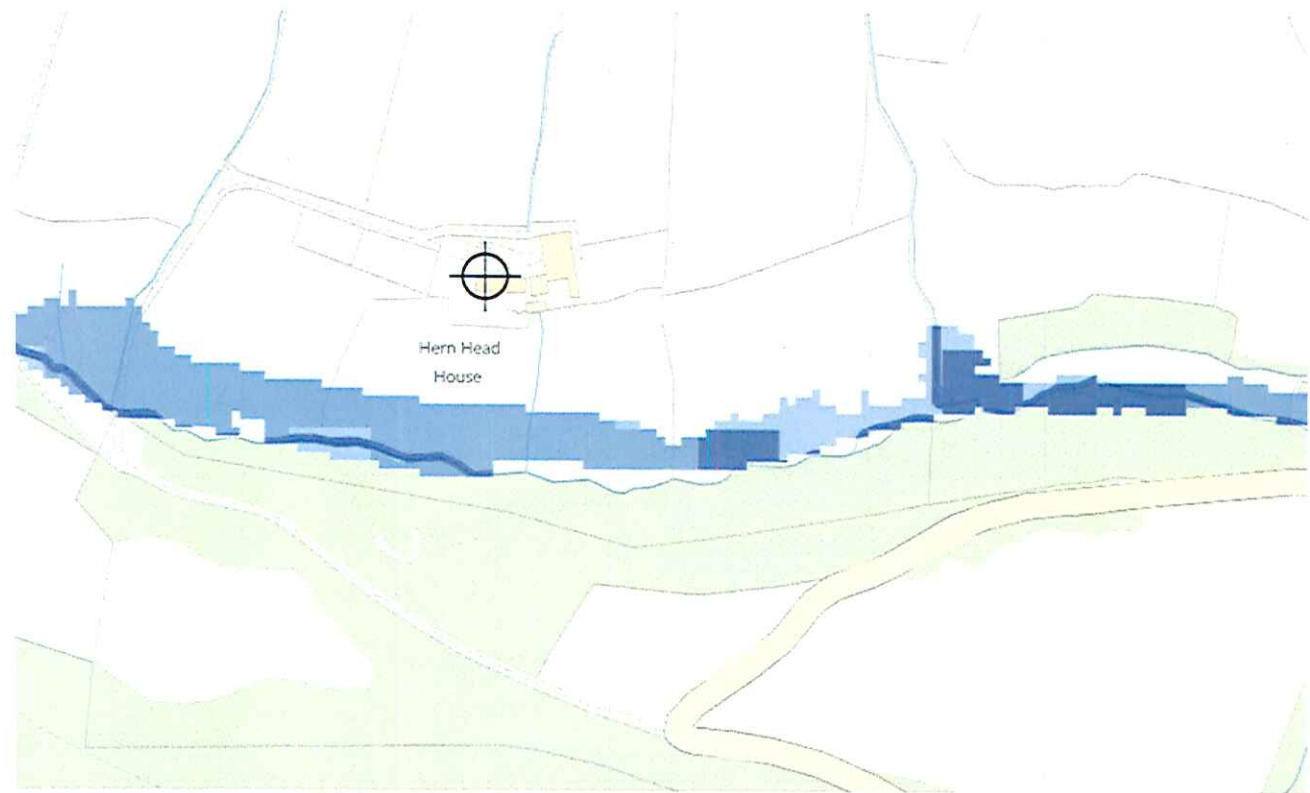
Fig. 14: Flood risk map extract from Environment Agency website

From information available on the Environment Agency website, it has been determined that the property falls outside the area prone to significant flooding risk as demonstrated below on the Environment Agency flood risk map (Fig. 15).
