From:
To: [Planning](#)
Subject: photos re planning app nym/2018/0177/fl
Date: 02 May 2018 11:34:45

Can you please add these additional photos and geology information to my comments re planning app nym/2018/0177/fl They show how the cliff is constantly moving and the drainage pipes from 1950s coming out of the quarterdeck. neil purves, willow dene, church lane, Fylingthorpe, north yorkshire, y224pn Thanks Neil Purves

Robin Hood's Bay: Coastal erosion and geology

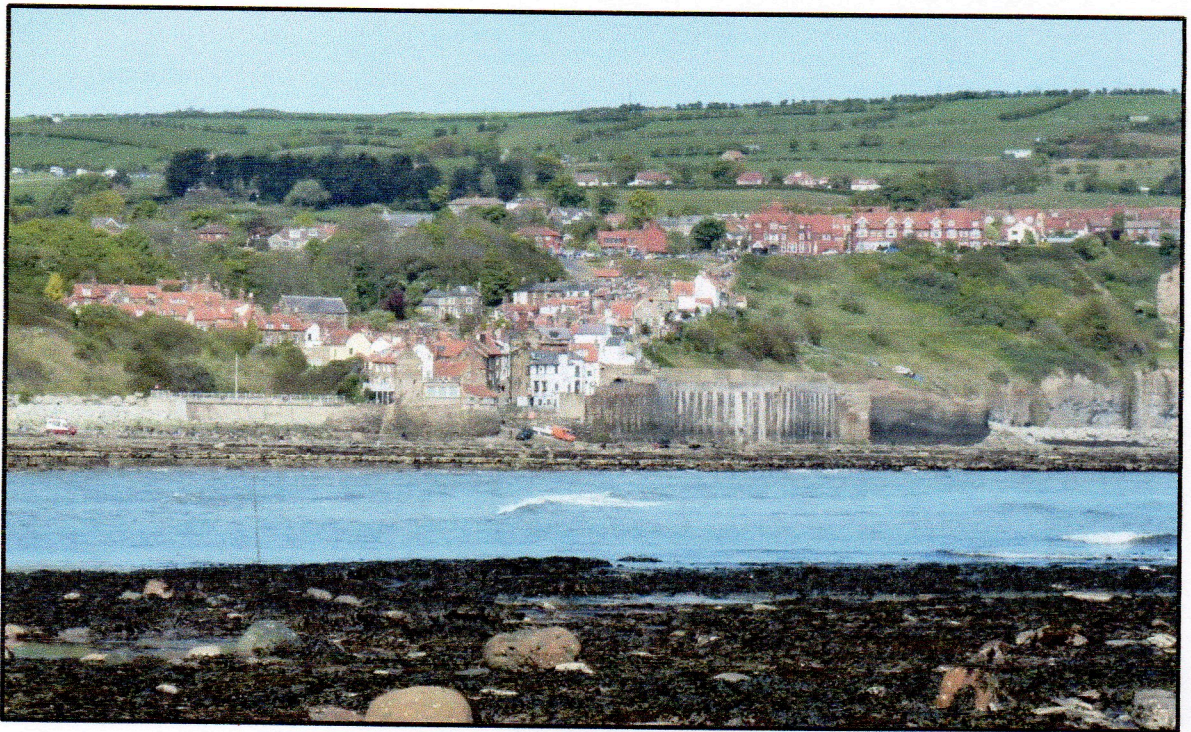
Robin Hood's Bay has a history of coastal erosion and landslides. In 1780 much of the original road into the village, King Street, was lost and since 1780 more than 200 properties have been lost as a consequence of cliff top recession. Up to 22m of coastline has been lost since 1895 particularly near the Victoria Hotel and the main road into the village.

It is mainly exposure to wave action which is causing the slow retreat of the coast. The dominant waves are from the north and northeast where the fetch is over 1500 km long. The main wave energy therefore runs southwards, straight along the northern cliff face and impacts almost directly on to the village frontage.

Profiles of the cliffs show that geomorphological influences are significant. There is evidence of active slope erosion, cliff-top recession and slope instability. Movement within the clay slopes above the sea cliffs is dependent on retreat of the lower sections of the sea cliffs. As the cliffs retreat, landslides on the mid-slope section lose support from beneath and reactivation of landslips may occur with the till slopes degrading to a more stable slope angle. The movement affects localised areas of the slope with loss of land at the top of the slope as witnessed by realignment of the coastal cliff path. The movement tends to occur as 'one-off' slips rather than being a continuous, gradual process.

Recession rates depend on the strength of the underlying rocks. An average rate of 0.3m per year is given for Robin Hood's Bay but this is likely to increase in the future compared to historic rates due to climate change.
