**BAT SCOPING REPORT
MIDDLE RIGG FARM
STAINSACRE
NORTH YORKSHIRE**

**FOR
KEVIN HOWARD**

STATUS:	R1
TYPE SURVEY	20/07/07

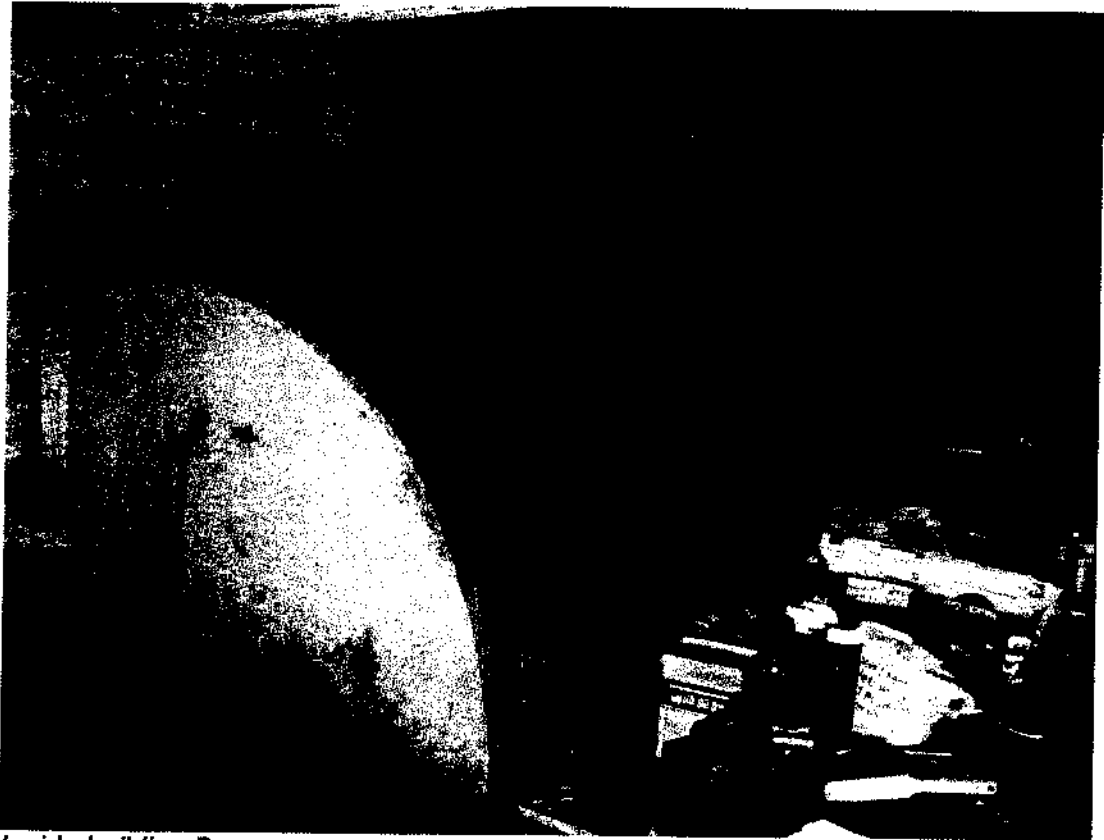
Inside building B
