Project : Proposed extensions to dwelling and conversion of barn to holiday cottage

Location : Coopers Farm, Aislaby Side, Egton, Whitby

Title : Proposed floor plans of barn

Application for Planning Permission. Town and Country Planning Act 1990

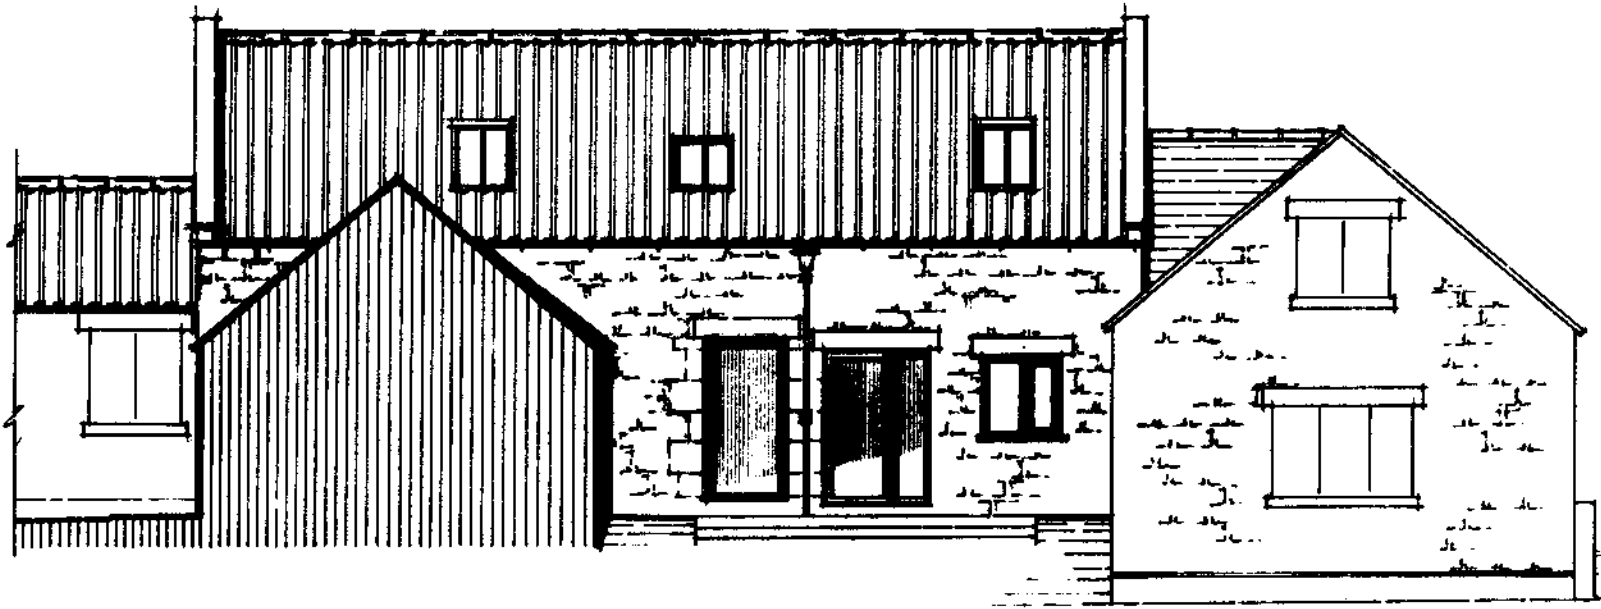
south elevation

Existing entrance openings to be adjusted as shown and fitted with matching brown painted frames and thermal glazing, set well back in reveals, adjacent window to be fitted with brown painted casement frame to match windows in adjacent cottage. New and replacement windows in north and west walls to be of white painted timber in hopper and casement patterns as shown, set well back in reveals.

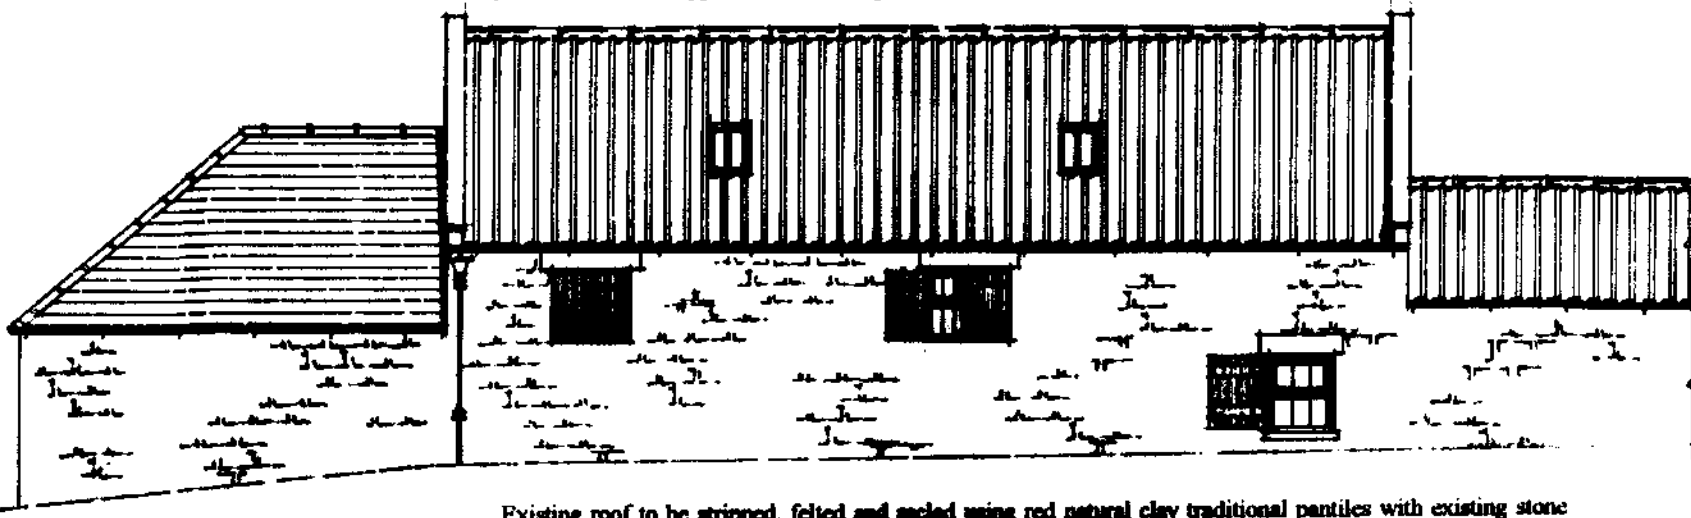
north elevation

Existing roof to be stripped, felted and sealed using red natural clay traditional pantiles with existing stone ridges and copings reinstated. Install 'Conservation' pattern rooflights as shown, provide black uPVC rainwater guttering on rise & fall brackets and matching black downpipes.

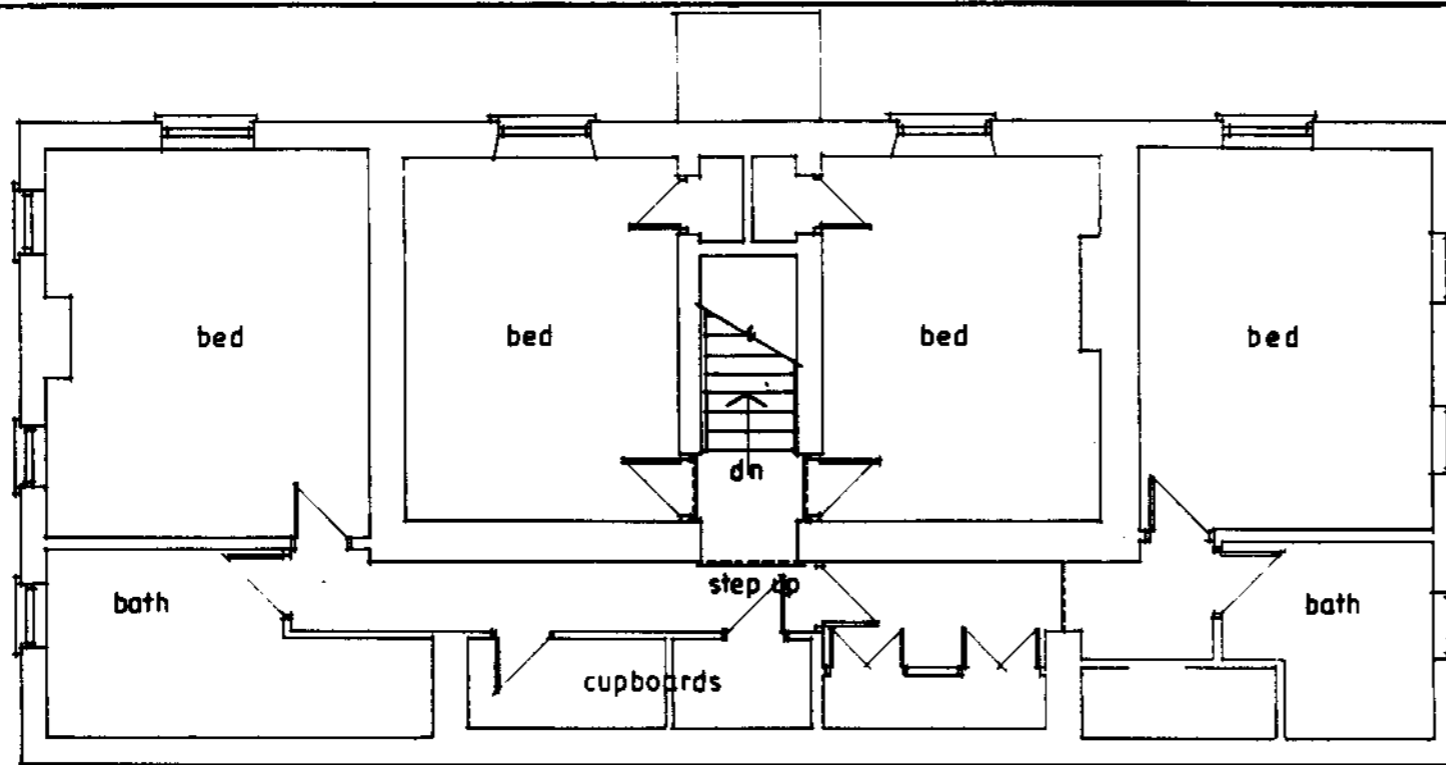
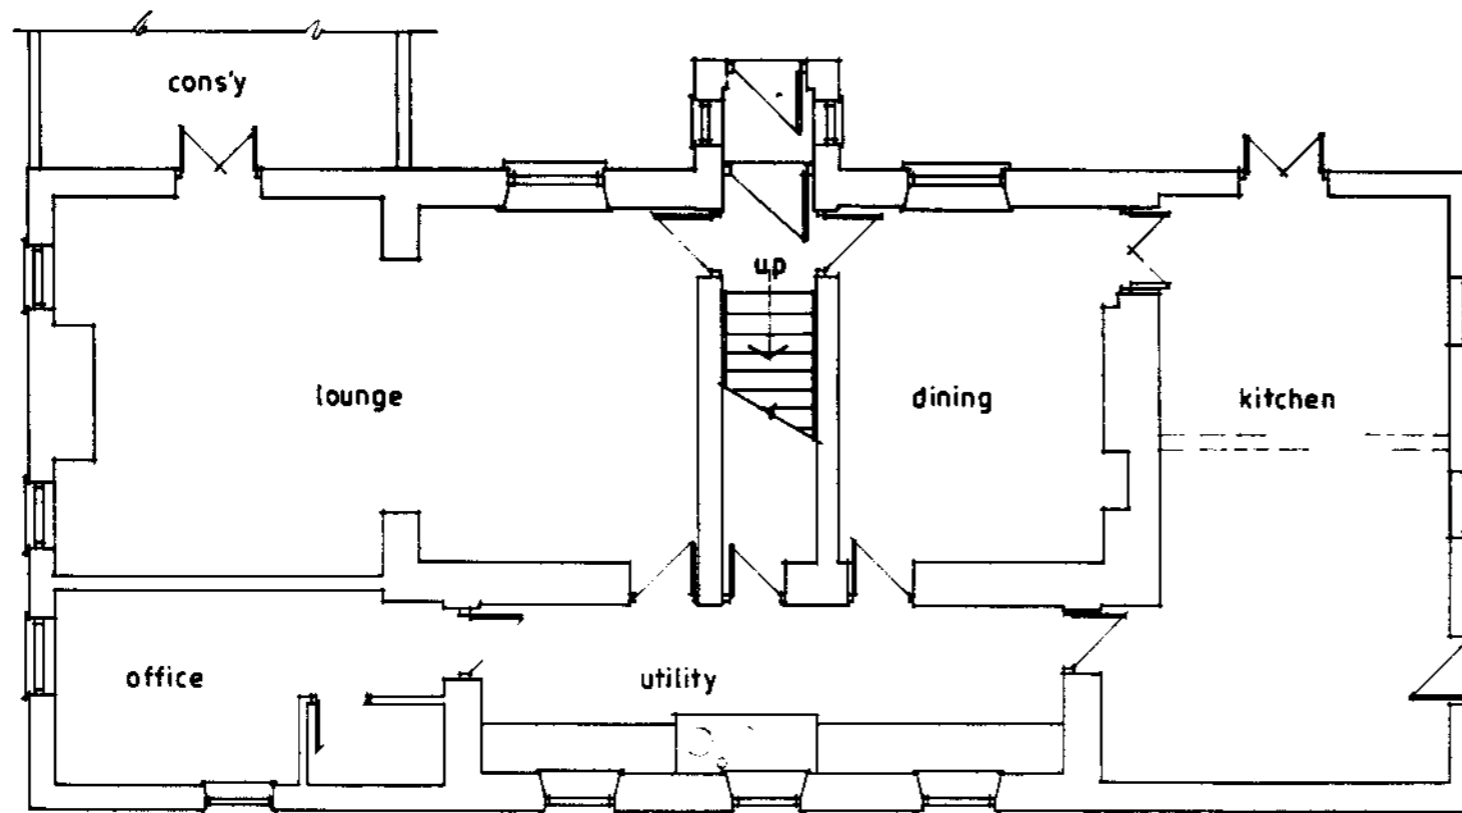
Title : Existing floor plans of house

FIRST FLOOR

GROUND FLOOR

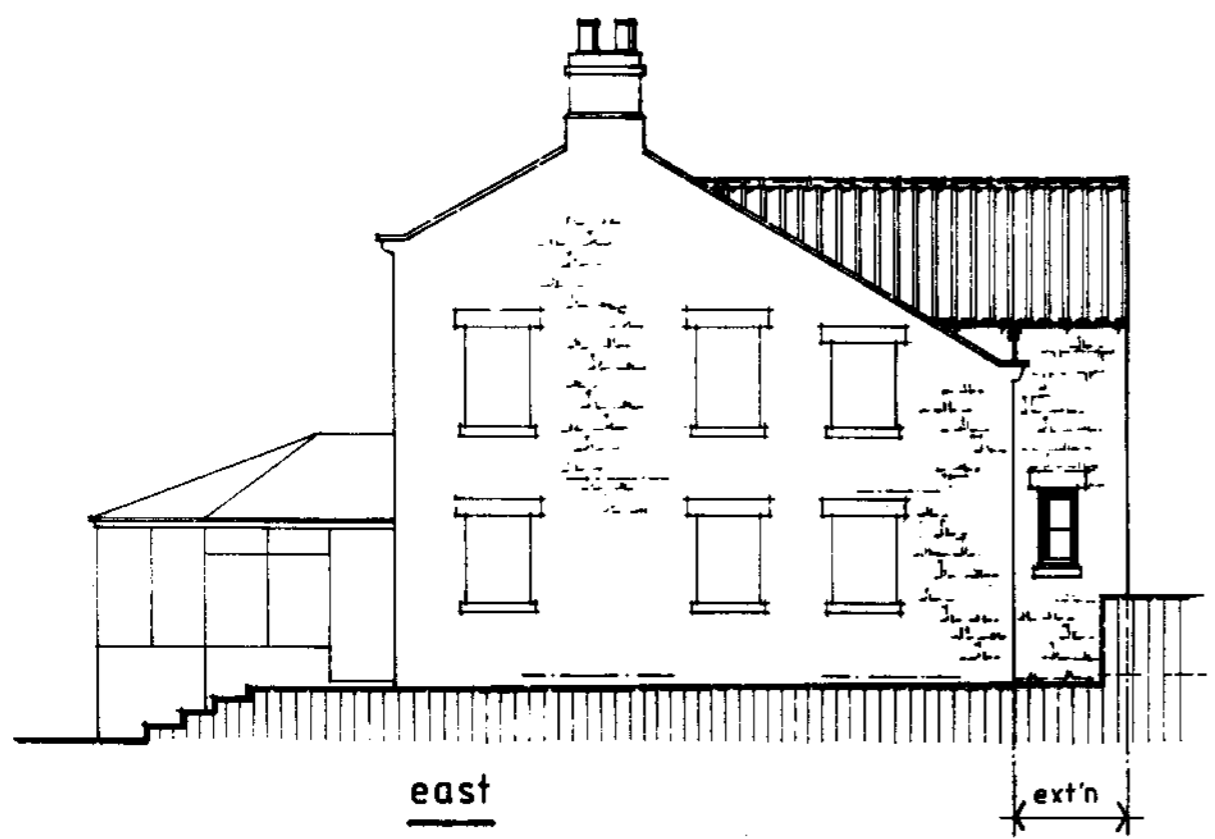
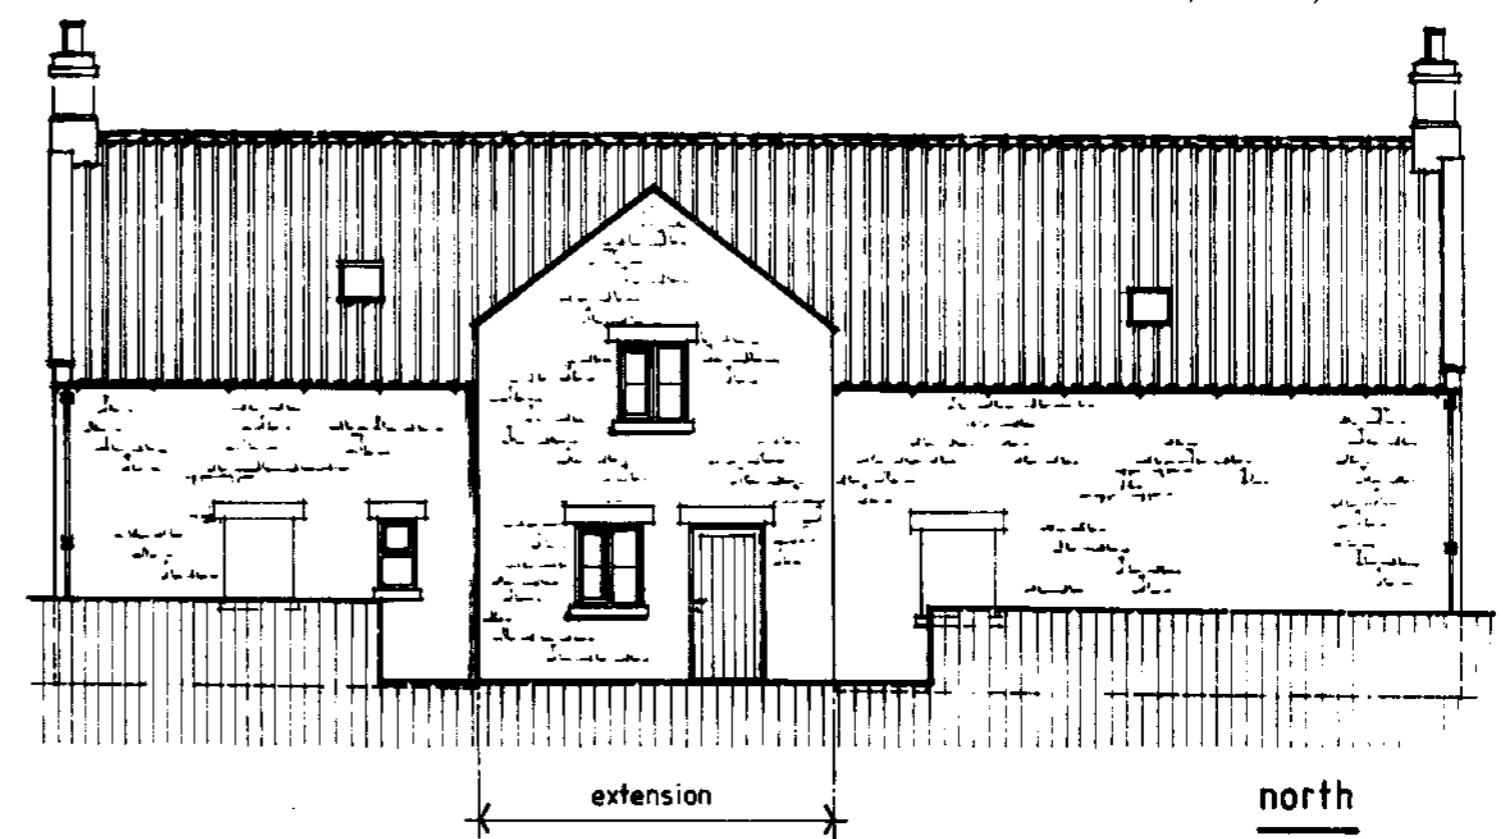
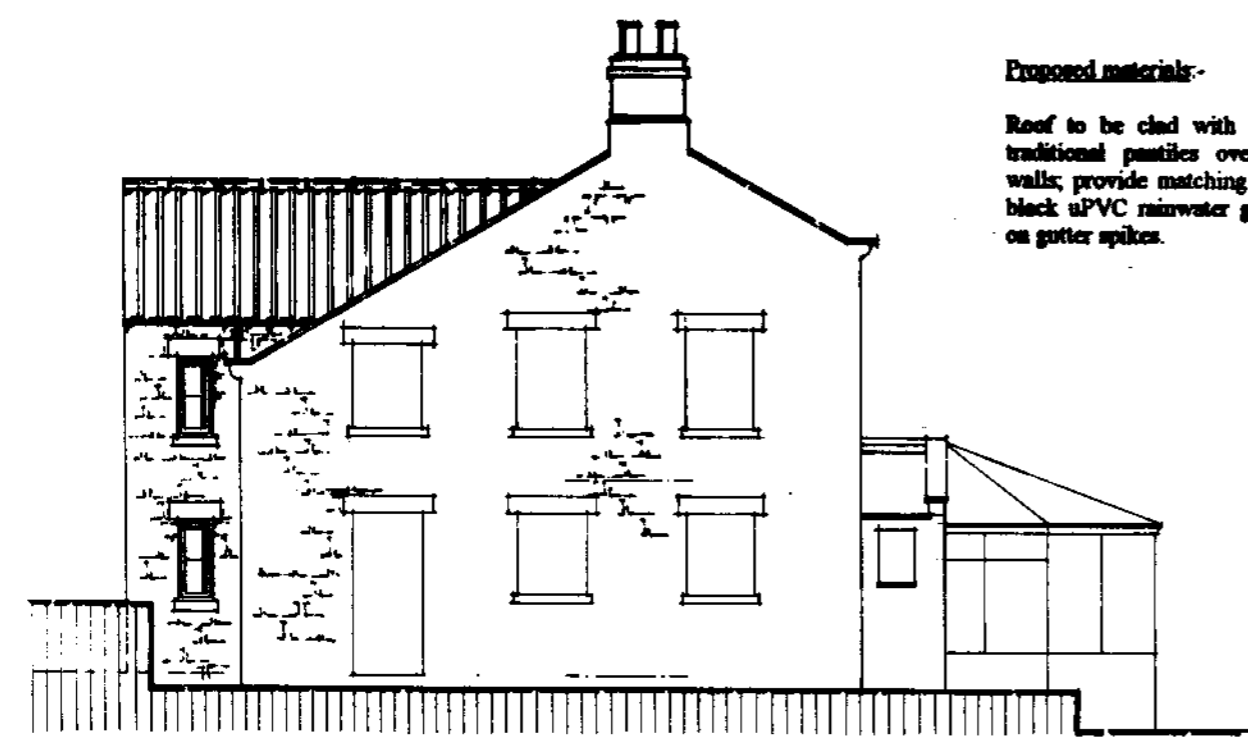
Roof to be clad with matching red natural clay traditional pantiles over matching natural stone walls; provide matching white uPVC windows and black uPVC rainwater goods, these to be mounted on gutter spikes.
