BUILDINGS AT SUNNY BANK COTTAGE

HACKNESS

ENVIRONMENTAL ASSESSMENT RELATING TO DEVELOPMENT

Mrs IVY STUART

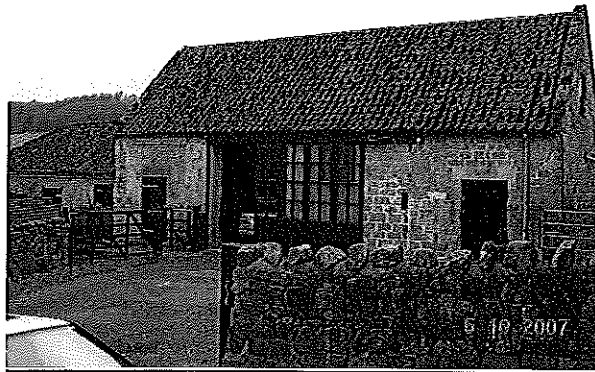
The site for the development proposal comprises the range of buildings at Sunny Bank, Hackness, currently including the two storey barn and adjoining store and

stable, all dating from the late 18th or early 19th century (Frontispiece). The buildings consist of a stone-built barn used on the ground floor as a garage and adjoining store and with a full length storage floor above and including the roof space. Adjoining the barn on the south end is a small range of single storey loose boxes used for stabling and poultry. All are currently in general use. The whole range is roofed with clay pantiles. The subject buildings form part of a larger group of similar buildings close by.
