Bat Survey Report

High Barns, South side of road,
Whitby Laithes,
Hawsker Lane,
Whitby,
North Yorkshire.

Date of Survey: 04 September 2010.

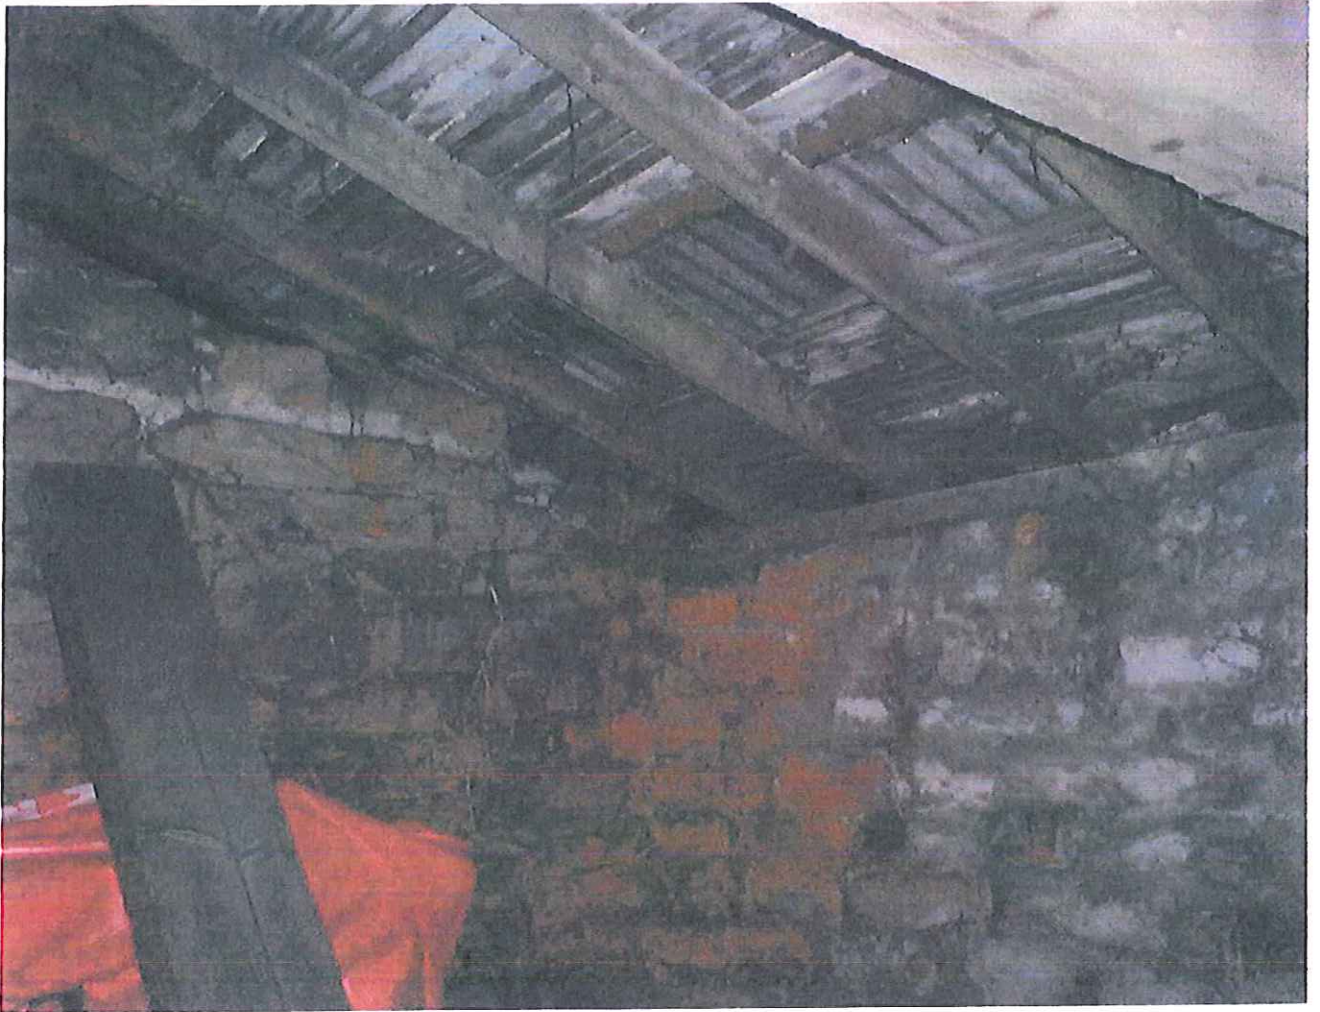
Appendix 1: Detail of North facing wall and roof taken from within the building.

On the 7th September a detailed examination of the property was conducted. This found that the building which used to house stock and had an earth floor was stone built and had an asbestos sheet roof. The pointing on the walls seemed in reasonably good condition. The worst of the pointing is to be found on the South facing wall where there were gaps which go through to the inside from the outside. To the North side are some double wood doors which are ill fitting and to the East side there is a single wooden door with gaps in, making the whole building draughty. The roof consists of asbestos sheets. There is no underfelt but the roof is partially covered by lathes. There are no ridge tiles in place and the ridge is open. No signs of bats were found here. This building is unlikely to be of any use to bats due to the lack of draught free crevices or other suitable roosting sites within this structure. A photo of the North facing wall and roof taken from within the building is to be found at appendix 1.

No evidence was found to suggest that the building inspected has ever been a bat roost.

The wall to the left is an internal wall and not an outside one.
