Client: North Yorkshire County Council
 Project: Hackness Primary School
 Title: Ecological Scoping Report

Job No: BAE08907

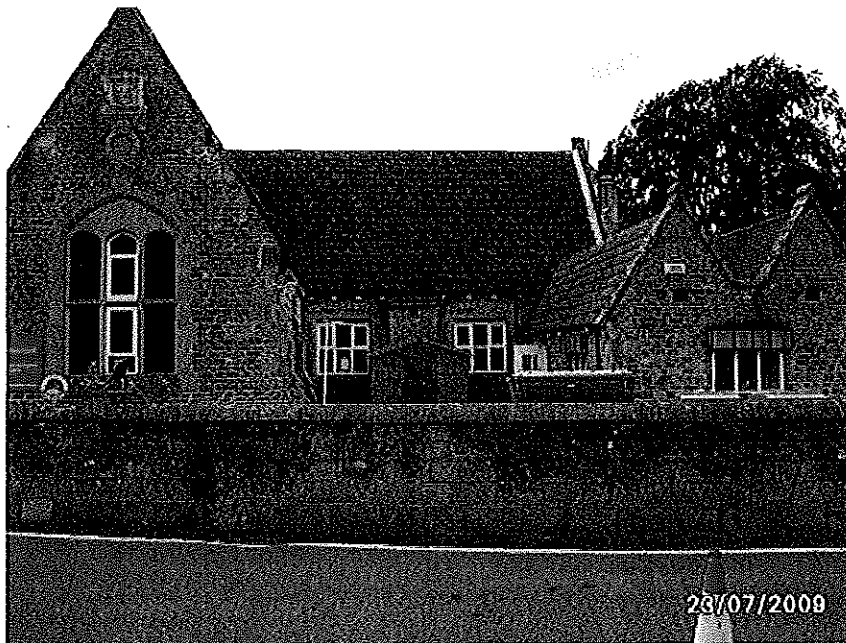
Photograph 1: External view of the school from the north.

The school (Picture 1) comprises former Victorian school buildings and an adjoining toilet block to the rear. The original school is single storey U-shaped building with pitched roofs. The eastern, multi-purpose wing of the school and the Key Stage 1 & 2 classes have particularly high vaulted ceilings which are obscured internally by suspended ceilings and above these, earlier cladding (Picture 2). The modern toilet block to the rear of the main school comprises a flat roof fitted with skylights. The western wing of the school comprises a twin pitched roof covering the kitchen, entrance hallway and staffroom.

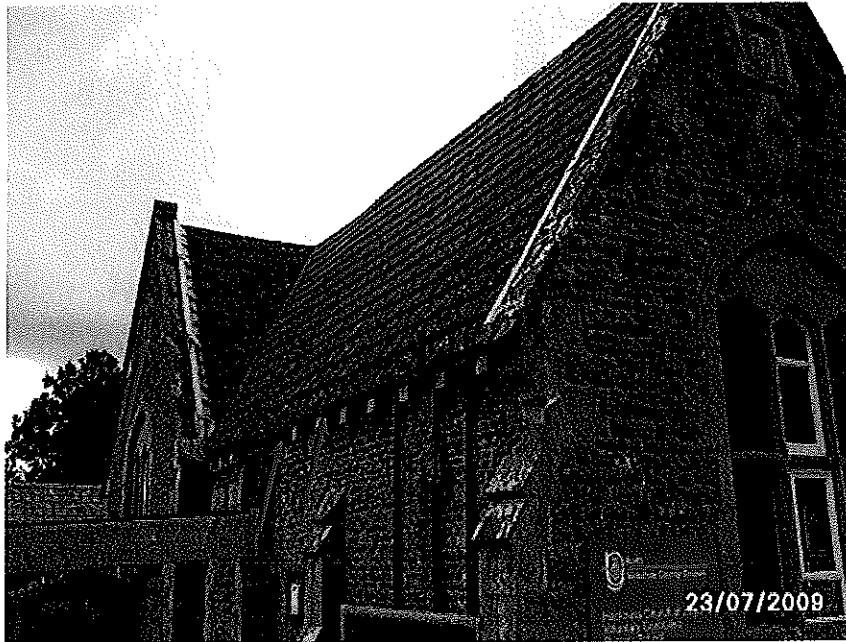
Photograph 3: Picture indicating position of louvre in gable end and gaps at top of wall in foreground offering bat roosting potential.

The entire school building was assessed externally and internally for its potential to support bat roosts. The pitched roofs were in good condition with only small gaps noted to the mortar used to bed the ridge tiles on the west facing roof pitch (Target Note 1). Louvres (Picture 3) covering the ventilation slots at the gable ends of the Key stage 1 & 2 building provide possible entry points for bats with gaps in mortar above the western facing louvre (Target Note 10). These features offer medium potential to support bats particularly as they lie in close proximity to other features offering high potential. Several features were noted to the top of the wall opposite the main entrance to the school (Target Notes 3, 4 & 5, Picture 4) where gaps were present between the top of the wall and the roofing felt and under the roof timbers that support the wooden guttering. The north-west corner of the eastern wing has a gap at the top of the wall under which were found bat droppings, believed to be Pipistrelle, sticking to the wall as well as several droppings caught in cobwebs just below the top of the wall. The eastern side of this wing of the school also contained gaps below where roof timbers rest on the wall. Using the criteria set out in Table 1,

the eastern wing of the school was assessed as having high bat roosting potential. Although the internal inspection of the wing revealed cladding it is believed that there is a space between this and the roof tiles above. A small gap was also noted at the top of the wall to the rear of the school near the boiler house but this was heavily cobwebbed and felt to be a feature of low potential. The flat roofed toilet block presented no suitable features and was of sound construction. The internal inspection of the roof voids above the suspended ceilings throughout the school revealed no features suggestive of or suitable for, bats.
