Woodleigh House, Aislaby  
Mr. A. Little

**Woodleigh House, Aislaby**  
**Bat Scoping Survey Report**  
14/01/09

**MAB Environment & Ecology Ltd was commissioned by Mr. A. Little to undertake a bat scoping survey of an out-building at Woodleigh House, Aislaby, to accompany a planning application.**

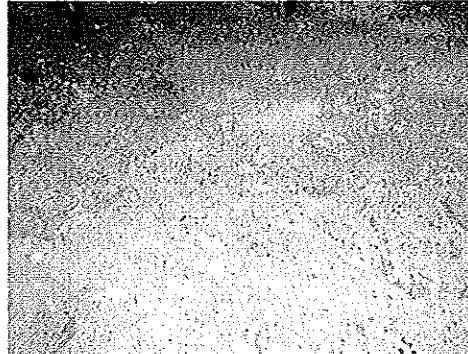
Internally, because of the dry undisturbed conditions under which bat droppings would have accumulated and been visible to the surveyor, if present, such evidence would also have been identified during the internal inspection.

8. Undisturbed second storey floor of middle store room
