Bat Survey Report

Grosmont Chapel,
Grosmont,
Near Whitby,
North Yorkshire.

Date of Survey: 12 May 2011.

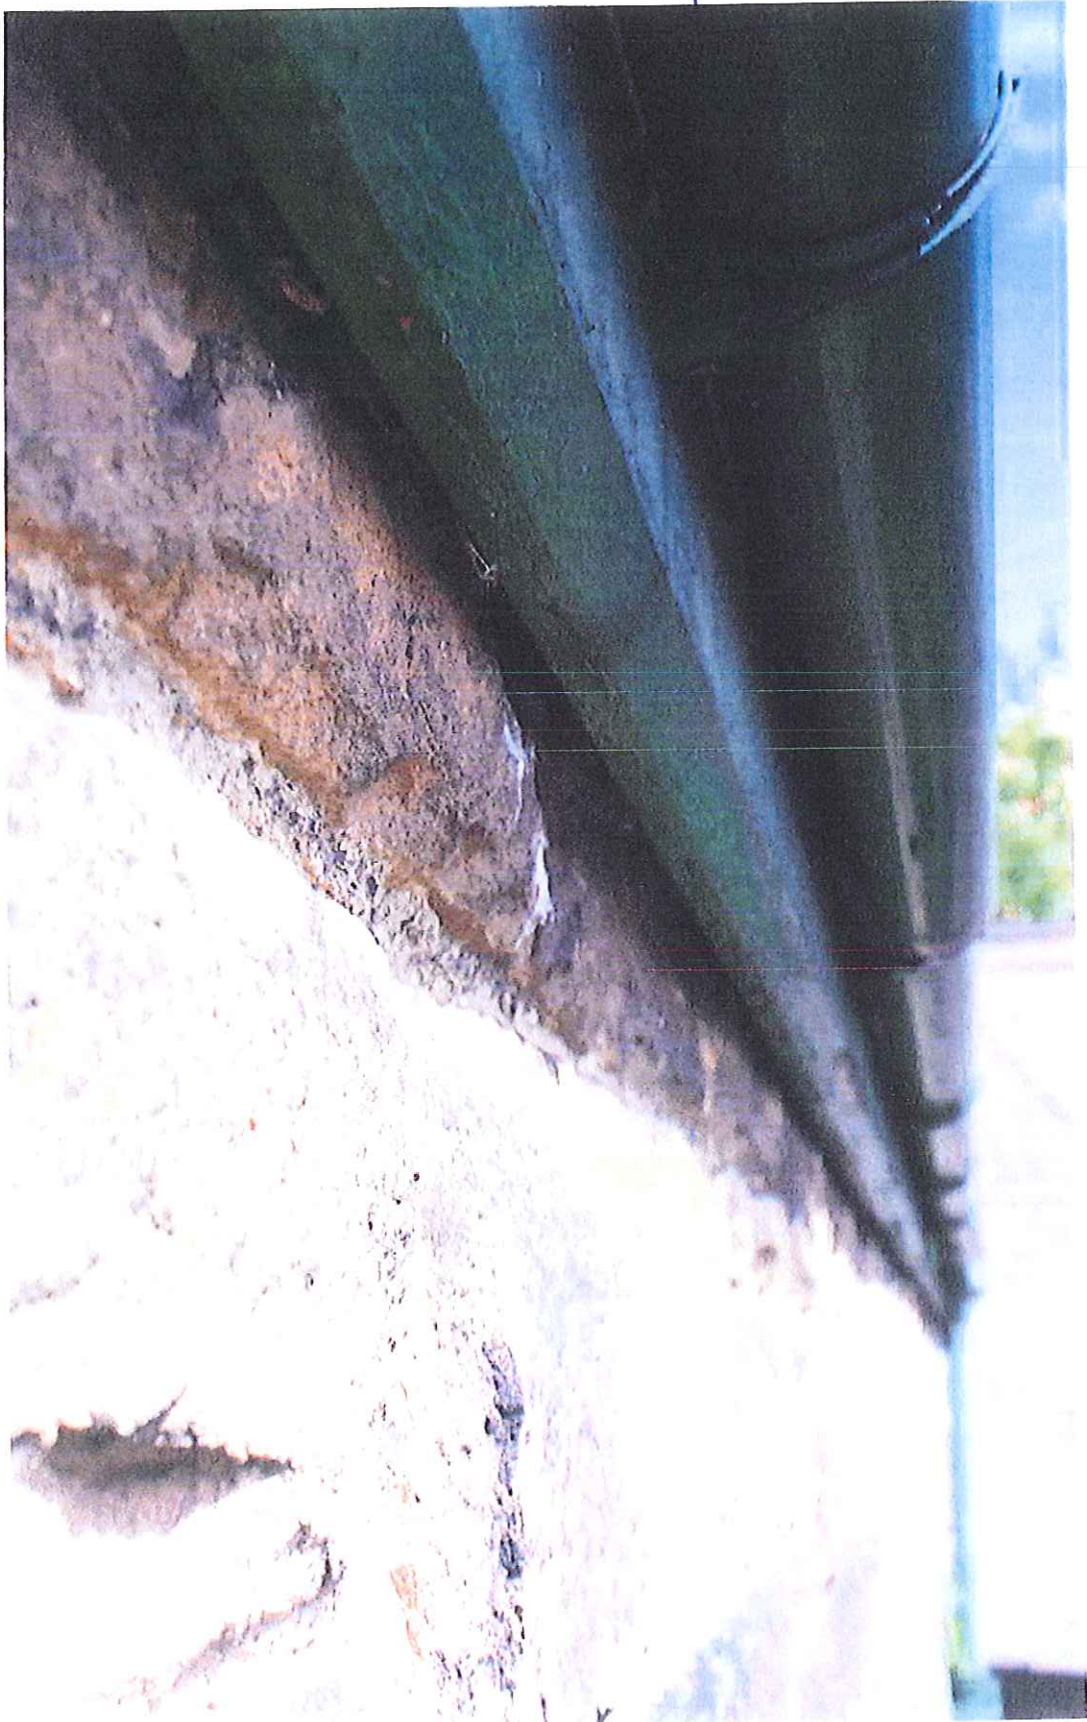
Appendix 3: Photo of barge boards on the Chapel.

There was no evidence of bats found on the outside of the building. The pointing on the walls looked in reasonable condition as did the pointing around the roof. The chapel is a stone built building. Some of the slates had let loose but there were no great holes in the roof. The roof was covered with slates. The Chapel had wooden barge boards upon which the guttering is attached (see appendix 3 for a photo). There are two louvred openings into the roof space, one above the front door and the other at the back of the property (one facing East the other West). The main chapel showed no signs of bats being present. The loft area was inspected from the loft hatch

The survey carried out on the 29 May 2011 was carried out on the South side of the Chapel by looking North North East so that the whole of the South side of the main roof could be seen as well as the barge boards, the barge boards and the West side of the vestry roof could also be seen from here, as could the front of the Chapel. 1 Pipistrelle was seen emerging from the barge board above the vestry door at about 21.40. Another was seen emerging below the hopper below the gutter at 21.44. A third Pipistrelle was seen emerging from the barge board between the two windows nearest Ings Terrace at 21.47. A fourth Pipistrelle was seen emerging from the barge board at the junction of the vestry and the Chapel at 21.50. The species was identified using a Batbox IIID detector. No bats were seen to be leaving the roof or walls.

As bats were found on the South and West facing barge boards of the Chapel and the roof is being replaced or at the least repaired it is considered that the proposed development may have an adverse impact on local bats. As such mitigation measures need to be in place in order to conserve the roost.

It is suggested that any work to the roof, gutters and or barge boards be delayed until the bats are hibernating (from about October) and all works completed before the following spring (around April). The existing barge boards are to be retained or replaced with similar timber boards and the existing gaps between boards and stonework maintained in order to preserve the roost. If this is done then there should not be a need to apply for a licence as the bats are not disturbed and the roost is maintained. It is further suggested that should the barge boards need to be removed they are removed in such a way as to prevent any bats hibernating behind them from being squashed between the boards and the stonework. Should any bats be encountered at this stage then all work must stop and further advice must be sought.

Evidence was found of Pipistrelles using the barge boards on the South facing side of the Chapel and the West facing barge boards of the vestry as a roost. Mitigation measures (as mentioned under impact assessment above) need to be in place before any work is carried out which may affect this roost.

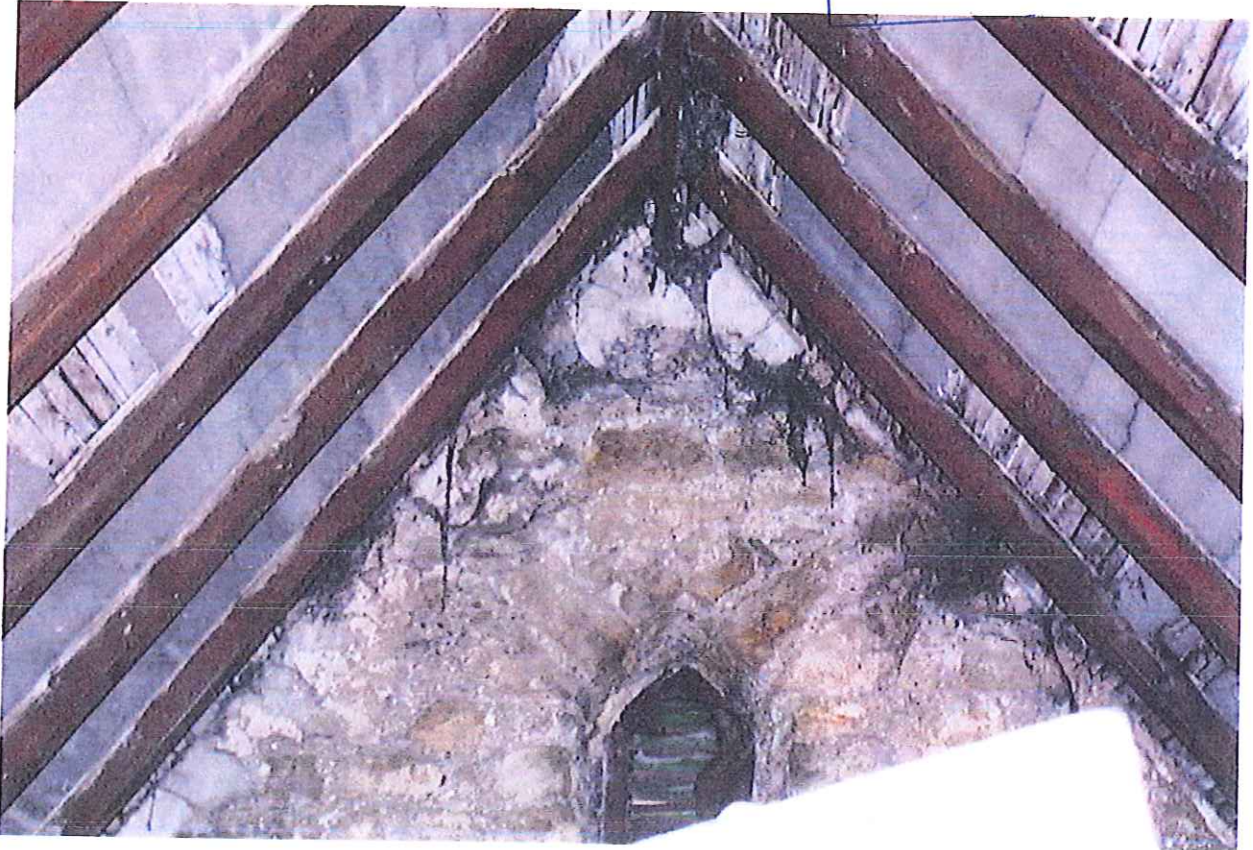
Appendix 4: Photo taken looking East in the loft of the Chapel.

only as the ceiling was domed (see appendix 4 for a photo taken looking East). Due to the louvred openings the loft was draughty but not excessively so. The inside of the roof was slatted and plastered. There were no signs, from inside, of bats ever having used this loft.

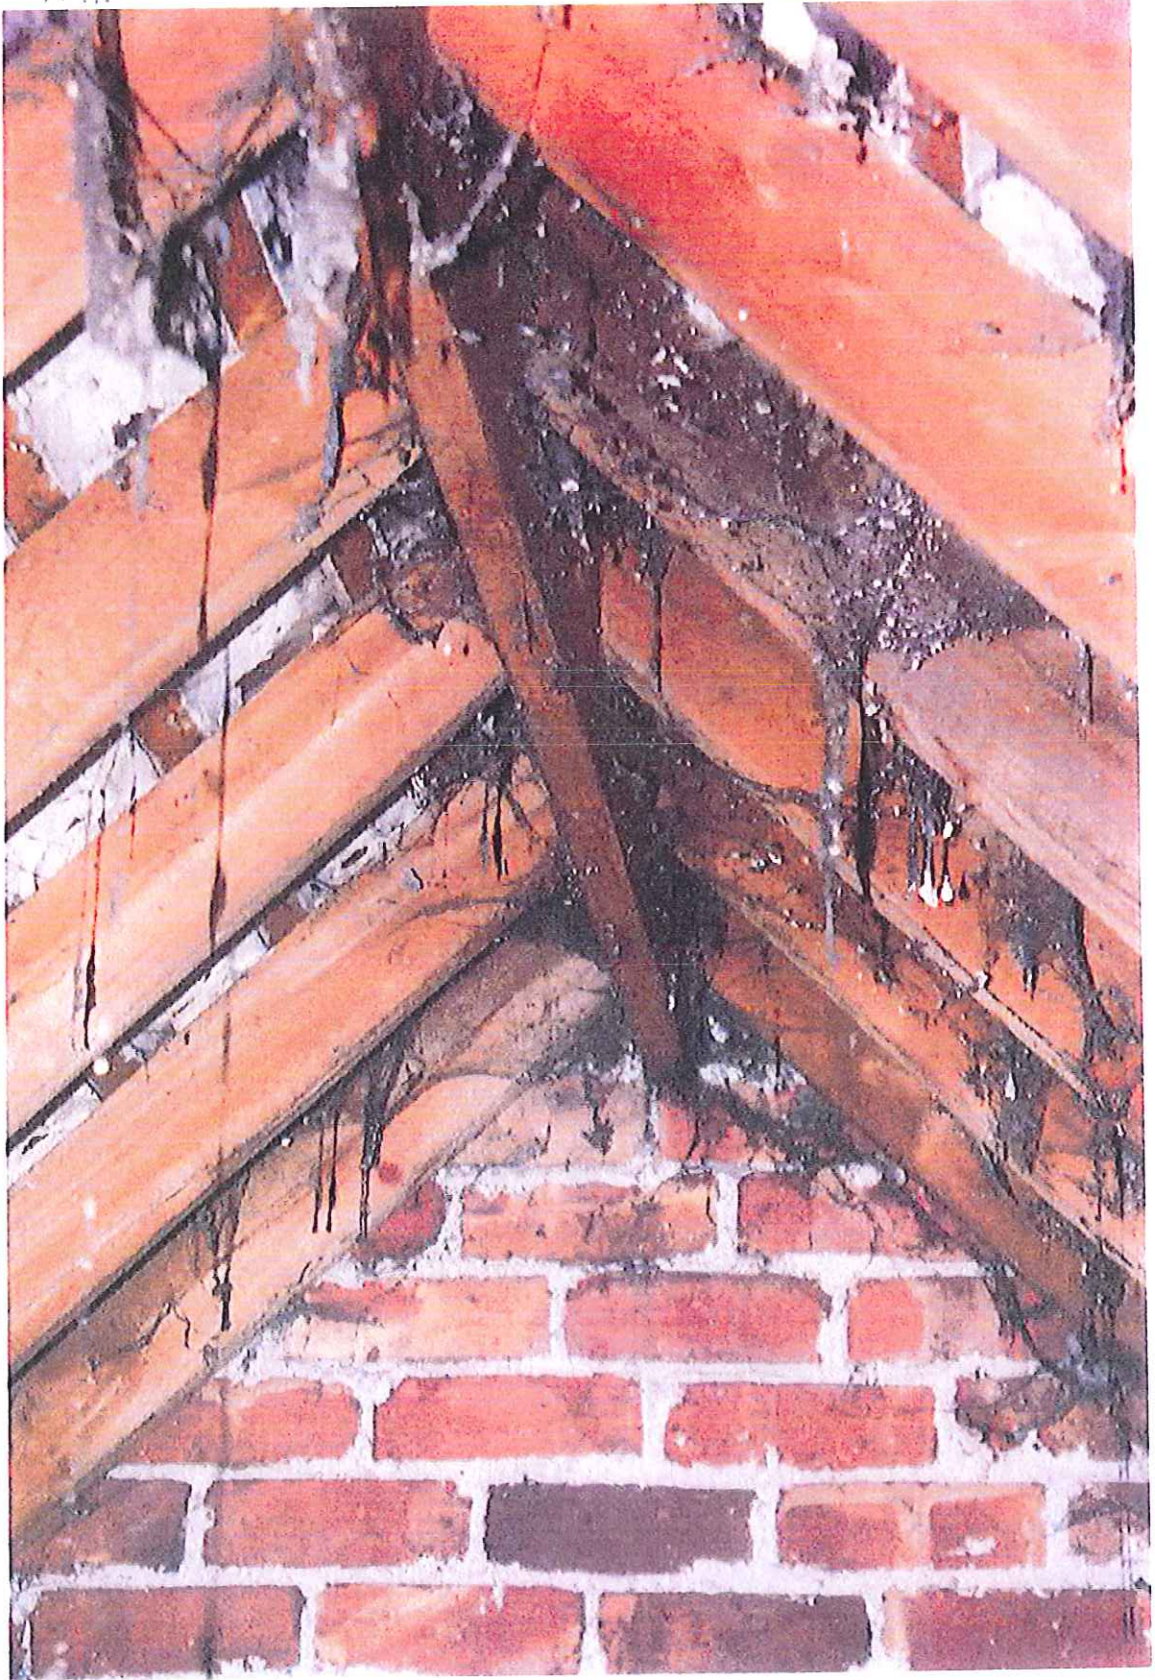
Appendix 5: Photo taken looking East in the loft of the School Room.

There was no evidence of bats found on the outside of the building. The pointing on the walls looked in reasonable condition as did the pointing around the roof. The School Room is a stone built building. Some of the slates had let loose but there were no great holes in the roof. The roof is covered with slates. There are no barge boards on the School Room and the gutters are attached to the stonework (or pointing). The main building showed no signs of bats being present. The loft area was inspected (see appendix 5 for a photo taken looking East). The slates were visible from inside the roof and no evidence of bats could be found.

As the School Room is not a roost no mitigation measures need be in place as no adverse impact on local bats is likely.

No evidence was found of bats using, or having used, the School Room as a roost and as such no mitigation measures need to be in place as it is considered that the proposed development will have no adverse impact on local bats.
