## **The Huntsman, Aislaby Whitby**

### **Bat Survey**

April 2011.

# Report of Bat Survey

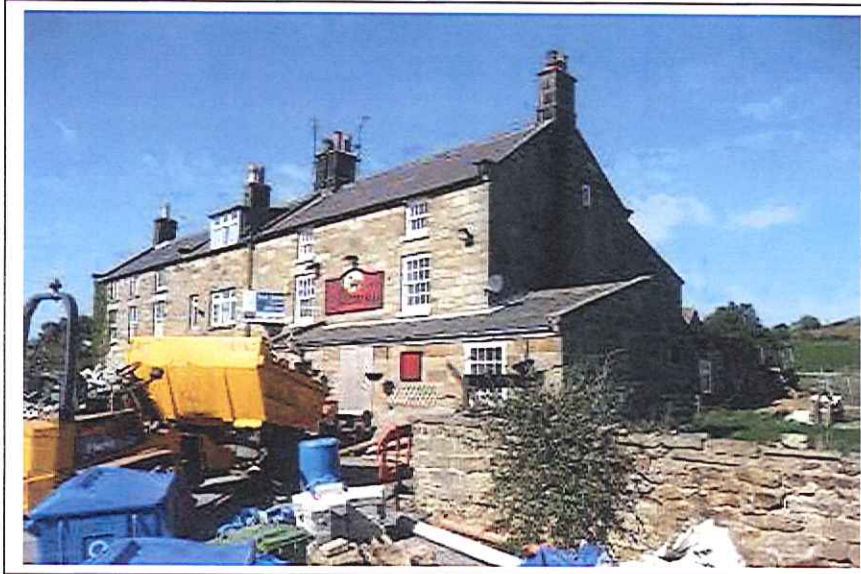
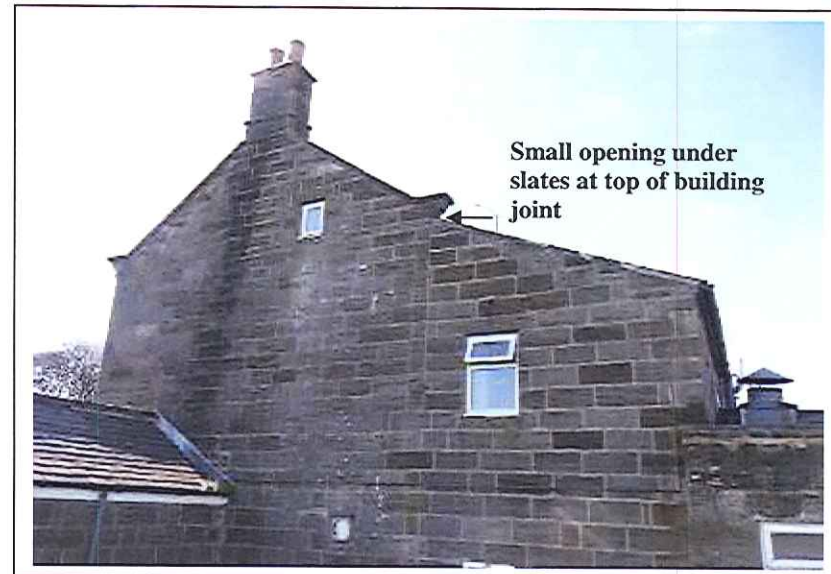
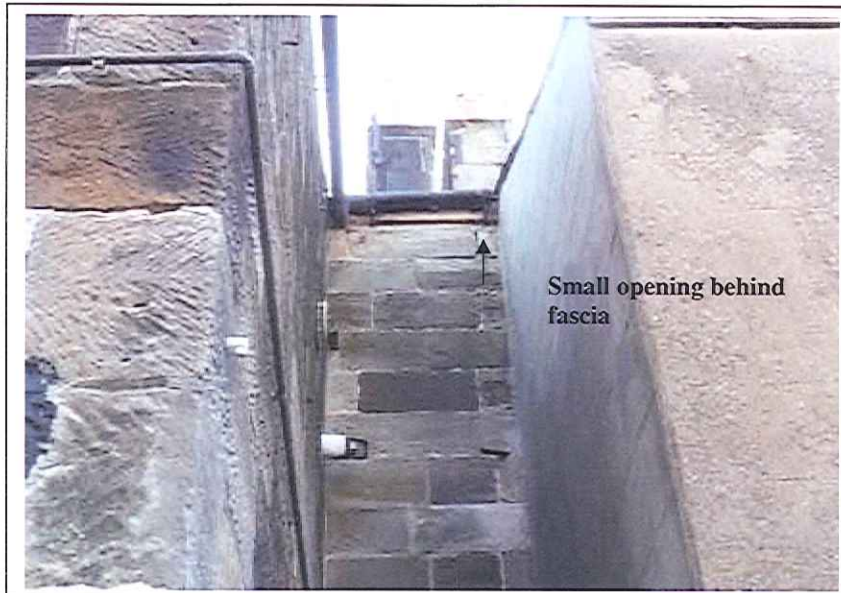
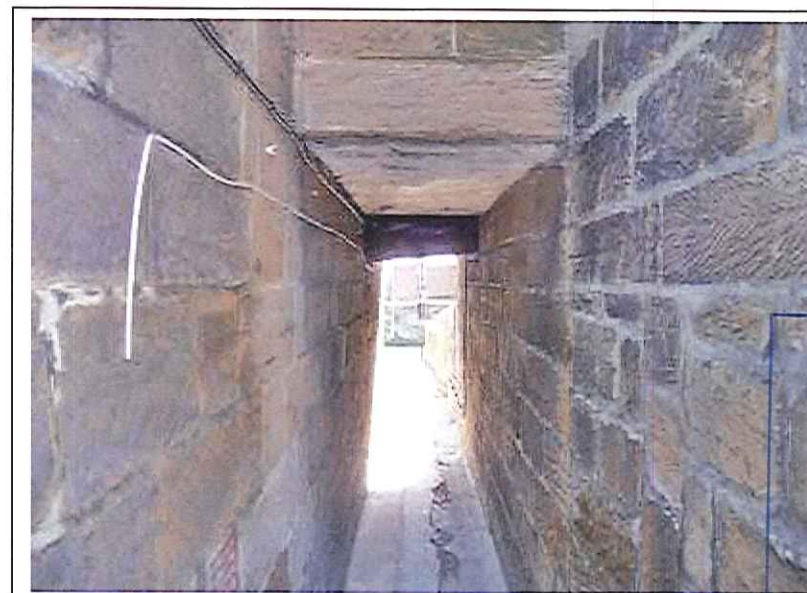
FIG 1

Ref	Description
A	<p>Two storey public house with stone walls and pitched blue slate roof with the rear roof slope extending over an extension. The front eaves had a course of projecting stone slabs extending approx 75mm from the wall face to support the guttering leaving no potential access points for bats. The east gable was a plain wall with a vertical building joint where the extension was added. This was generally well pointed but with a single very small opening immediately below the roof slates. The rear wall contained a narrow recess with an open passage through the building. The eaves had a timber fascia, generally sealed but one small opening was noted at the head of the passage. The soffit of the passage was well sealed with no suitable openings. No signs of use were found externally. External views are shown in Fig 1.</p> <p>Internally the main loft space was substantially occupied by attic rooms leaving only a low apex loft unsuitable for bats and in any case heavily cobwebbed and with no signs of droppings on the surface of loft insulation indicating that a bat roost was not present. A triangular eaves loft was present under the rear extension but also fairly low and unsuitable for bats. No droppings were found here either. Both of these loft areas are shown in Fig 2.</p>

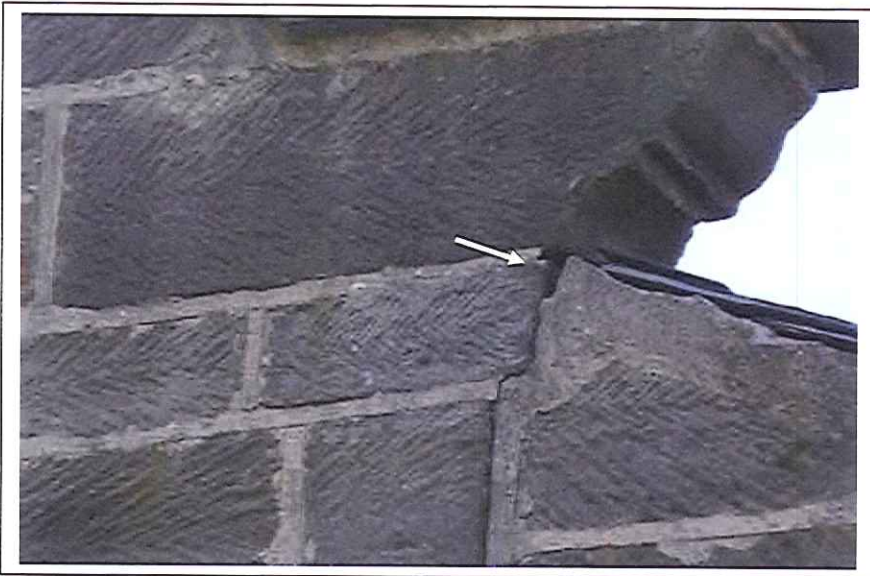
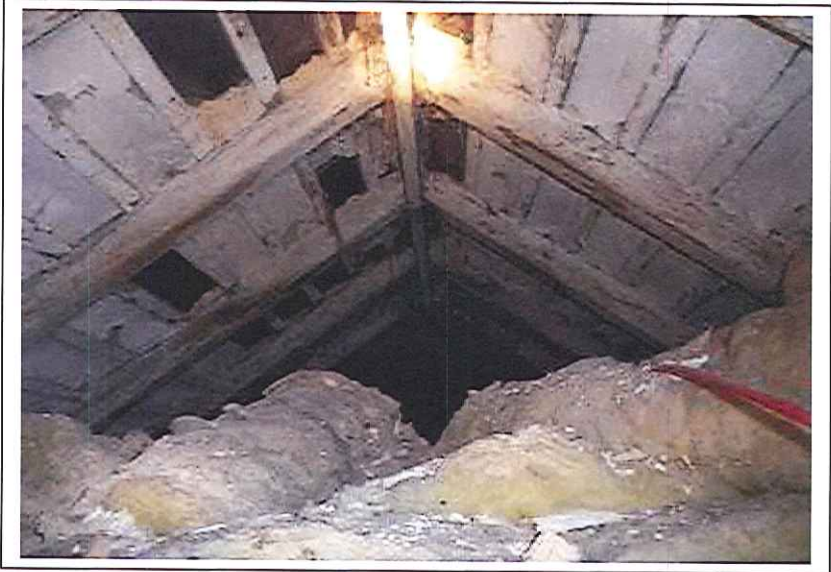
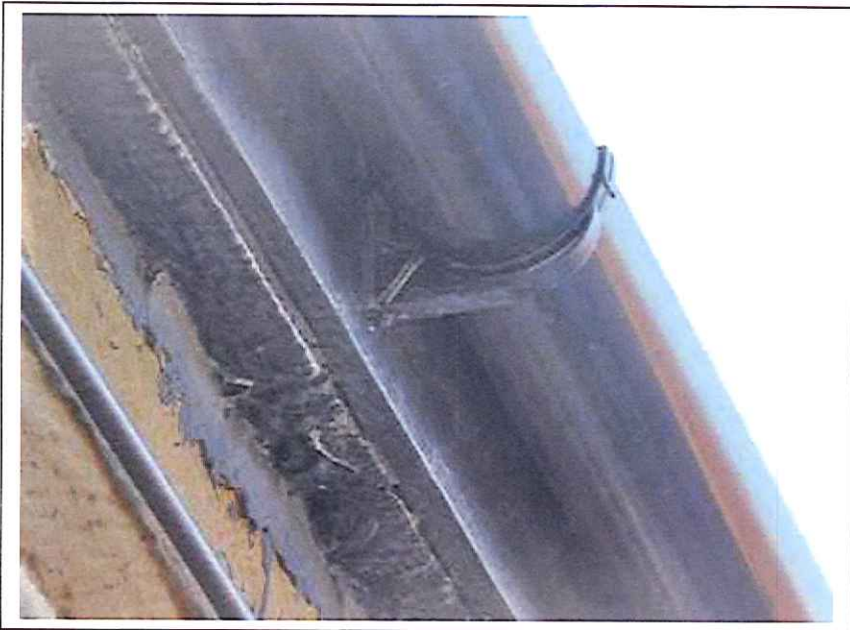
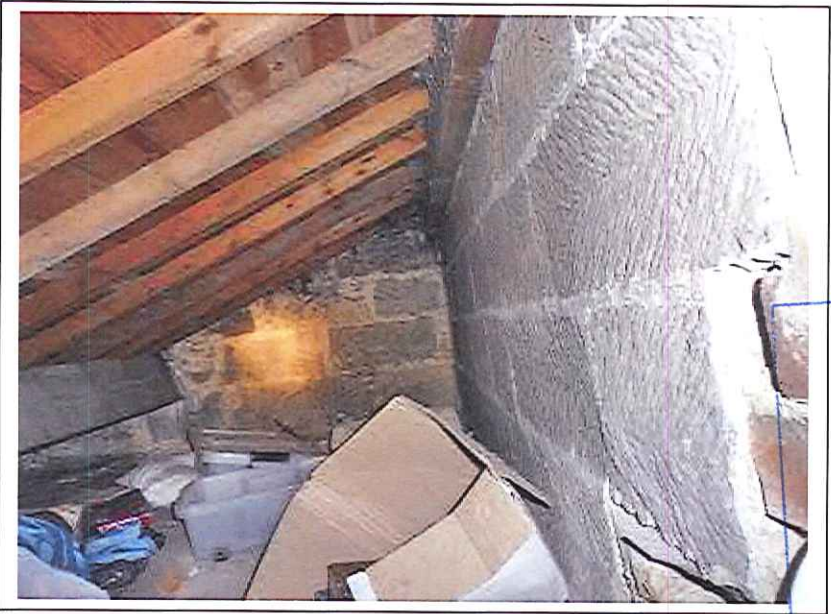
FIG 2

- 11.2 Internally the two loft areas in the main building were small and generally unsuitable for bats and no signs of droppings bats were found. The loft in barn C was small and enclosed with no suitable access points. Barn C was similarly small although with slightly more access potential because of the pantiles but no signs were found.

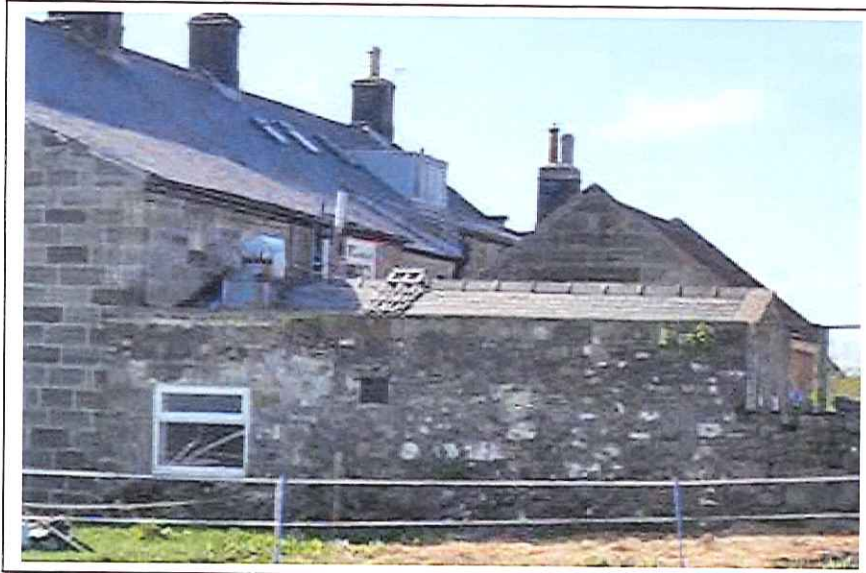
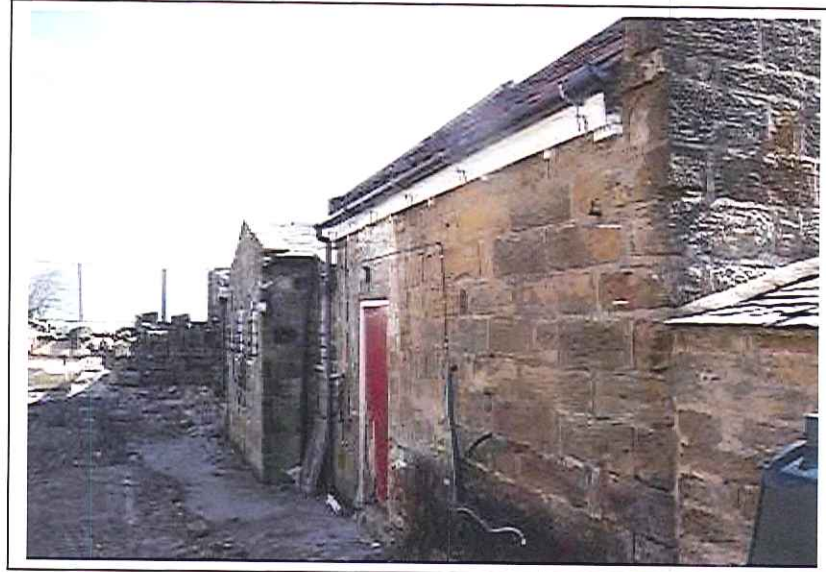
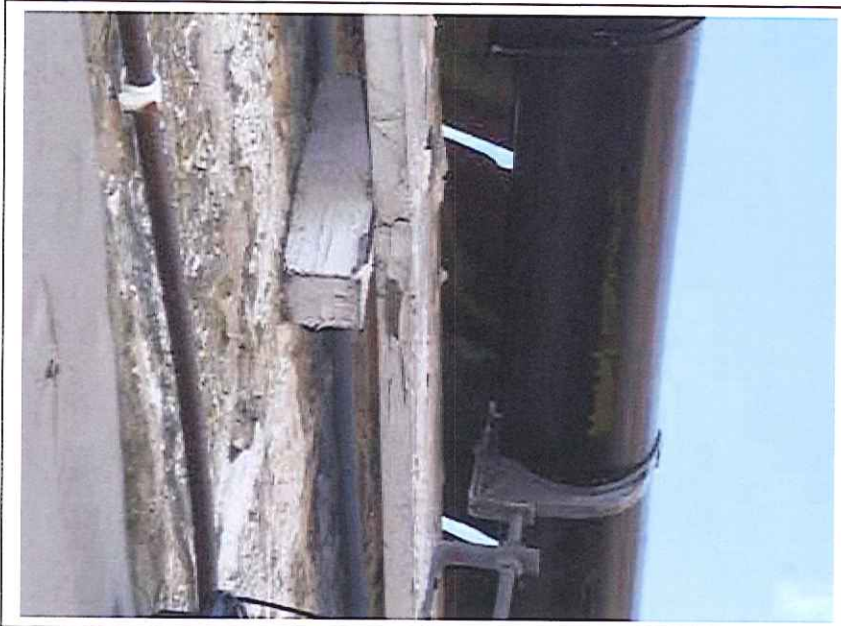
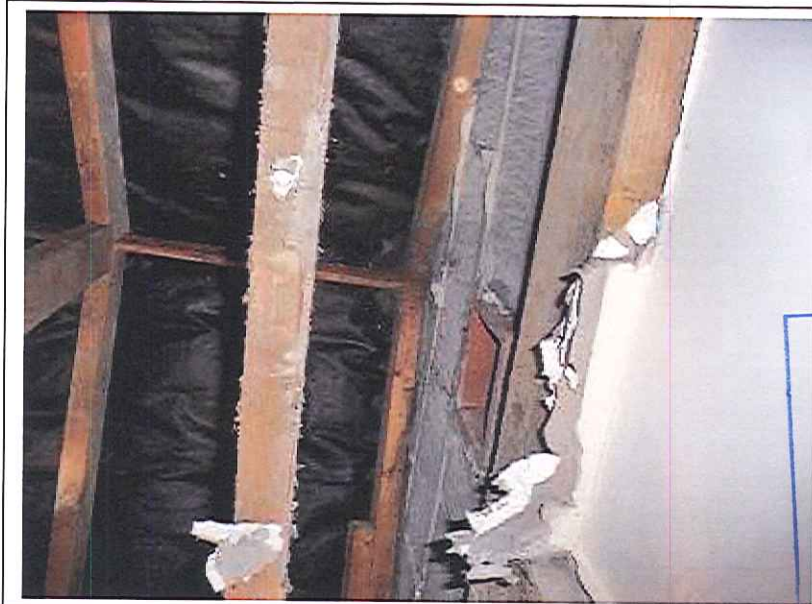
FIG 3

B	External area between the buildings enclosed with a timber clad wall and roofed with translucent sheets. No potential for bats.
C	<p>Single-storey kitchen extension with stone walls and a blue slate roof. The north wall formed the site boundary and the west gable were finished with concrete parapet copings well pointed with no suitable openings. Externally there were no potentially attractive roost locations for bats. Illustrated in Fig 3.</p> <p>Internally the original plaster ceiling had been removed to reveal a shallow loft approx. 750mm to the ridge, The roof was lined with under-felt. The ridge area and the inside gable walls were cobwebby. No signs were found.</p>
D	<p>Two-storey stone barn with clay pantile roof. The gable walls were finished with copings, well pointed with no suitable openings. The eaves on the south side were covered by a building whilst on the north side a timber fascia well away from the wall and open top and bottom. Externally there were no potentially attractive roost locations for bats. Illustrated in Fig 4.</p> <p>Internally the upper floor was accessed from external steps and was open to the underside of the roof which was closely lined with lath leaving no gaps next to the ridge board. The ridge and gable apexes were very cobwebby. There were no signs of droppings, urine spotting or discarded insect remains present.</p>
