Bat Survey Report

High Barns, South side of road,
Whitby Laithes,
Hawsker Lane,
Whitby,
North Yorkshire.

Date of Survey: 04 September 2010.

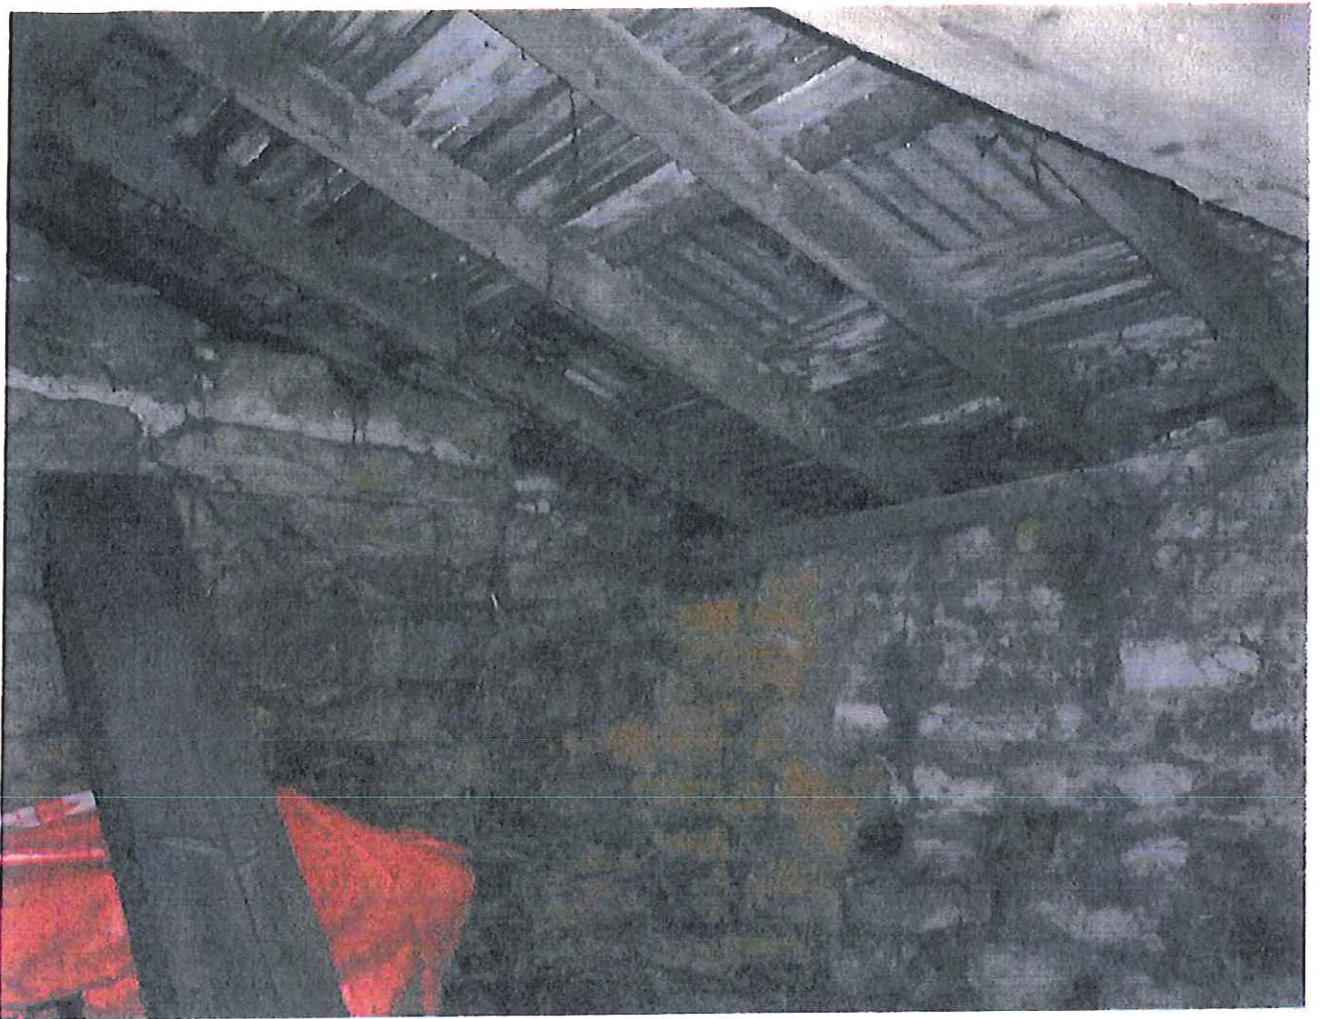
Appendix 1: Detail of North facing wall and roof taken from within the building.

On the 7th September a detailed examination of the property was conducted. This found that the building which used to house stock and had an earth floor was stone built and had an asbestos sheet roof. The pointing on the walls seemed in reasonably good condition. The worst of the pointing is to be found on the South facing wall where there were gaps which go through to the inside from the outside. To the North side are some double wood doors which are ill fitting and to the East side there is a single wooden door with gaps in, making the whole building draughty. The roof consists of asbestos sheets. There is no underfelt but the roof is partially covered by lathes. There are no ridge tiles in place and the ridge is open. No signs of bats were found here. This building is unlikely to be of any use to bats due to the lack of draught free crevices or other suitable roosting sites within this structure. A photo of the North facing wall and roof taken from within the building is to be found at appendix 1.

The wall to the left is an internal wall and not an outside one.
