## Bat Survey Report

Hillside Farm,  
Sleights,  
Near Whitby,  
North Yorkshire.

Date of Survey: 20 September 2011.

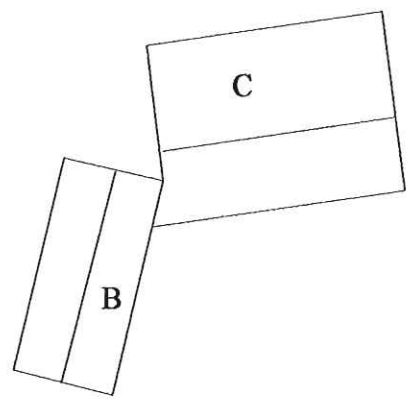
Appendix 1: Sketch of the various buildings inspected.

Appendix 1 shows a sketch of the various buildings inspected. Building A is the farmhouse, building B is an old cattle shed and building C has a couple of pigsties attached. The surrounding area is open fields (grassland with hedges) and pockets of woodland close by and moorland at the top of the hill to the South towards the A 169 at about 280 meters altitude. The Esk is at the bottom of the valley (about 0.25 Km away) and runs North East to the sea..

- A Farmhouse.
- B Old cattle shed.
- C Remaining shed.

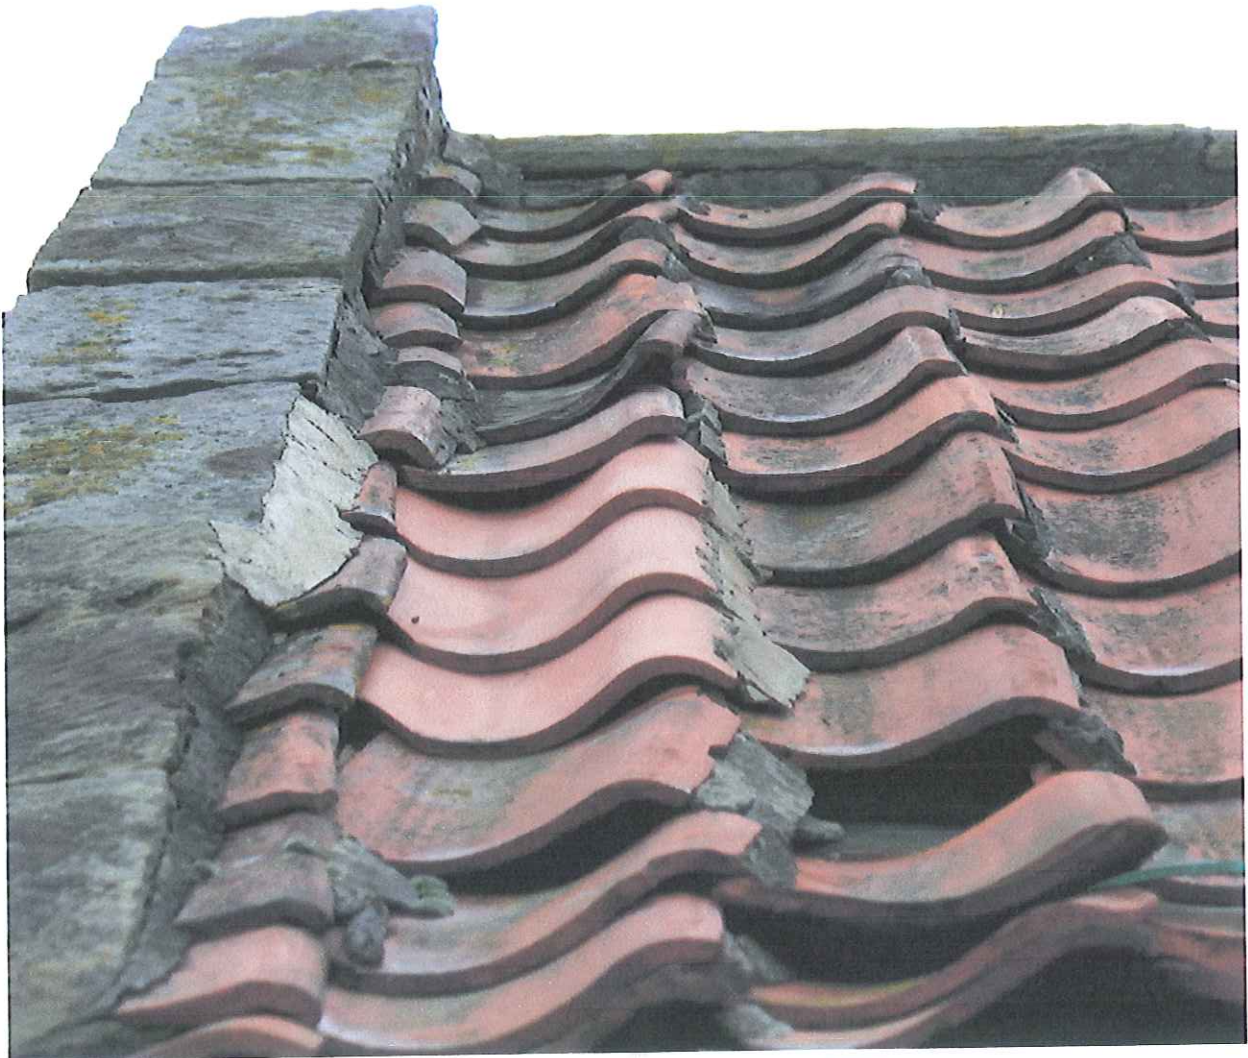
Appendix 2: Photo taken looking East at northern end of the old cattle shed.

The survey was carried out on the western side of the farmhouse so that the North and South side of the farm house could be seen as well as the western side of the old cattle shed. At 06.10 a single Common Pipestrelle (the species was identified using a Batbox IID detector) was seen at the northern end of the old cattle shed and finally disappeared under the ridge stone at the north western side of the building (see appendix 2 for a photo of the entrance, this being under the left hand ridge stone as seen from the West. No other bats were seen using any of the buildings surveyed. Other bats were seen flying along the hedges at either side of the main road species unknown as they were out of range of the bat detector.

Evidence was found of Pipistrelles using the ridge on the West facing side of the old cattle shed as a roost. Mitigation measures (as mentioned under impact assessment above) need to be in place before any work is carried out which may affect this roost.

As a bat was found on the North West side of the old cattle shed roof and the roof is being repaired it is considered that the proposed development may have an adverse impact on local bats. As such mitigation measures need to be in place in order to conserve the roost before any work can be carried out

It is suggested that should planning consent be given one of the conditions of the consent should be that a mitigation plan needs to be in place and agreed before any work is carried out which is likely to impact the bats or their roost.
