NYM / 2013 / 0391 / FL-4

Bat Survey to The Orange Tree

Rosedale East
Rosedale Abbey
YO18 8RH

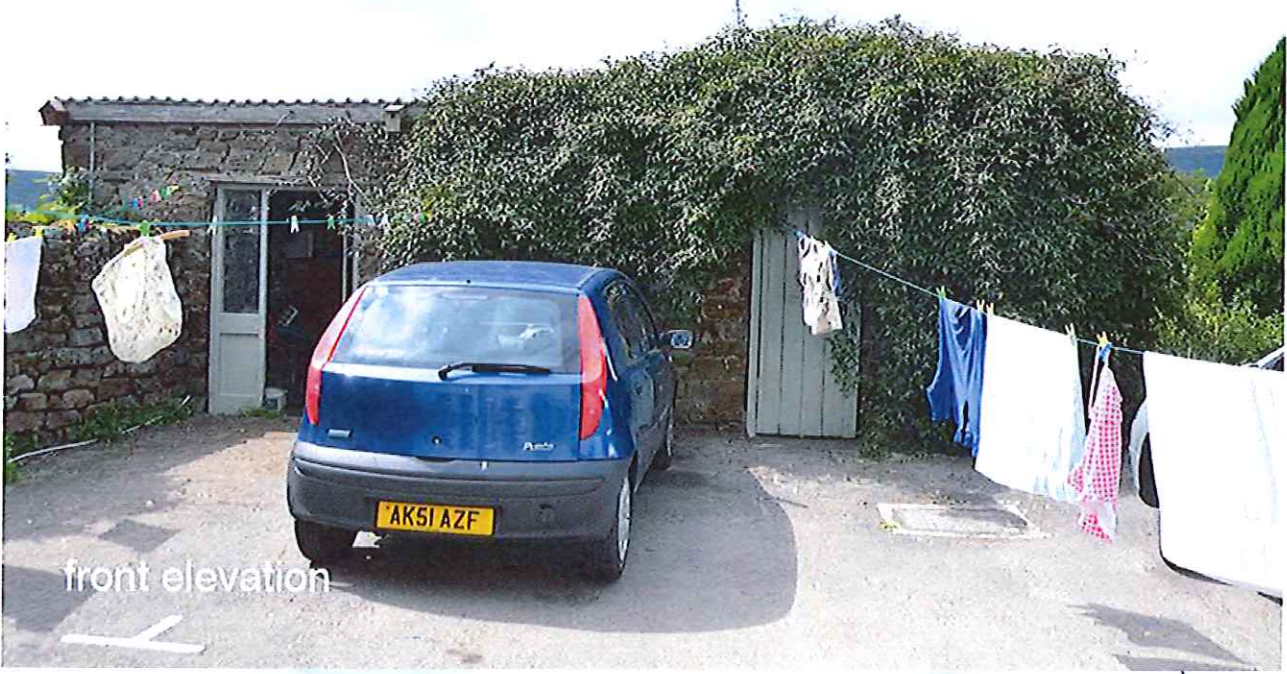
front elevation

- 6.1.3 Externally, the roof is gentle sloping from front to back (east to west) and has a covering of marl tiles. None of the tiles appeared to be missing and the tightly interlocking nature offers little roost potential. There are no gable walls and only the west and the east elevation have fascia boards. The majority of the front (east) and side (north) elevations are completely obscured by a large clematis which will prevent access to bats.

- 6.1.4 There are wooden fascia boards to the front and rear of the building but at the front, only around a metre of fascia is not obscured by the clematis. This was easily inspected using a high powered lamp which showed the gap behind the fascia to open out onto the internal roof space and as such does not provide tight enough crevices. The fascia board running along the back of the outhouse is similar in construction and although it appears to provide a small crevice, looking up into it with a lamp reveals that it simply opens into the building. The two remaining sides (south and north) do not have fascia and are dry pointed and without gaps.

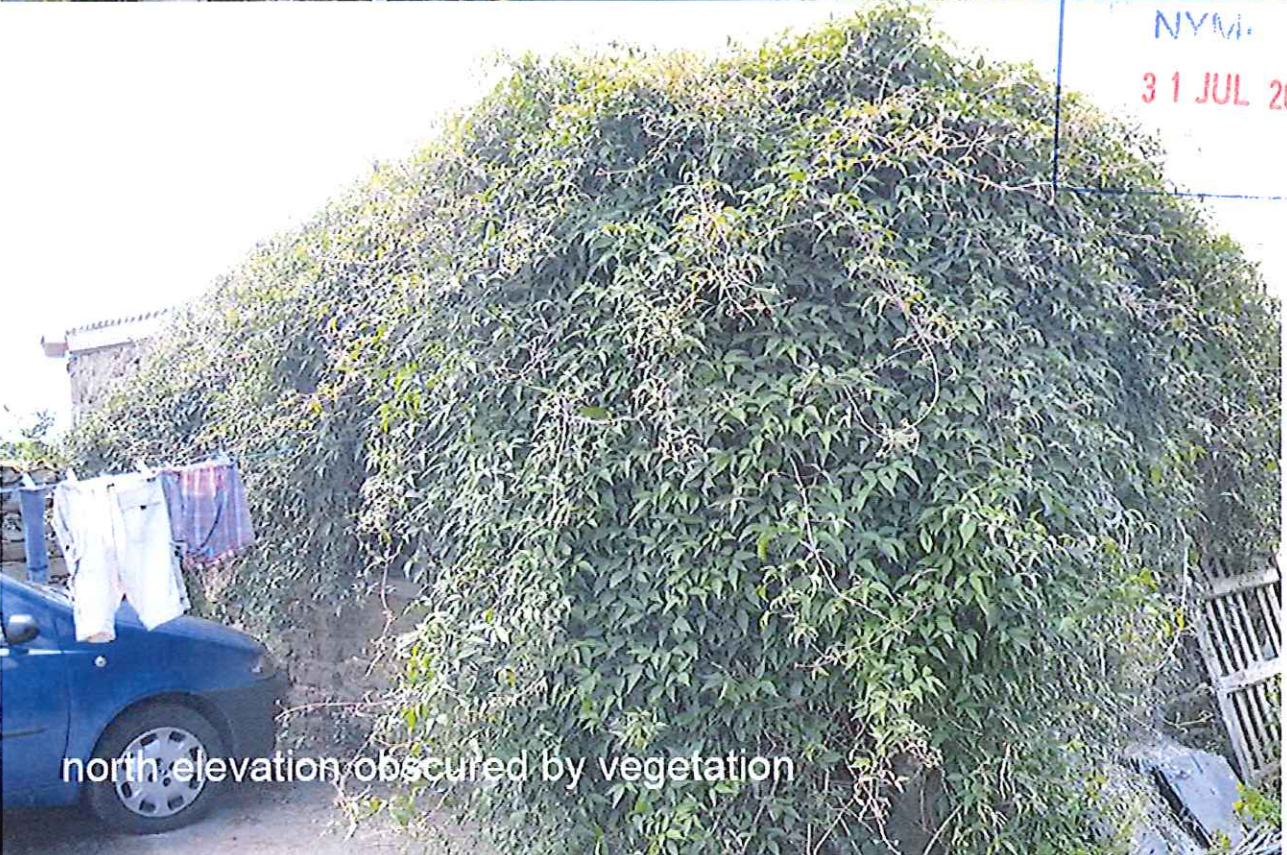
north elevation obscured by vegetation
