Bat Survey Report

Manor House Farm,
Newholm,
Whitby,
North Yorkshire,
YO21 3QY.

Date of Survey: 12 June 2012.

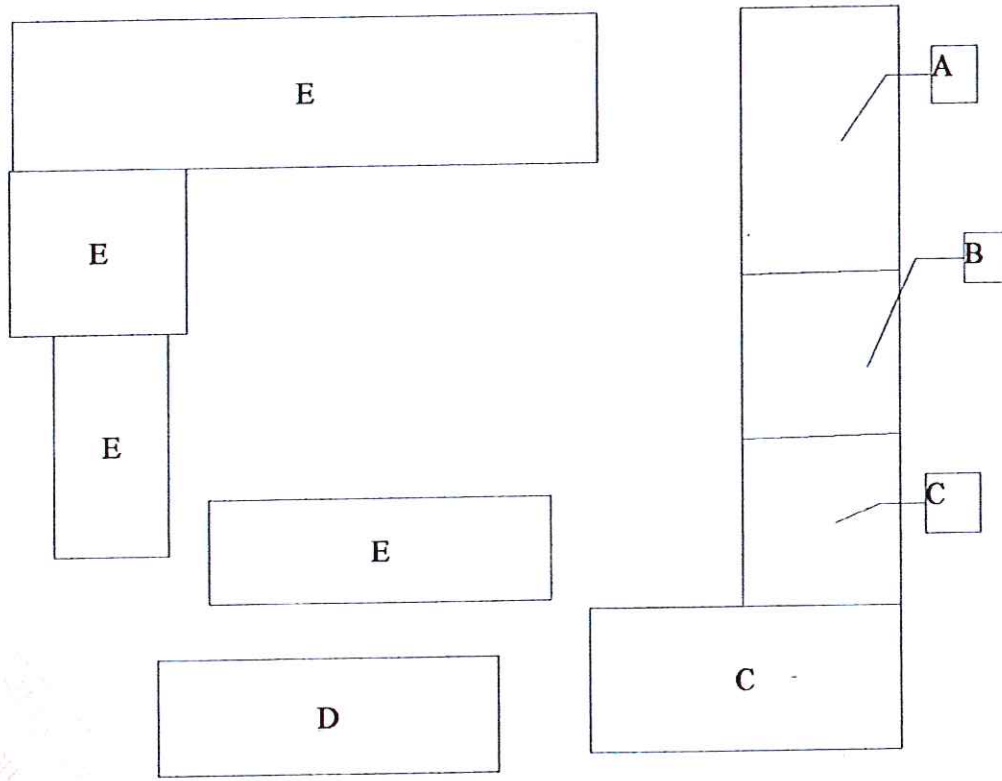
Appendix 1: Sketch of the various buildings.

The site is approximately 350 m to the North of the A171 as it passes the sign post to Newholm travelling East into Whitby. The outbuildings surveyed are the two buildings marked C on the sketch at appendix 1. Appendix 2 shows the surrounding countryside and appendix 3 is a close up of the various buildings..

- A: Farm House
- B: Converted outbuildings
- C: Outbuildings to be converted
- D: Dutch Barn
- E: Shed

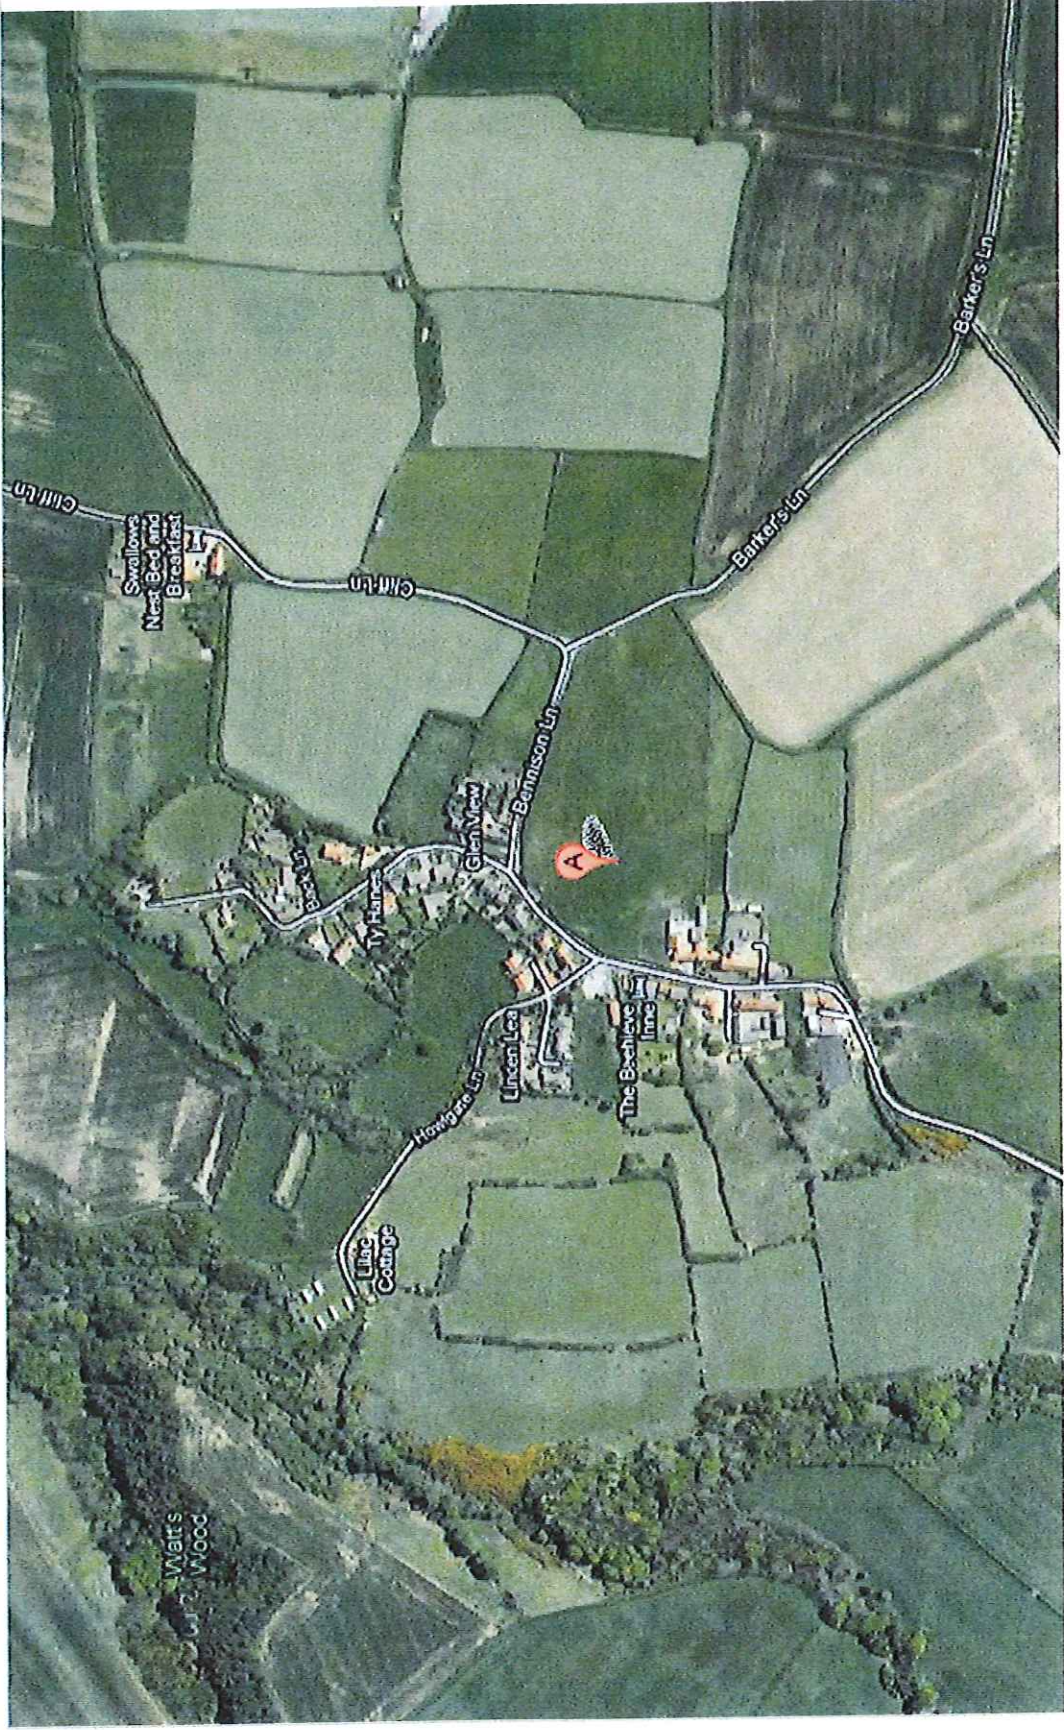
Appendix 2: Surrounding countryside.

The surrounding area is agricultural fields (grazing and arable) with hedges and there is a wood nearby (about 275 m to the North West). The North Sea is about 1 Km to the North.
