BUILDINGS

AT EVERLEY BARNS

HACKNESS

ENVIRONMENTAL ASSESSMENT RELATING TO DEVELOPMENT

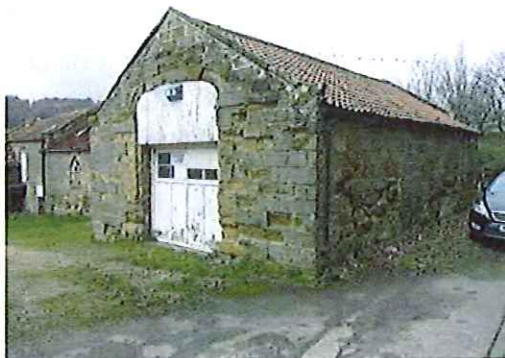
Fig.1. Coach house building (1).

1. Coach House (Fig1). A single storey building on the road side. Rubble filled walls in dressed limestone. Clay pantile roof is under-drawn with bituminous felt after more recent re-roofing.
2. Former Smithy (Fig 2). A single storey building in similar construction, but with un-altered roof.
3. Stable. Internal walls plastered to ceiling height and with false ceiling providing roof void above.
4. Two-storey building (Fig 3). Built in dressed limestone with tabled roof, part covered with clay pantiles and part with blue slate, all without under-drawing. Part of the building has an upper floor with dormer window.
5. Former garage (Fig 6). Built in rough dressed limestone and with collapsing roof covered with clay pantiles.
6. Below Buildings 4 and 5 is a small machinery shelter, built in timber framework with corrugated iron covering.

In Building 1 there are some missing roof tiles, although the roof ridge tiles were well set. There were cobwebs at the roof ridge, indicating a lack of bat activity, especially Brown Long-eared bats, which tend to roost at ridge level. Several openings give access for birds and bats to the inside. No droppings or food remains were found on any floor or other surfaces.

The recent re-roofing of some parts of the buildings (1) has been a major repair. All tiles in these areas are well bedded at the verge in cement and ridges and verges are all well pointed up. The bituminous felt under-lining has effectively sealed off most of the most common access points for bats except where further damage has created more gaps.

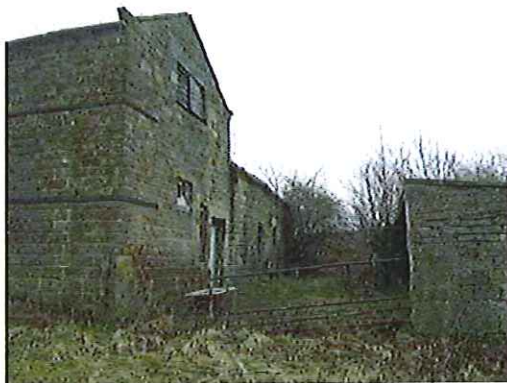
Fig 5. Building (4).

Building 4 is a 2-storey building with part upper floor and possibly of earlier construction. Part of the roof has been replaced with blue slates, without any under-drawing, with the remainder still in clay pantiles. Bat droppings, provisionally

identified as those of Pipistrelle species, were found in small quantities at random on the ground floor, mainly below the upper floor and around the doorway.

Inside the first floor rooms a small number of butterfly wings were found beneath the dormer window, which has several gaps between the glass panes allowing access for bats or birds. No droppings or other signs of habitation by bats were found within the upper rooms. The ceiling is attached directly to the roof timbers, without provision of any access to spaces above.

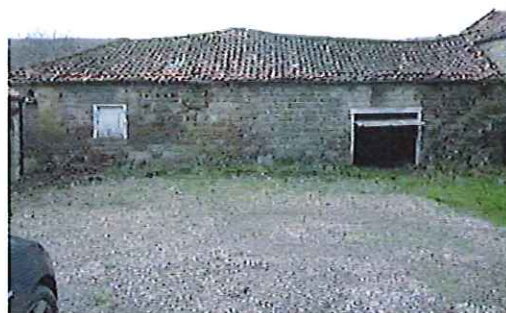
Fig 6 Former garage building (5).

Building 5 is a single storey building of one compartment, built in stone with clay pantile roof. The roof is in a state of near collapse following the rotting of timber trusses. The walls and roof are in poor condition, with several gaps in eroded mortar and with missing roof and ridge tiles (Fig 6, 9, 10).

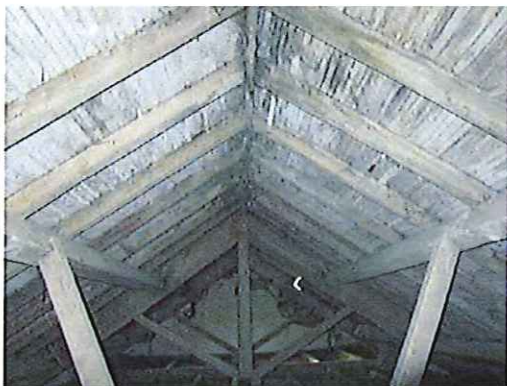
Building 3 is a former stable, with lime-plastered walls inside and false ceiling at eaves level leaving a roof void (Fig 7). The roof is in similar construction to 1 and 2, with many cobwebs to be seen at ridge level and hanging from the timbers. Although butterfly wings were found inside the roof void no droppings or food remains were found on any floor or other surface.

Fig 7 Roof void above stable (3).

The random presence of butterfly wings at the upper areas of the roof was not accompanied by the finding of any bat droppings, and since the ridge in Building 3 was covered by significant quantities of cobwebs there is no indication that Brown Long-eared bats have been present. No nocturnal moth wings were found.

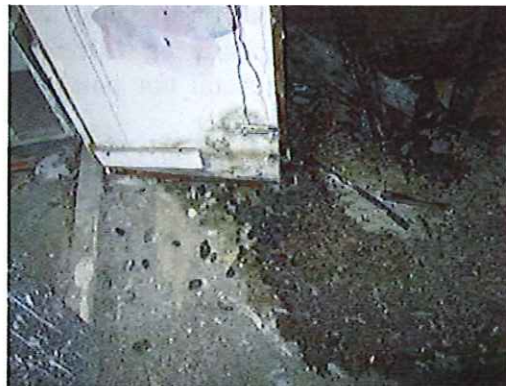
Barn Owl pellets were found in some quantities around a hole in the roof near the adjoining valley gutter, with copious amounts of droppings on the adjoining walls and beams (Fig 8).

Fig 8 Barn Owl pellets in Building 4.

The confirmed presence of Barn Owls in the building and the evidence of their habitation indicate long term occupation as a roosting and potential nesting site. Given the legal protection given to Barn Owls it will be necessary to provide appropriate mitigation plans to protect the site or to provide adequate and practical compensation for potential loss of habitat by the existing population.

The presence of Barn Owls within the buildings indicates the legal requirement to protect the habitat or to provide suitable and adequate compensation for the loss of habitat to be caused by the proposed development.

Proposals for the mitigation of the impact on the Barn Owl population caused by the proposals are attached at Appendix 6, for which licensed approval by Natural England will not be necessary.

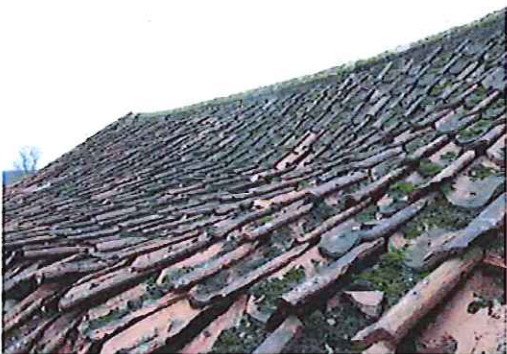
Fig 9 Roof of Building 5

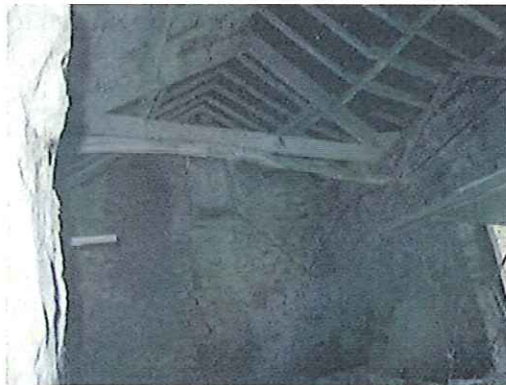
Fig 10 Interior of building 5.

Evidence of habitation by Barn Owls was found on the floor of the buildings 4 and 5, shown by quantities of fresh pellets on the floor debris (Fig.10). The pellets contained the undigested fur and bones of small mammals typically regurgitated by Barn Owls.

Evidence of their presence was also seen in the quantities of droppings on the timber roof trusses and walls immediately above the pellets.
