BAT REPORT

Linglands Cottage, Gowlands Lane, Cloughton, North Yorkshire. YO13 ODU

September 2014

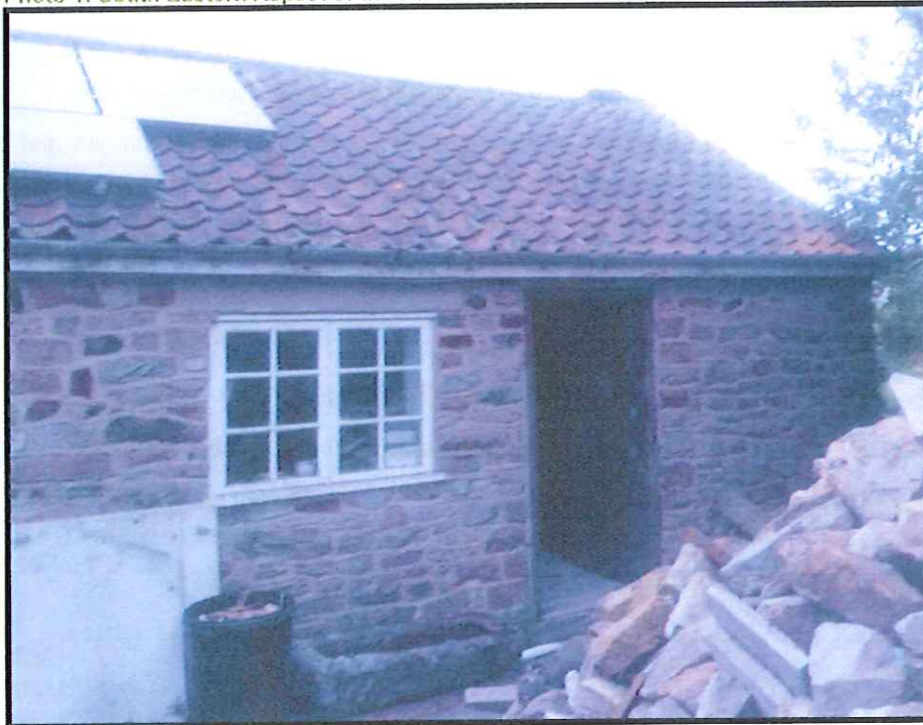
Photo 1: South Eastern Aspect of the Barn

- 4.3 The wall construction of the single storey barn comprised a stone outer and concrete block inner with a cavity between. The roof comprised a pitched clay pan tile roof and clay ridge tiles with a bank of 17 solar panels to the south. All windows and entrances were situated on the southern aspect which comprised three garage doors leading to the western and central internal sections and a timber window and door leading to the eastern internal section. Wooden soffits and fascias were present at the eaves. No barge boards were present on the gable ends. The western gable was abut to a further building used as dog kennelling.

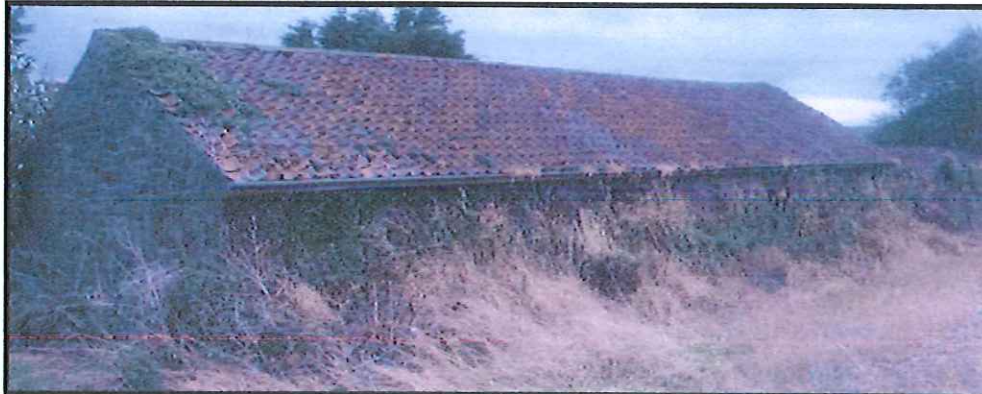
Photo 4: Northern Aspect and Eastern Gable.

- 4.4 Potential bat access points comprised the following;
- Numerous slipped tiles throughout roof structure;
 - Occasional missing roof tiles;
 - Gaps in soffits and fascias on northern and southern aspects providing access to the top of the wall plate and wall cavity.

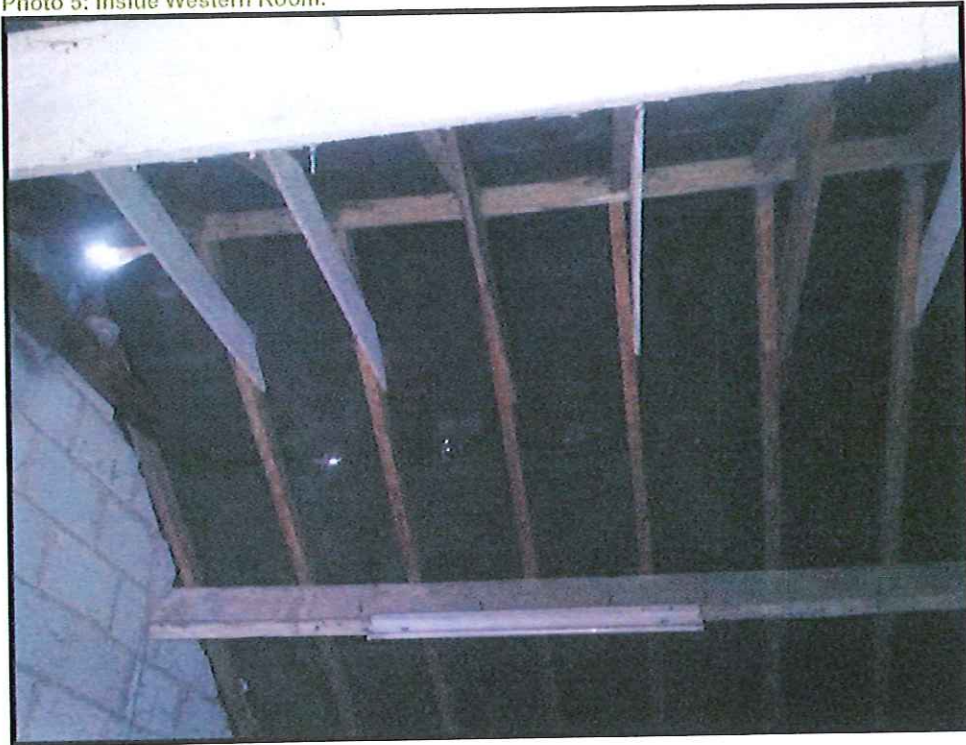
Photo 5: Inside Western Room.

- 4.6 The western and central rooms were accessed via wooden garage doors. Each room was vaulted with concrete block walls and partitions. These rooms had substantially sized wooden tie beams and queen posts, which at the joints some gaps were present. At the time of survey these gaps and the ridge were both heavily cobwebbed making them unlikely to be used by roosting bats. On the western gable wall a large hole was present close to the apex which was open to the exterior through a missing tile. Within the roof structure a number of swallow nests were present.

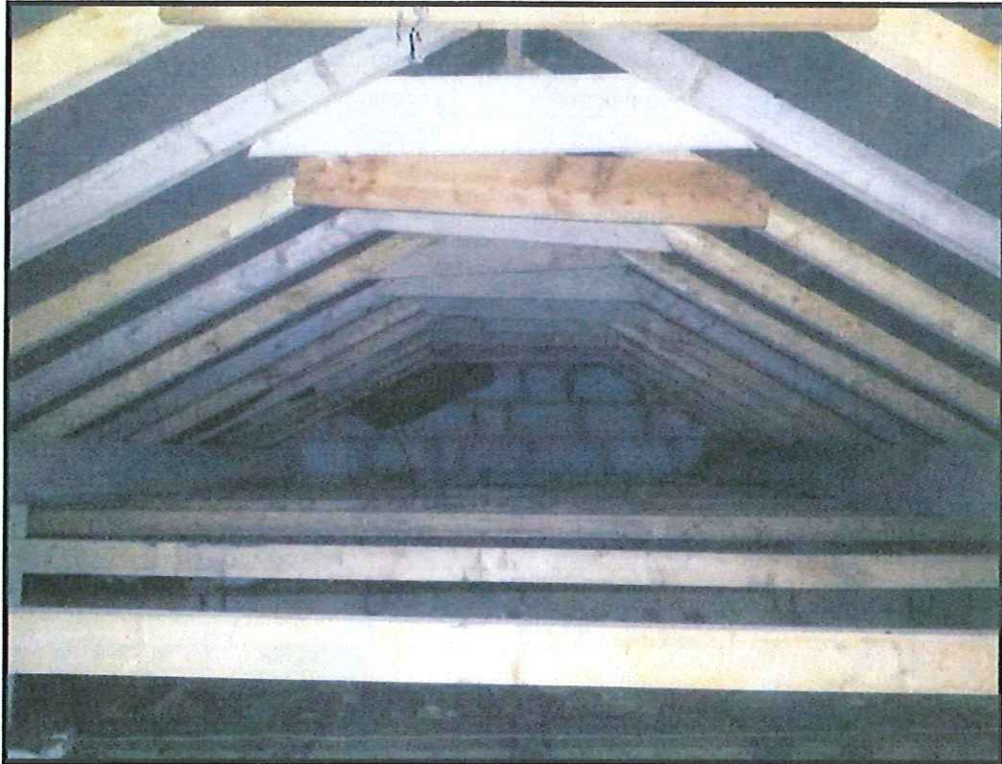
Photo 7: Inside Eastern roof Void.

The roof void was typical of the roof construction throughout the rest of the building and measured approximately 1.5 m to the ridge which was heavily cobwebbed. Daylight was visible in sections of the eaves where the soffits and fascias were damaged and thus providing potential bat access point to the roof void. A small amount of insect frass was present within the roof void but was not considered to be associated with bat feeding remains.
