Site: Dalton Cottage, Egton Bridge, Whitby, YO21 1XE.  
Client: Ms. L. Heath.  
Date: 29<sup>th</sup> January, 2012.

## Proposed Repairs

Dalton Cottage  
Egton Bridge  
Whitby  
YO21 1XE

## Bat Survey Report

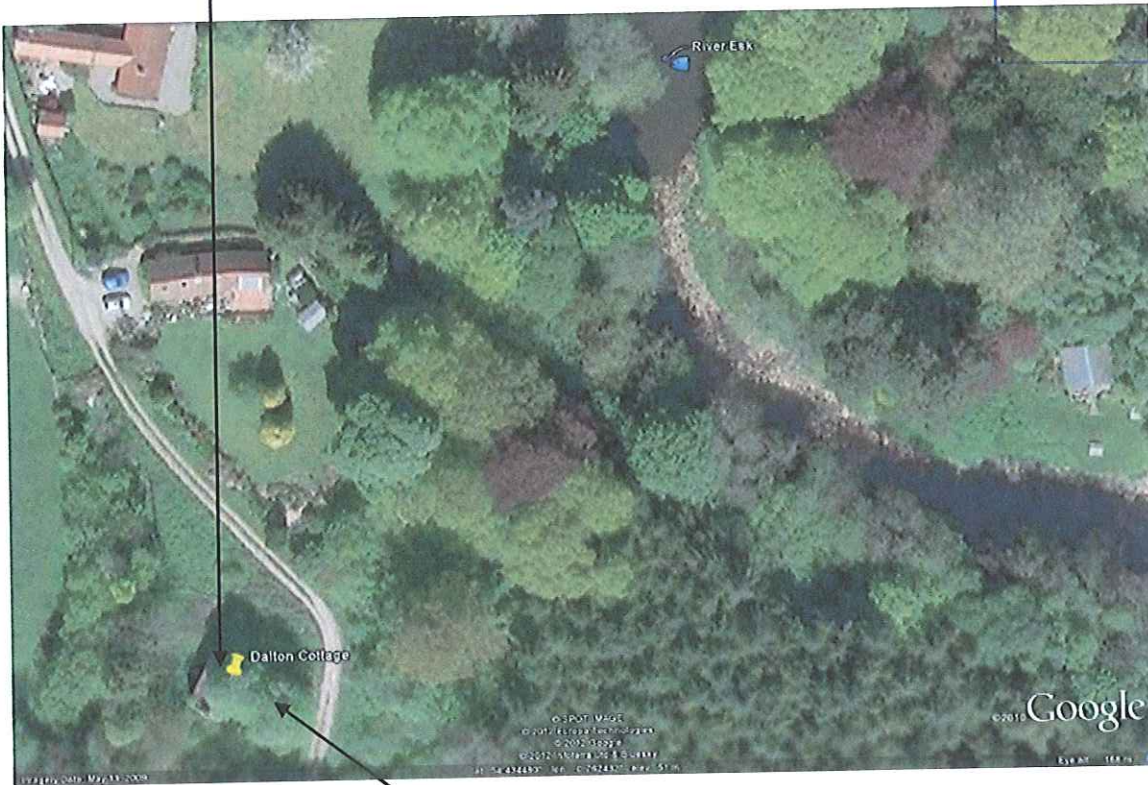
At the time of inspection the two trees had blown down.

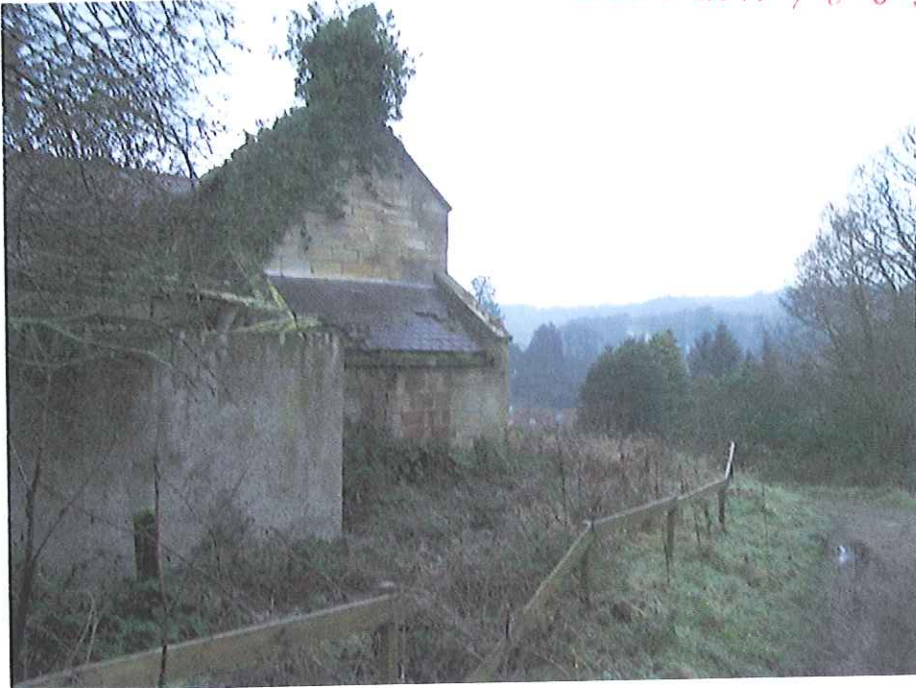
East Elevation

The cottage is in a state of disrepair resulting in the collapse of the valley gutter causing sections of the first floor landing to collapse due to ingress of water. Also the East wing of the cottage has serious structural movement. There is a detached outbuilding which has partly collapsed.

It is proposed to take down the defective East wing and rebuild to match existing.  
Strip off the roof and replace defective timbers and felt and re-slate to match existing.  
Replace first and second fix joinery and renew all services. The partly collapsed outbuilding is to be demolished and a new structure erected, subject to planning permission.

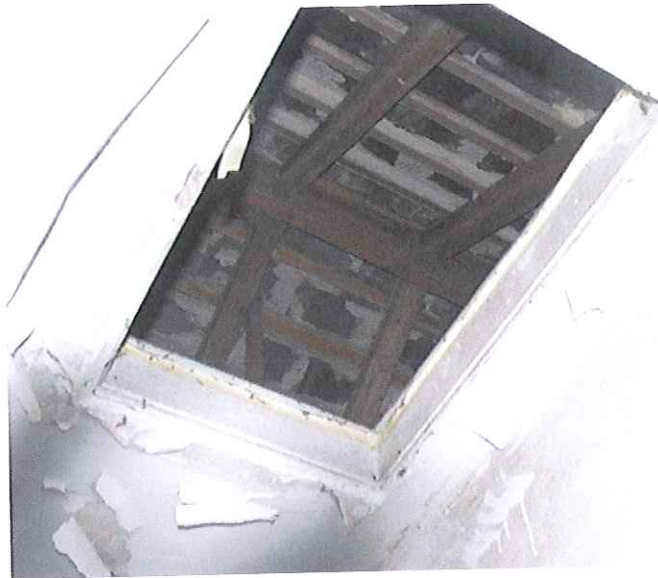
Dalton Cottage roof

Potential location areas for bats are under the roof and adjacent to roof timber frames and under the flashings and adjacent to doors, which were also inspected.

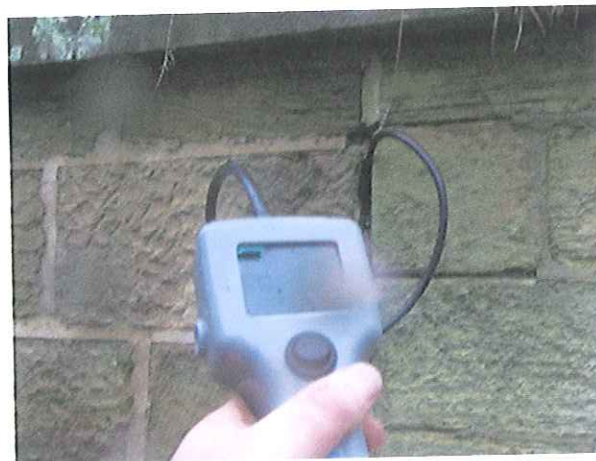
East elevation wall

In general all gaps around doors and other access points and stone work were all inspected in detail using the endoscope.

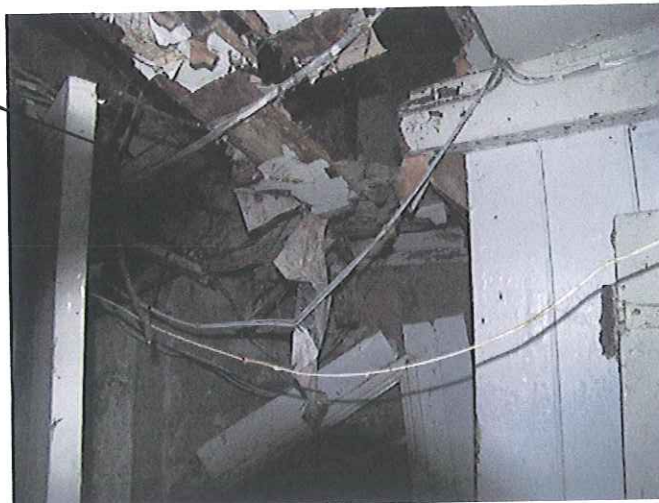
In view of the time of year at which the survey was undertaken, an evening emergence bat activity survey was not appropriate. Access to parts of the first floor was prevented due to the collapse of the first floor landing.

Collapsed first floor landing:
