Update to Ecological Survey report

Cloughton Fields, Station Lane, Cloughton, Scarborough,
YO13 0AD

Report date: 13 March 2013

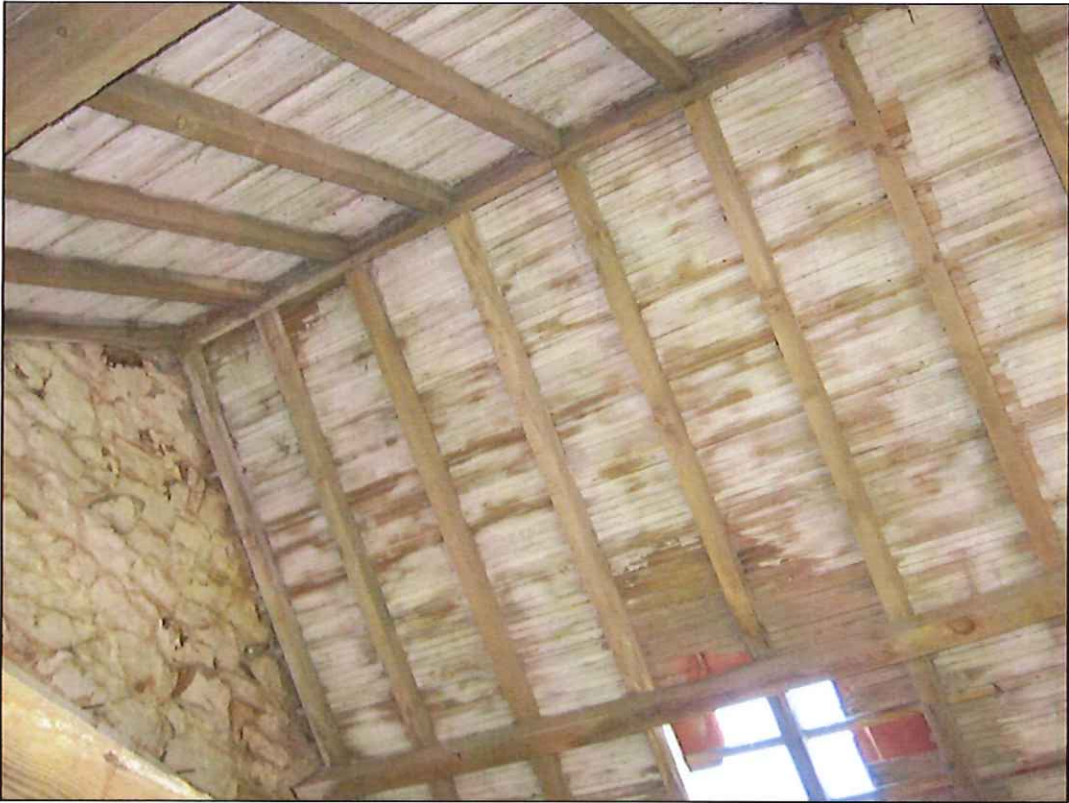
All buildings present at the time of the previous survey are still present and are in a similar condition. No works have been carried out to the buildings other than the digging of test pits in each building to assess the foundations.

Underside of roof of main barn, 27 February 2013

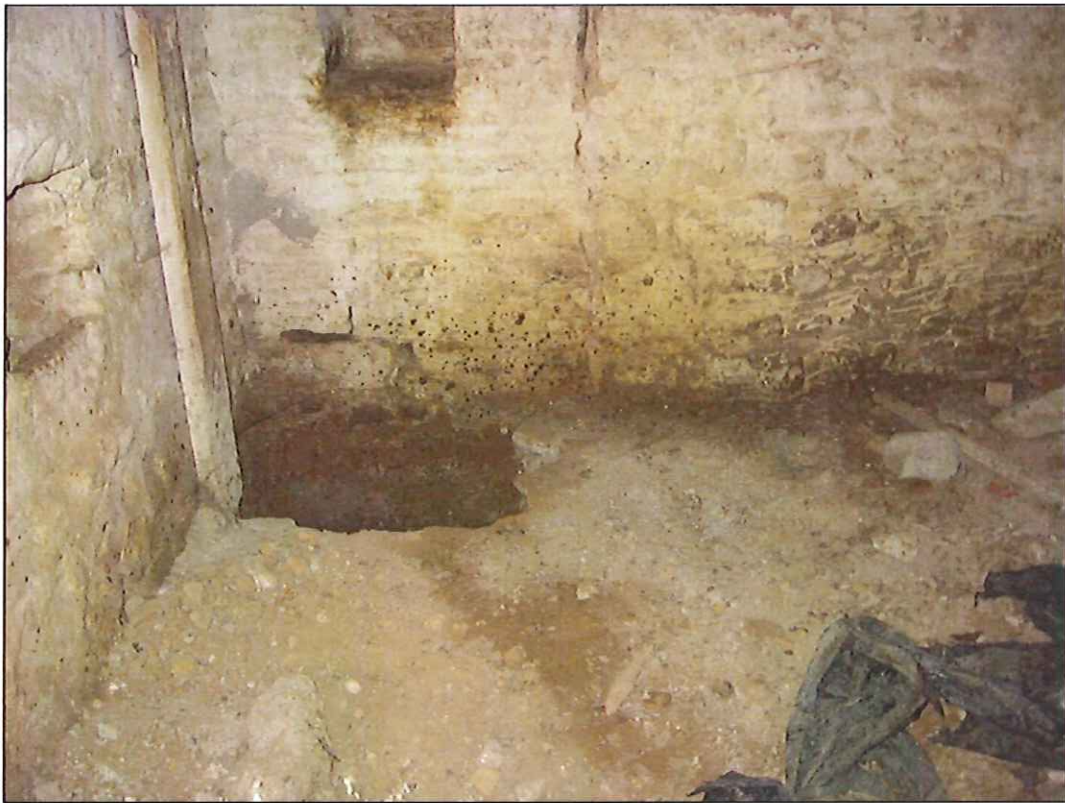
Example of test pit to check foundations

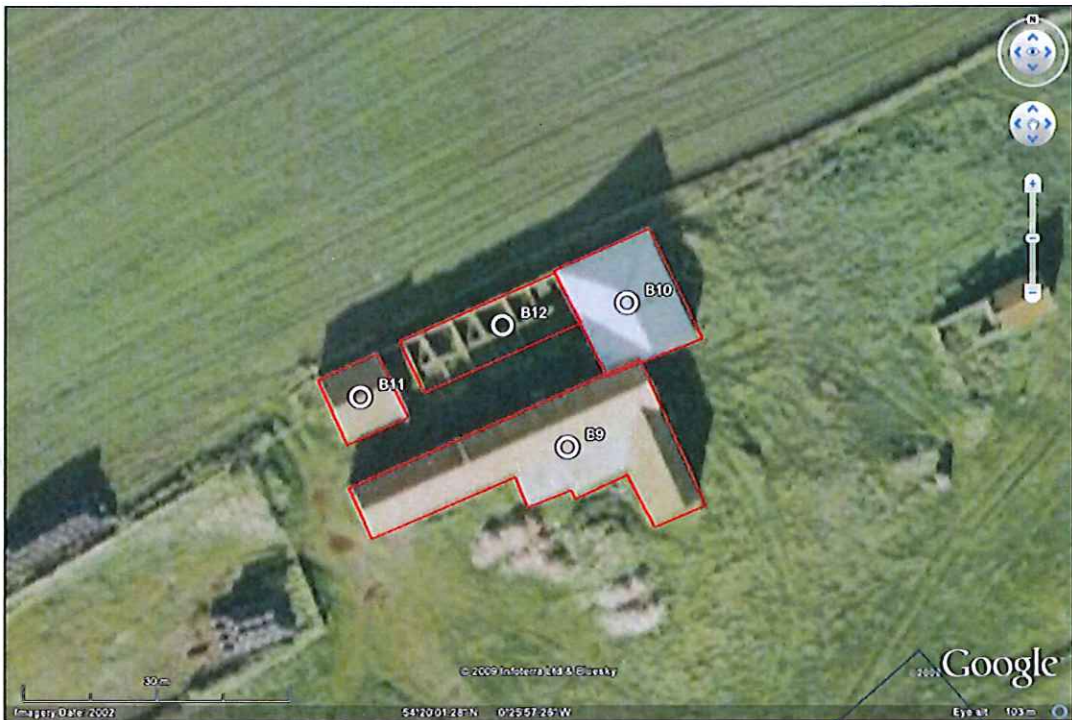
Aerial photograph of the buildings

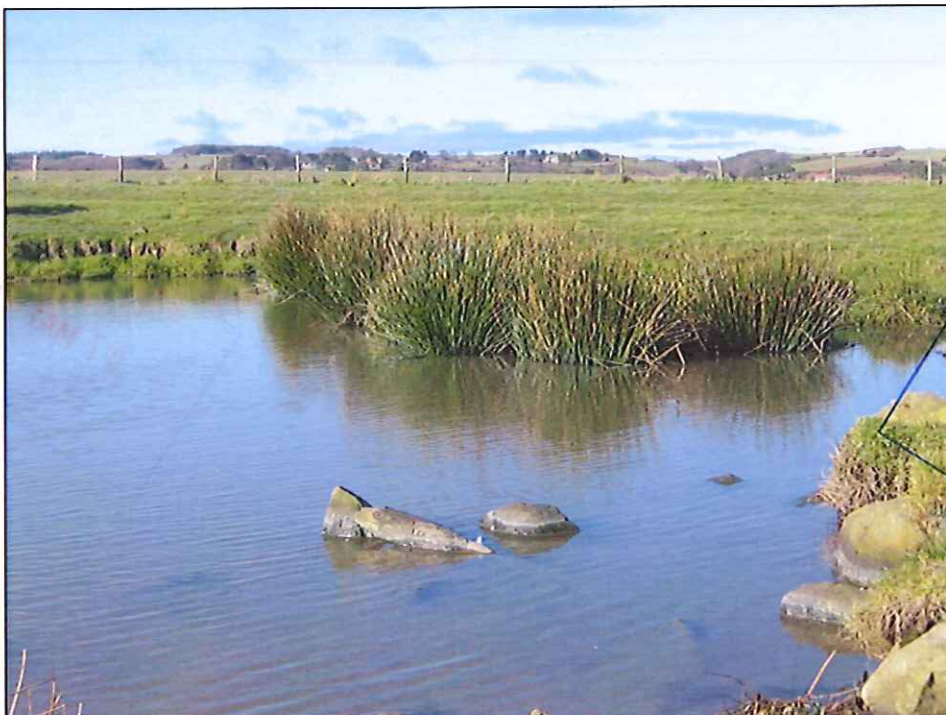
The pond to the east of the barns was very full compared to the water levels during the previous survey, but the water was extremely muddy. There is now a little emergent vegetation. There were no signs of water vole and the habitat was considered unsuitable for great crested newt and otter due to disturbance from cattle and waterfowl.

Pond, 27 February 2013

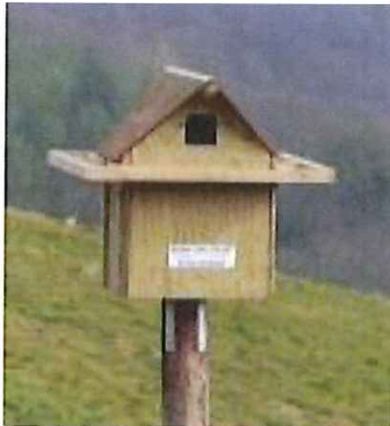
The basic box should be built using exterior grade rot-resistant or CCA treated sheet material. 12mm tannalised softwood ply and 25 x 50mm tannalised batten is ideal. There is also a small amount of 50 x 50mm timber and a piece of 18mm ply needed. During construction a waterproof sealant should be applied to all the wood joints to increase weather protection. The roof should also be treated with Creosote or other water-resistant preservative and the apex covered with a strip of aluminium or copper. The front, back and sides must overhang the floor and a 20mm diameter drainage hole should be drilled in each corner of the floor. There should be a large access panel to enable debris to be cleaned out.

The box should face open ground and preferably be close to rough grassland. Avoid facing the box towards the prevailing wind and rain. The simplest option is to attach the box to the pole before it is erected. Each half of the exercise platform should be slid onto the box after erection and retained by screwing through the two outer battens.

A pole box is large and heavy and cannot be adequately supported on a thin or flexible pole. A good pole will not only support the box for many years, but will also be strong enough to take the weight of someone climbing a ladder leaning against it. Most proper electricity or telegraph poles are suitable, but must be cut to the correct length. The erected pole should be at least 4m above ground level, so the complete pole needs to be 6m long and 150mm in diameter.

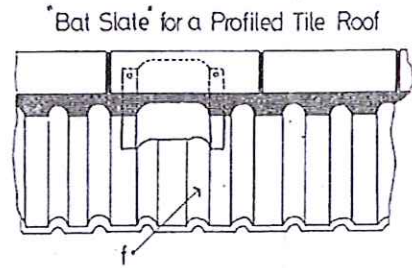
Fig. 5

Bat access slates cannot be purchased, but can be quickly made from a piece of lead. The lead must be at least Code 6 quality, as the use of a lower code will soon sag. A 300mm square of lead is sufficient to make one slate. The 'slate' should be hammered into shape to the dimensions shown by moulding it over a piece of wood.

On a profiled tile roof the bat slate can only be fitted under the ridge tiles, as shown in the diagram.

The bat slate must be fitted against a rafter to enable bats to crawl in and out of the loft space and a small hole must be cut in the felt immediately beneath the access slate.

- Key: a Ridge Tile
 b Mortar
 c Plain Tile
 d Slate
 e Modified Ridge
 f Profiled Tile

During the course of roof works existing bat access and casual roosting points may be lost, so new ones must be created. This can most easily be achieved by the inclusion of 'bat access slates' in the roof above the loft space over the proposed tack room. A minimum of four bat slates must be provided at the ridge.
