Bat, Breeding Bird and Barn Owl Survey

Laithes Garage

Hawsker Lane, Whitby

October 2013

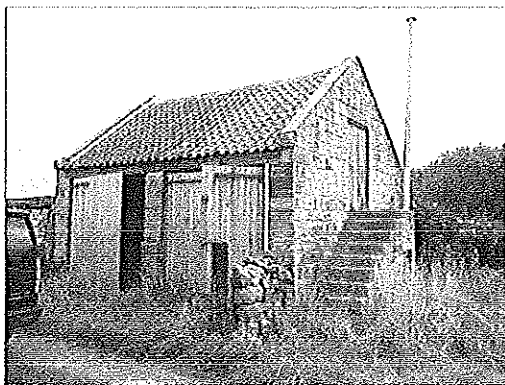
The outbuilding comprises a main garage/old agricultural outbuilding constructed out of stone with a pan tile roof; and an attached lean-to store to the north which is constructed out of stone with a corrugated tin roof.

Photo 1 - View of the outbuilding from the south.

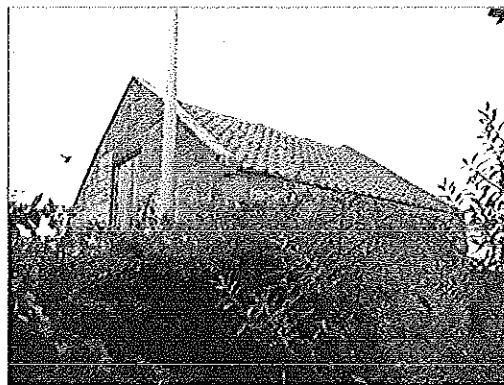
Externally, the masonry is well pointed, and the pan tiles are all in place however many are loose creating roosting opportunities and/or access into the space between the tiles

Photo 2 - Eastern roof pitch and rear elevation.

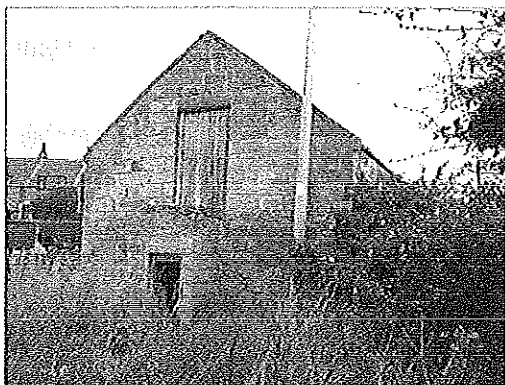
Photo 4 - Southern gable end.

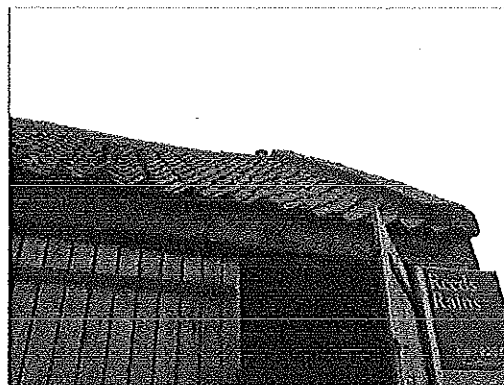
and the lining below. There is a small section of the west pitch which has been re-roofed more recently. Gaps are also present along the eaves, and around the timber door frame on the south gable end, but dense cobwebs were present around these points. The ridge and verge are both well sealed with mortar.

Photo 3 - The western roof pitch. A small patch of the roof has been repaired more recently.

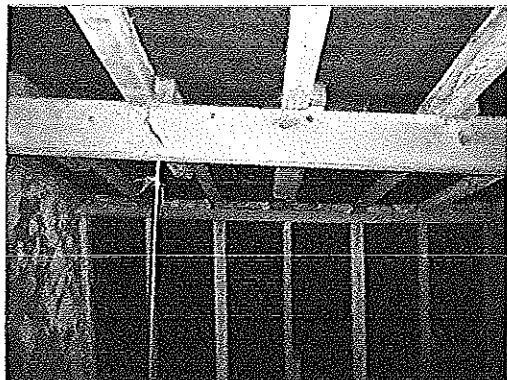
The main building is two-storeys high; however an upper floor is only present over one half of the building. This upper floor was considered unsafe at the time of survey. A deep crevice within the stonework in one corner of the ground floor was inspected with a flexible endoscope. The internal crevice led into a deep cavity, although no evidence of bat use could be found around this area. A small number of bat droppings were present, caught in cobwebs on some of the rafters and roofing timbers within the southernmost part of the outbuilding. The pan tile roof is lined below with traditional bitumastic felt.

Photo 5 - Thick traditional felt lining to the underside of the roof.

Re-roofing is likely to require use of breathable roofing membrane, as it is not possible to retain a roof void when converting such a small building. Breathable membranes are not compatible with bats, and therefore the roost area will be lost.

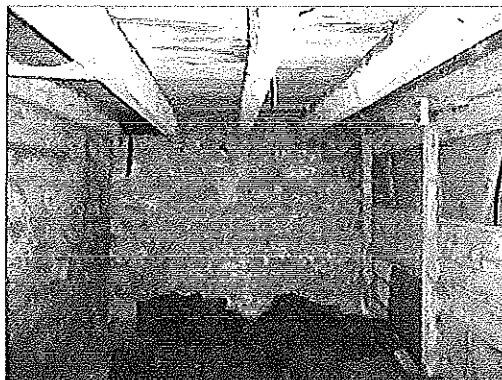
Photo 6 - The northern half of the building which is over two floors.

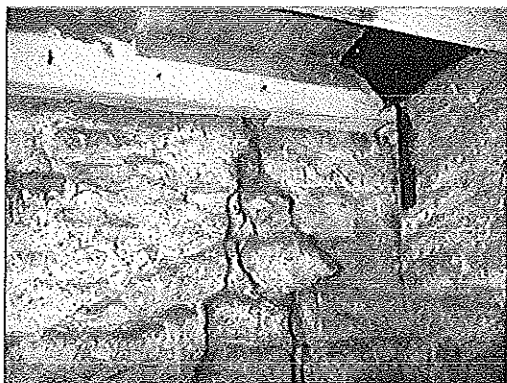
Photo 8 - Deep internal masonry crevice.

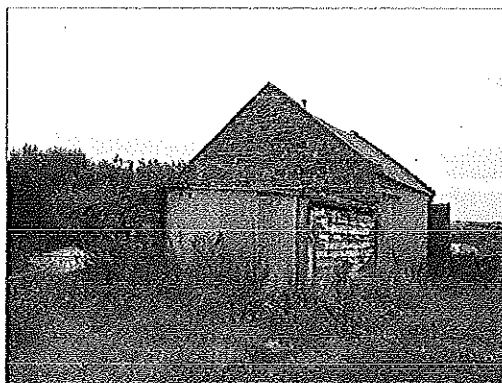
The attached lean-to is split into two compartments. The front half is very light with a thin, corrugated metal sheet roof. This section has very low bat roost potential. To the rear, the stone walls of the the store are of dry stone wall type construction.

Photo 7 - The small lean-to store attached to the north elevation.

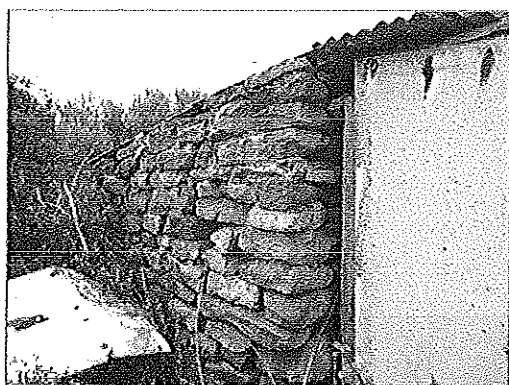
Photo 9 - Dry stone wall section of the attached store.

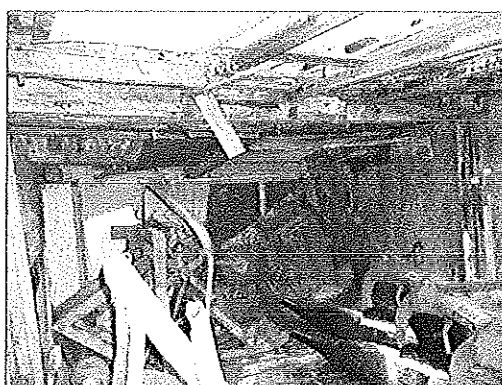
Photo 10 - Inside the lean-to. Conditions are very light and open.
