FACEBY LODGE FARM  
CARLTON -IN -CLEVELAND  
TS9 7DP

## Pre-Application Arboricultural Survey

8<sup>th</sup> March 2019

Prepared by  
Elisabeth Airey MSc MArborA HND(Arbor) Cert Woodland Mgt.

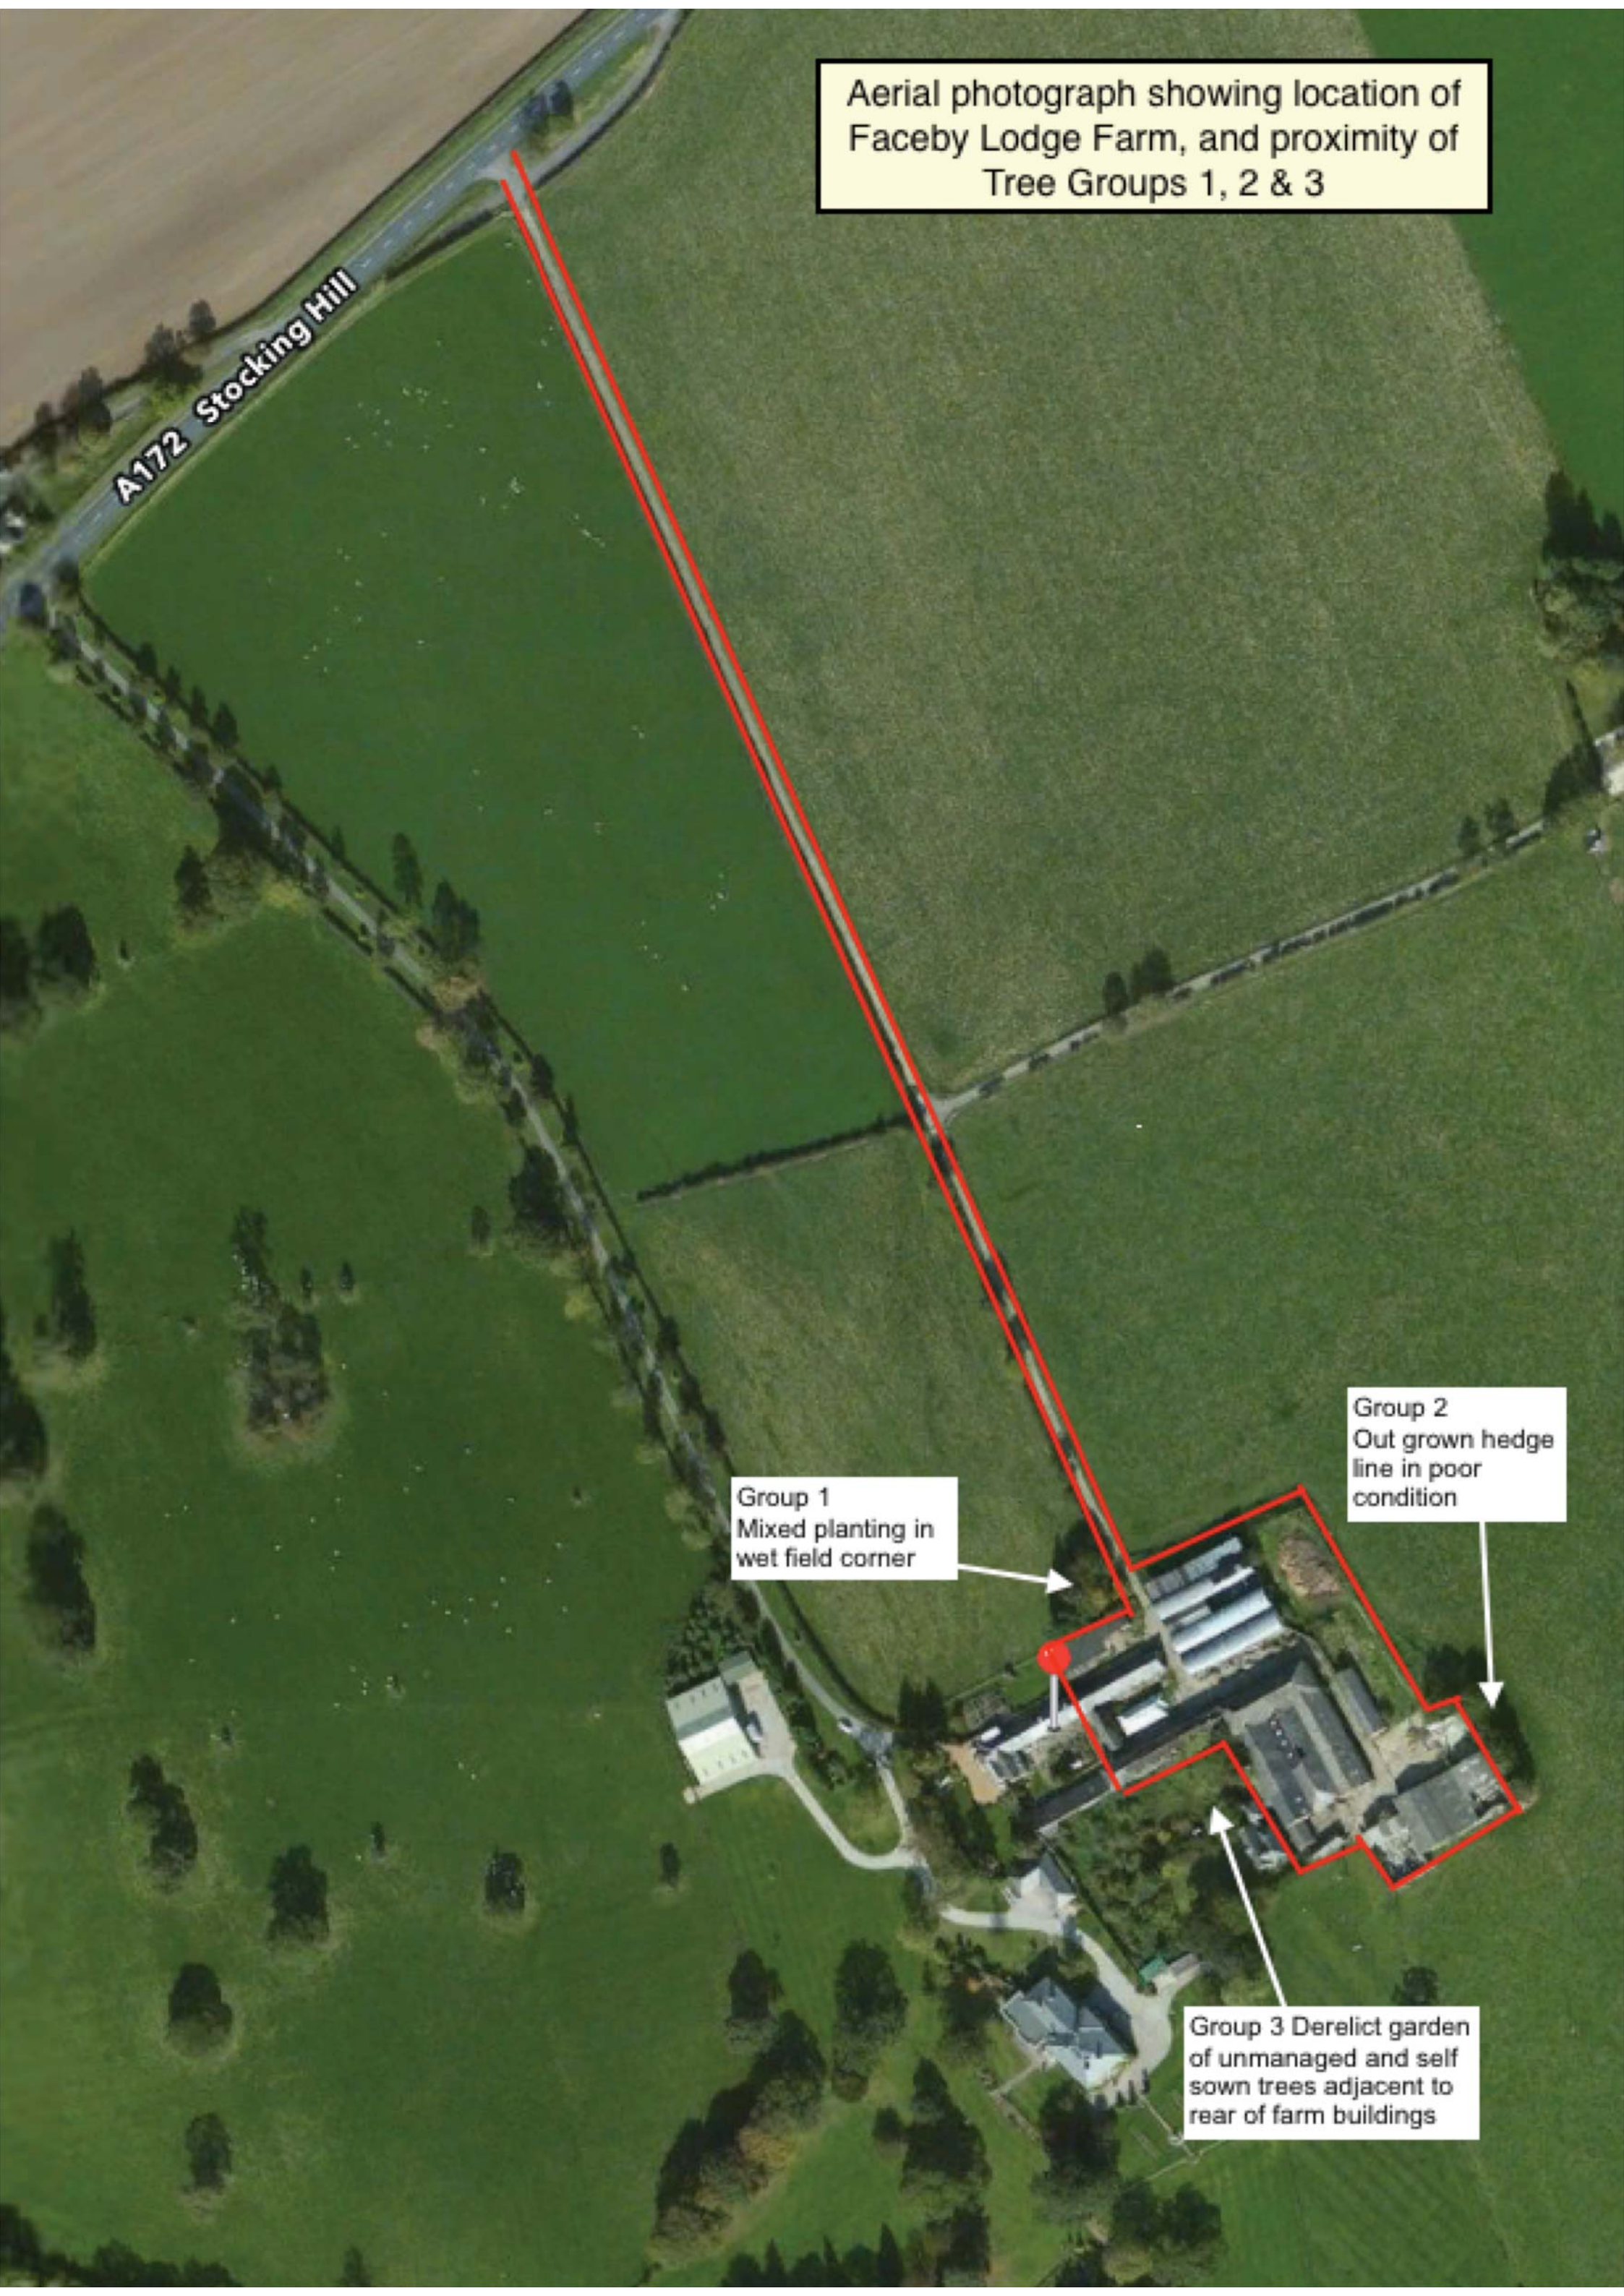
Group 2  
Out grown hedge  
line in poor  
condition

Group 3 Derelict garden  
of unmanaged and self  
sown trees adjacent to  
rear of farm buildings

Group 2	Monitor trees during demolition of adjacent building.	N/A	N/A
Group 3	Following agreement with landowner- fell self-sown trees and prune Horse Chestnut to mitigate ongoing damage to farm buildings.	N/A	Condition survey of remaining trees advised.
