Report on Reinstated Roof

Farm Building Conversion
Thirley Cote Farm
Harwood Dale
YO13 ODR

Report 11523 NID 06/02/2019

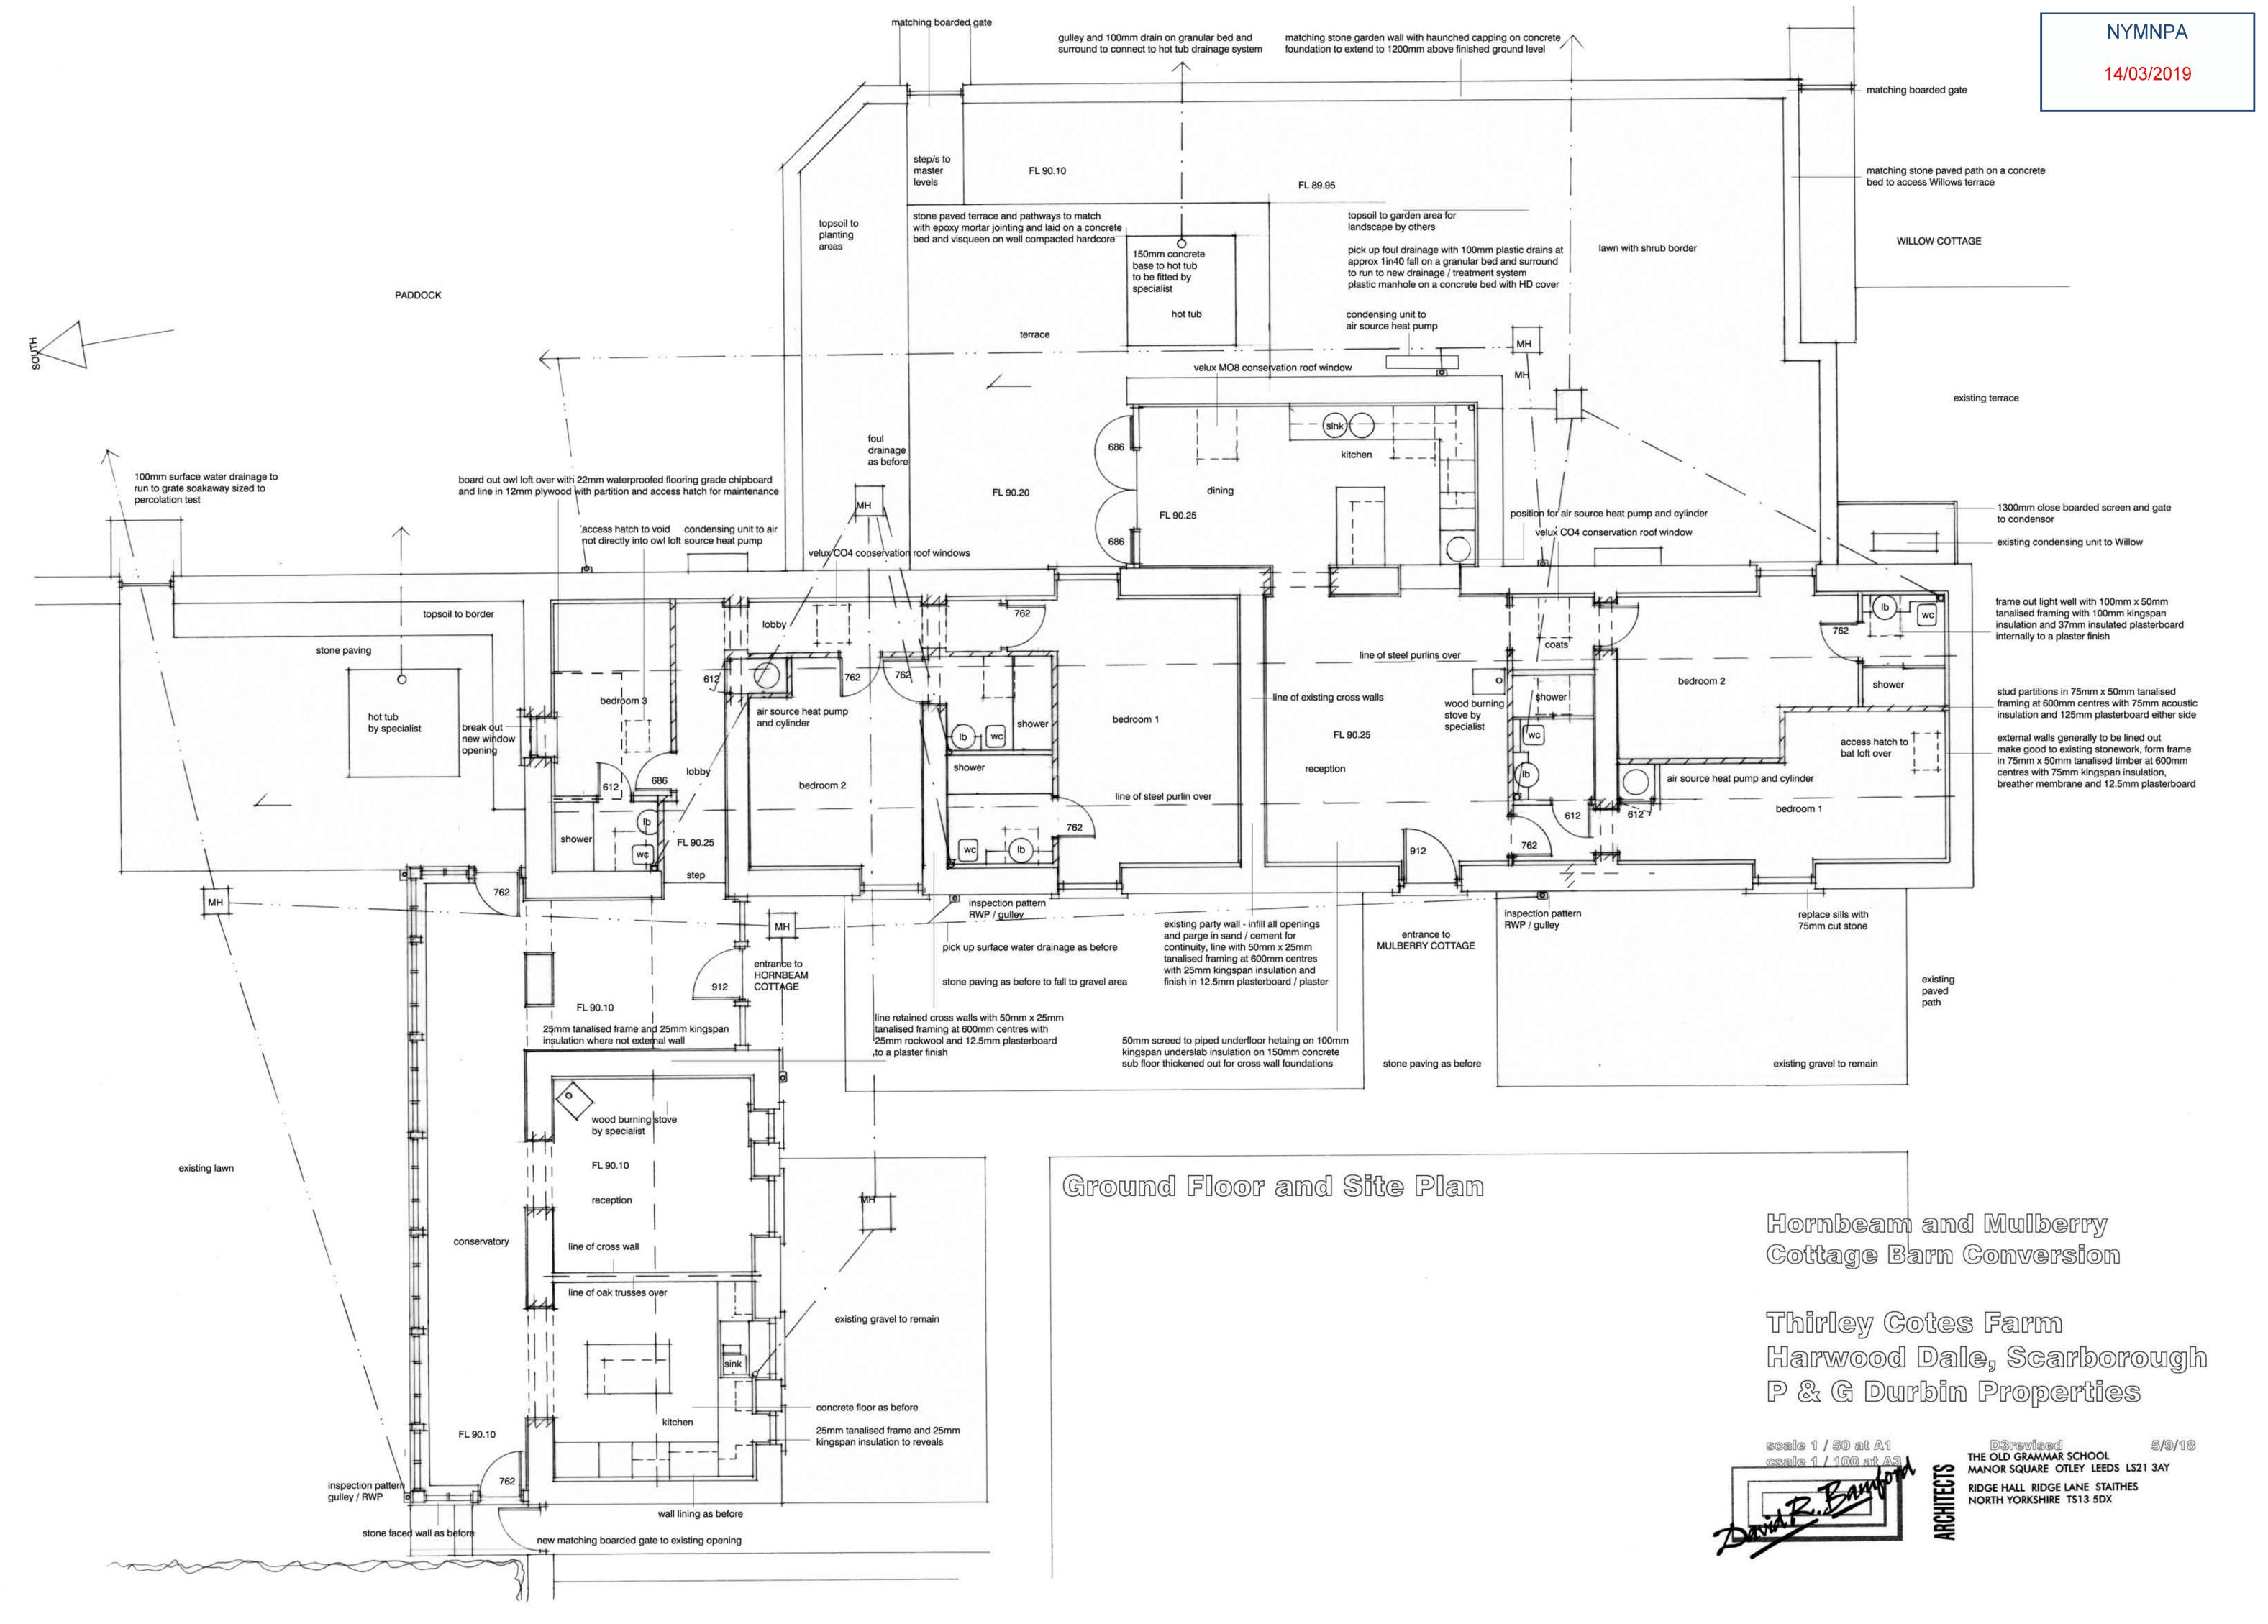
David R Bamford Drawing

Drawing of Hornbeam and Mulberry Cottage Barn Conversion at Thirley Cote Farm, Harwood Dale for P and G Durbin by David R Bamford, Architects.
