TREE REPORT

Altered access at Sunny Bank Barn Broxa Lane Hackness

**LAWSON HARPER
Amended 18 May 2015**

SUPPLEMENTRY TREE REPORT

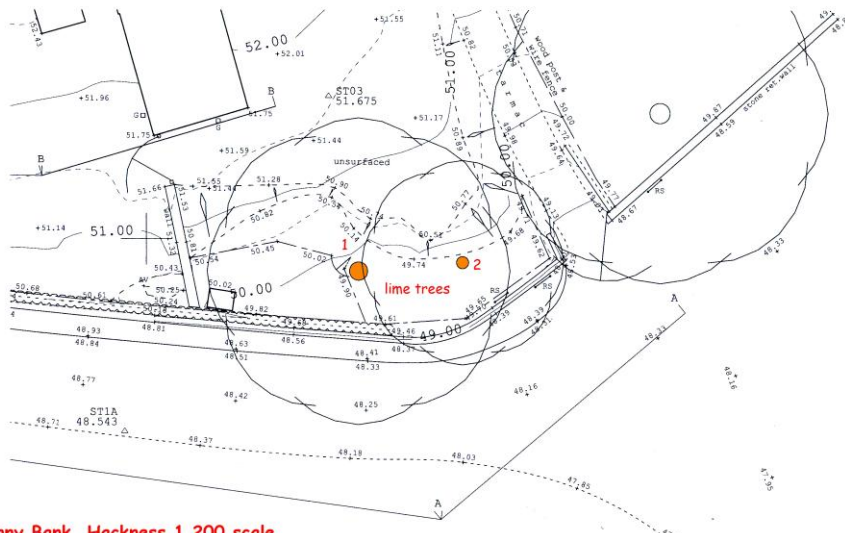
Fig 2 Tree positions and spread

The trees are located within 2 m to 3m of a retaining wall which forms a sharp change of level of some 1.3m. There is no sign of heave or root damage to this wall and the roots appear to have established to accommodate the level change.

There was slight late leafing out towards the top of the tree on the northern side but other than this no major issues observed there is moderate to light suckering at the base. Aphid residue is present as expected for the species but there are no signs of gall might or fungal disease
Trees 1 and 2 are in good to excellent condition.

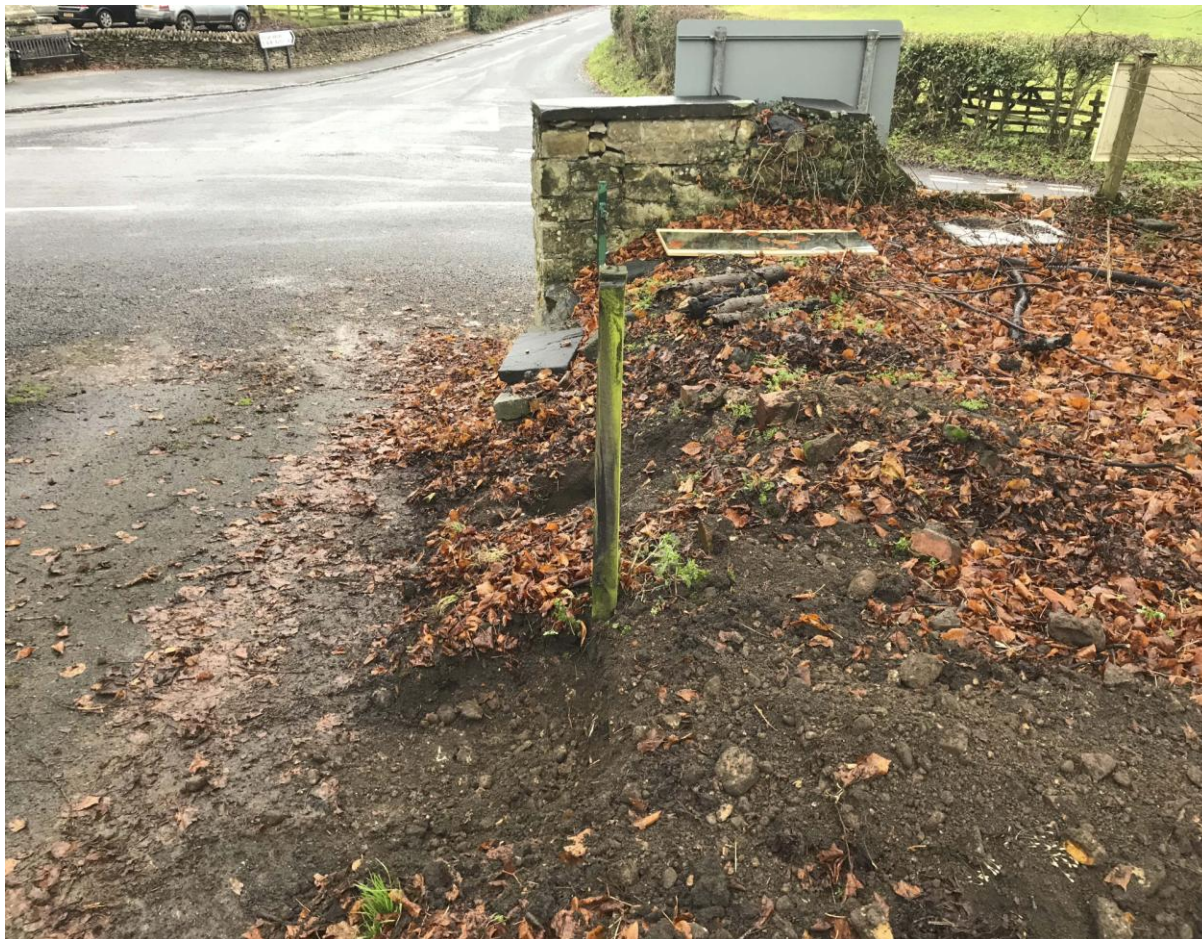
Photo 1 - Site entrance from inside the site

The conditions imposed by the North Yorkshire County Highways requires the access to be widened to 4.0M, from its current 3.6M and extending 6.0M into the site
