## 6.0 PHASING AND DISCUSSION

### **West range (1000)**

### **South range (2000)**

### **Cart shed (3000)**

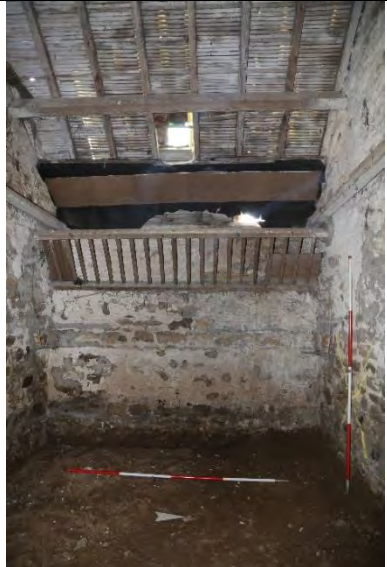
No.	Name	Description	Related Feature	Date	Significance	Photo
500	South loose box	A narrower room accessed only from a single door onto the foldyard. It would have had two floors including a hay loft. The hay rack and trough remains along the west wall.	501 south loose box door 502 hay rack 503 trough remains 504 beams 505 niche 510 north wall 520 east wall 530 south wall 540 west wall 400 north loosebox	Early 19th century	High evidential value as it a very well-preserved example of a loosebox.

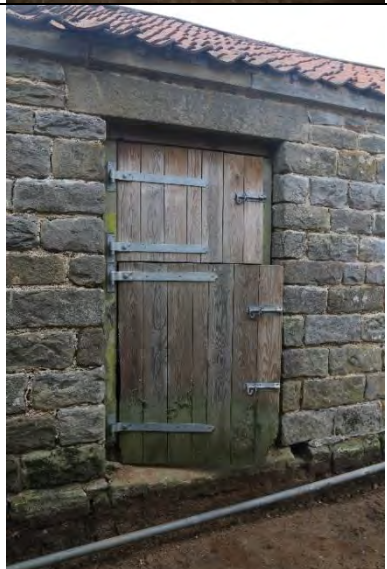
501	East door	The only access into the north loosebox, it opens onto the foldyard. It has a wide stone lintel and a large stone threshold.	101 west door 102 east door 201 west door 202 east door 301 west door 302 east door 401 north loosebox door	Early 19th century	High evidential value as an original feature of the building.

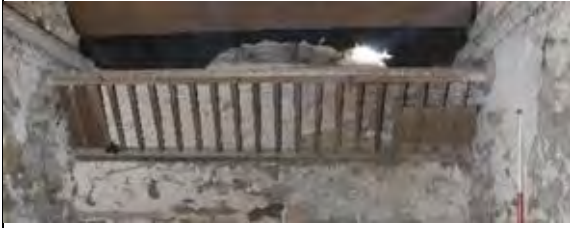
No.	Name	Description	Related Feature	Date	Significance	Photo
502	Hay rack	A large triangular wooden rack at the west end of the loosebox.	402 hay rack 601 hay rack	19th century	High-moderate evidential value.

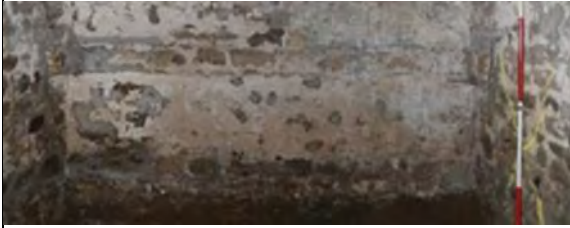
503	Trough remains	An upside-down semi-trapezoid of wood on the west corner of both the north and south wall indicating the location of the trough. There is also a scar along the west wall.	403 trough remains	19th century	High-moderate evidential value providing evidence for the use.

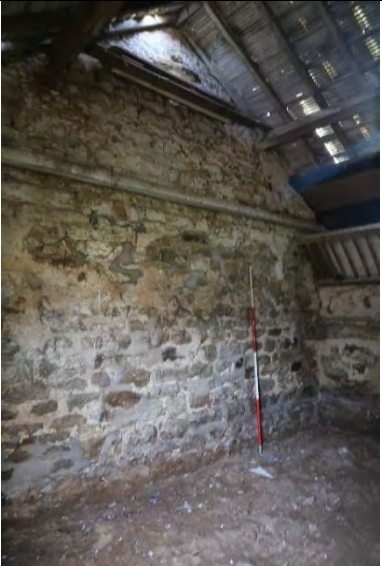
504	Beams	Projecting tie-beam located along the north and south wall used to hold the floor of the hay loft.	406 north loosebox beams	Early 19th century	High-moderate evidential value as it indicates the presence of an upper floor.

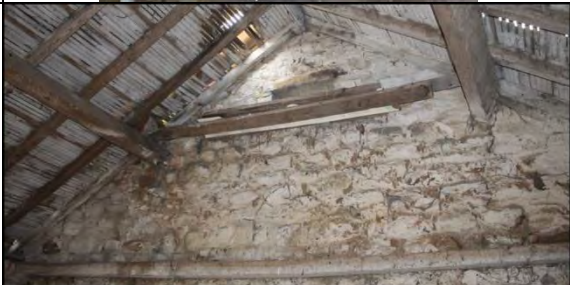
506	Opening	Short rectangular window on the gable of the south wall associated with the dovecot on the other side.	1201 Dovecot	Early 19th century	High: dovecote an important feature.

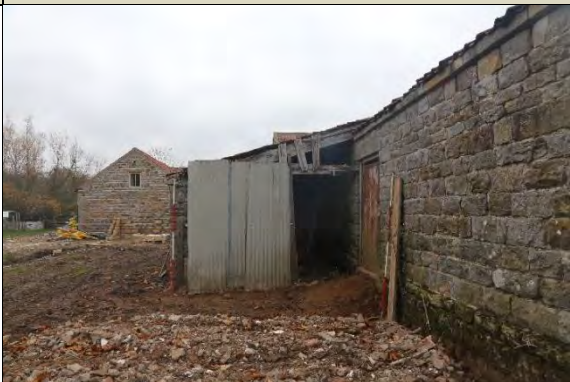
No.	Name	Description	Related Feature	Date	Significance	Photo
600	Outshot	A small outshot on the west side of the west range. Later addition, first shown on 1893 OS.	201 door 601 hay rack 602 truss 610 north wall 620 east wall 630 south wall 640 west wall	Late 19th century	High-moderate evidential value as late Victorian modification.

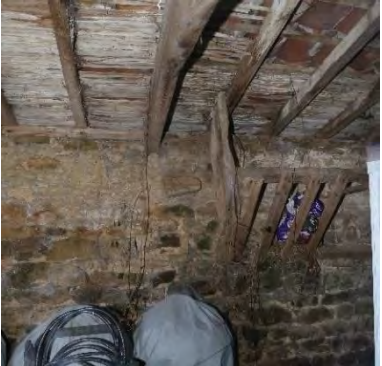
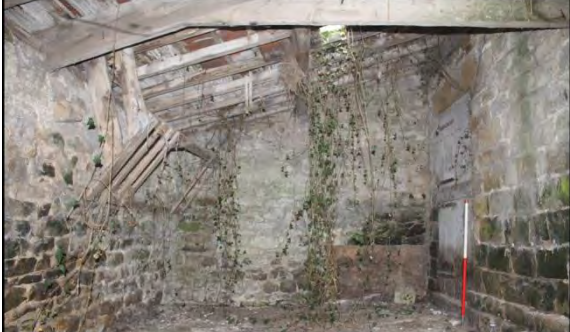
601	Hay rack	A partially dismantled hay rack located in the north-west corner of the outshot. It is tied into the wall and also hangs from the roof rafters.  The hay rack was obscured during the NAA survey.  Bottom photo by CS Archaeology 2018.	402 hay rack 502 hay rack	Late 19th century	High evidential value as indicates outshot was used for stabling.

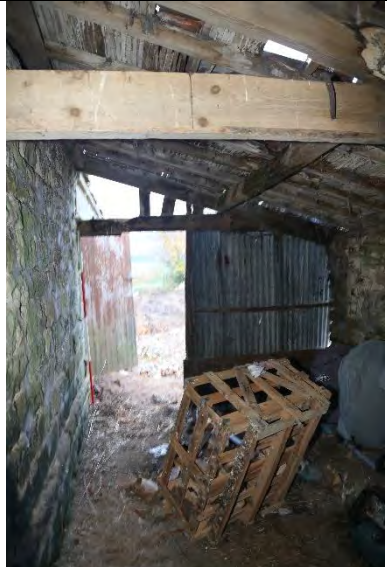
No.	Name	Description	Related Feature	Date	Significance	Photo
602	Tie beam truss	A half truss that supports the catslide roof of the outshot.		Late 19th century	High-moderate value as part of the original fabric.

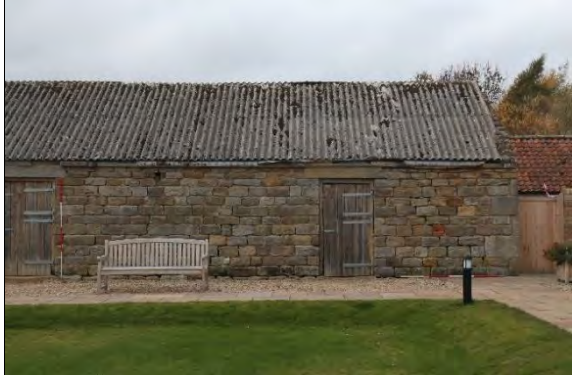
1010	East elevation	Front elevation of the west range facing onto the foldyard with primary access to all rooms of the range through five separate doors.	1011 blocked holes 1012 wooden remains 1013 ventilation slits	Early 19th century	High evidential value as primary access from foldyard and to looseboxes. Some aesthetic value.

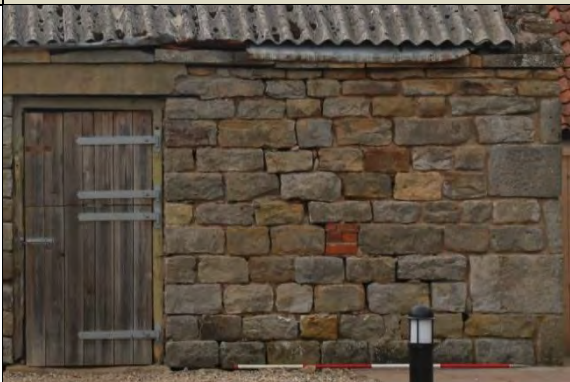
No.	Name	Description	Related Feature	Date	Significance	Photo
1011	Blocked holes	Square holes along the east elevation blocked either by stone or brick. Their use is unknown.		Early 19th century, later blocked	Moderate evidential value as indicative of specific use or structure at north end of building—exact function unknown.

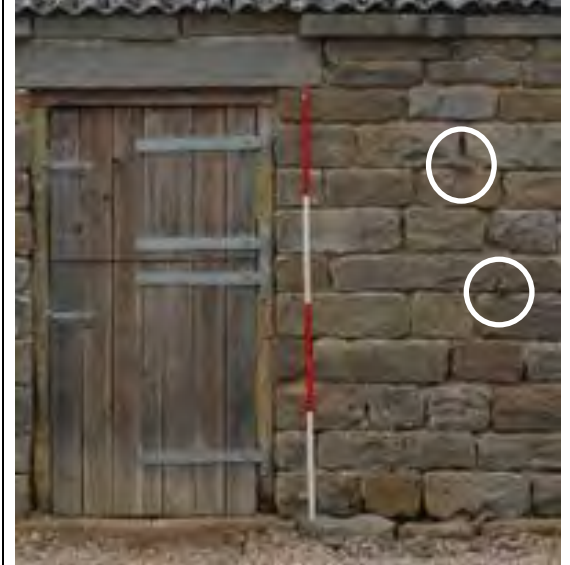
1012	Wooden fragments	Several wooden fragments protrude from the wall at various places along the elevation. Two examples are highlighted on the photo.	2302 wooden post 2303 wooden remains	19th century	Moderate evidential value although function is unclear.

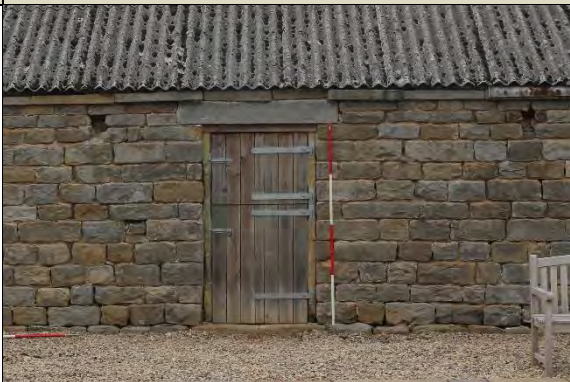
No.	Name	Description	Related Feature	Date	Significance	Photo
1013	Ventilation holes	On either side of door 302, two narrow ventilation niches flank the door. Could be putlogs for an external structure.		19th century	Moderate-low evidential value. Exact function is unknown but related to specific function at north end of building.

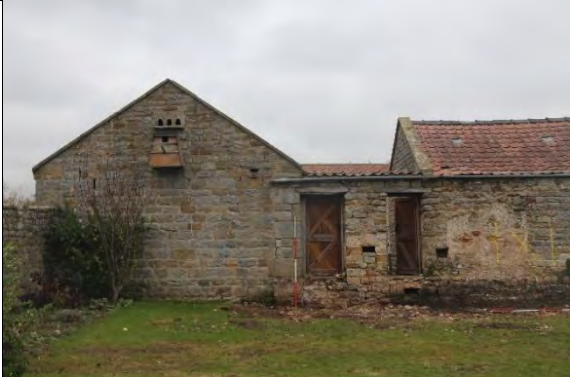
1200	South elevation	The wall is of plain stone with larger quoins. A dovecot is located near the top of the gable.	1201 dovecot 506 south loose box opening	Early 19th century	High evidential and moderate aesthetic value.

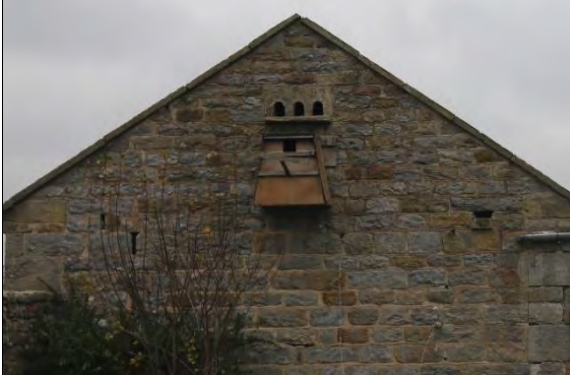
1201	Dovecot	The dovecot is composed of a single stone with three small arches over a stone ledge. Below it is placed a modern nesting box.	506 south loosebox opening	Early 19th century	High evidential and aesthetic value indicating the keeping of doves or pigeons.

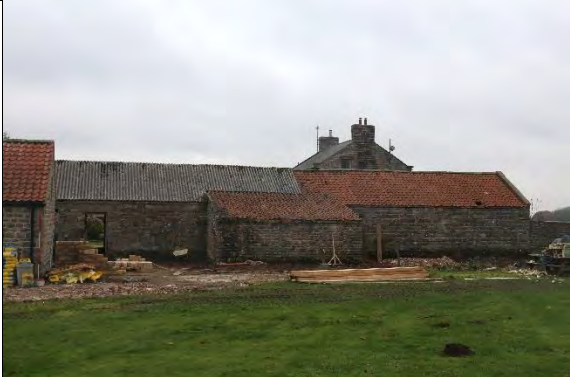
No.	Name	Description	Related Feature	Date	Significance	Photo
1300	West elevation	The west elevation includes two doors, one from 100 and another from 300. In the centre of the elevation is an outshot (600). Save the doors (101 and 301) the west elevation has few archaeological features.	101 west door 301 west door 600 outshot	Early 19th century	High evidential value as part of the original fabric.

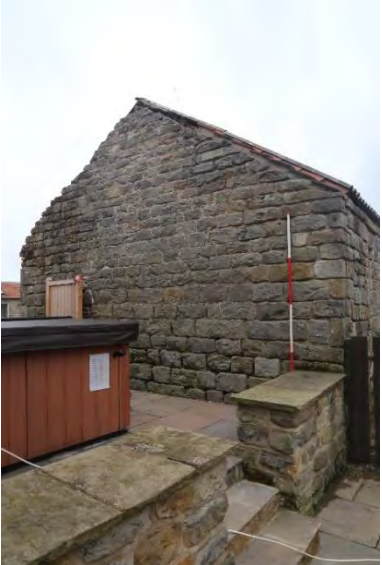
1400	North elevation	A plain elevation with no archaeologically significant features. The absence of defined quoins indicates that the gable was partially rebuilt.		Early 19th century	Moderate evidential value of change over time.

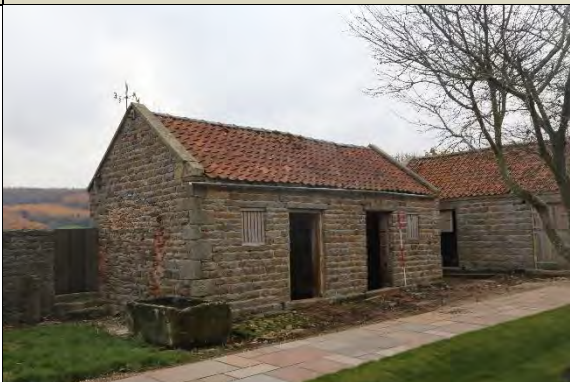
No.	Name	Description	Related Feature	Date	Significance	Photo
2000	South range	A small building used as a stable, first shown on 1912 OS map. To the rear was another, recently demolished, structure, formerly a greenhouse.	2100 west room 2200 east room 2300 north elevation 2400 east elevation 2500 south elevation 2600 west elevation 2700 greenhouse	Early 20th century	High evidential value as later development of the farmstead.

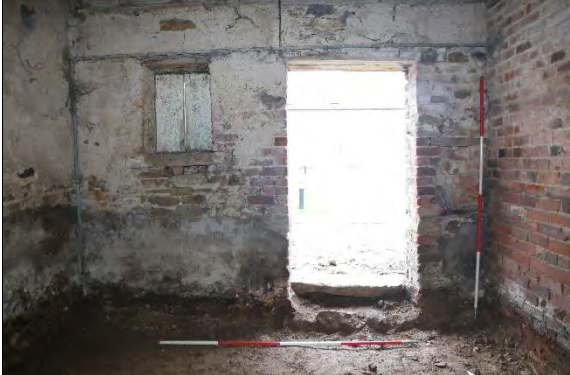
2100	West room	Accessed from the foldyard to the north. Louvre also facing north. Along the west wall, of brick rather than stone, was a hay rack and trough.	2101 west door 2102 louvre window 2103 trough remains 2104 swallow holes 2105 wall scar 2106 ventilation holes 2107 horizontal timbers 2110 west wall 2120 north wall 2130 east wall 2140 south wall	Early 20th century	High evidential value as evidence of the original fabric of the building.

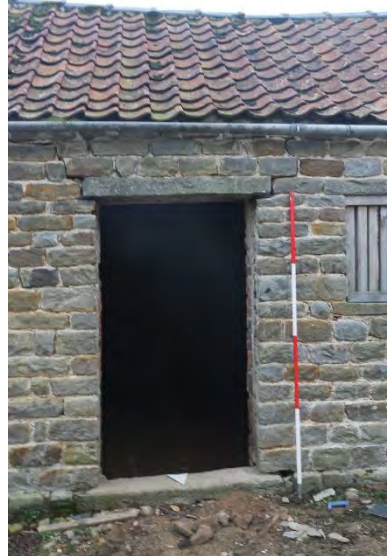
No.	Name	Description	Related Feature	Date	Significance	Photo
2101	West door	Door with a stone lintel and stone threshold. The interior lintel is of wood. The doorway currently has no frame or door.	2201 east door	Early 20th century	High evidential value as evidence of the original fabric of the building.

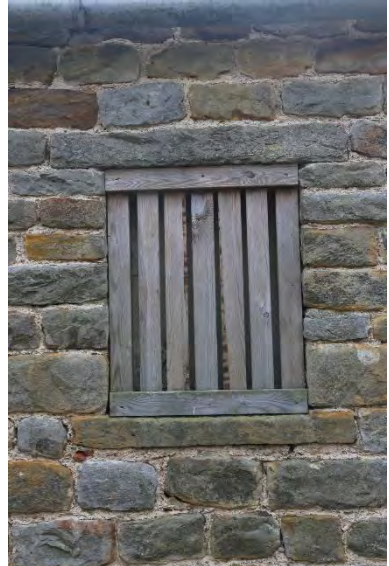
2102	West louvre window	A wooden louvre composed of seven vertical slats held by two horizontal slats on either end. This louvre is boarded up on the inside.	2202 east louvre window	Early 20th century	Moderate evidential value as evidence of the original use of the building for horses.

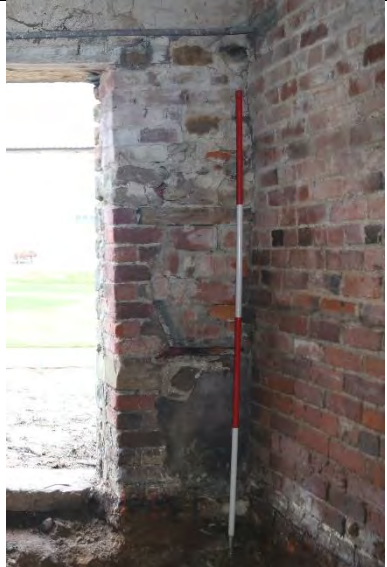
No.	Name	Description	Related Feature	Date	Significance	Photo
2103	Trough remains	An upside-down semi-trapezoid of wood fit into the bricks in the walls. It would have spanned the whole length of the wall with the help of a wooden support extending from the centre of the wall. A scar can be seen running along the length of the wall.	304 trough remains 403 trough remains 503 trough remains 2203 trough remains	Early 20th century	Moderate evidential value as evidence of use of the building.

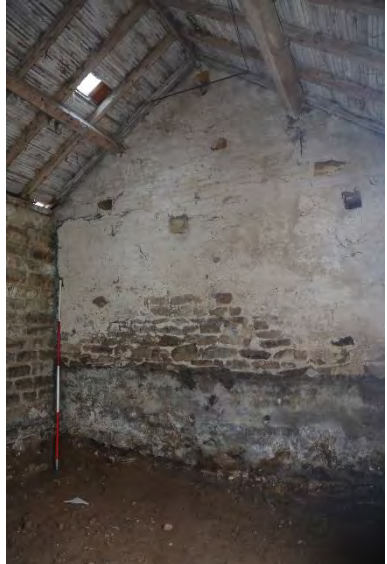
2104	Swallow holes	Small holes in the walls for birds.		Early 20th century	Moderate evidential value as it is not associated with historic use or phasing of building.

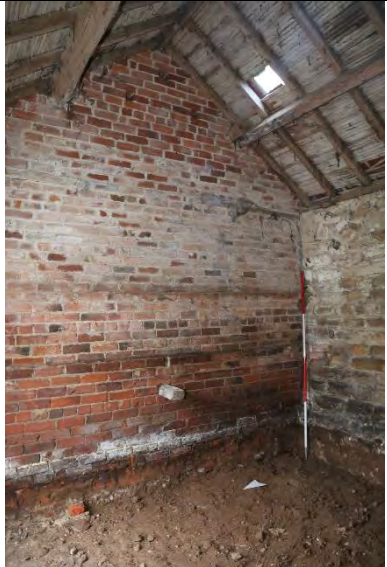
No.	Name	Description	Related Feature	Date	Significance	Photo
2105	Wall scar associated with hay rack	Two wall scars can be seen. The top one is associated with a hay rack.	2204 hay rack wall scar	Early 20th century	Moderate evidential value as provides evidence for the presence of a hay rack.

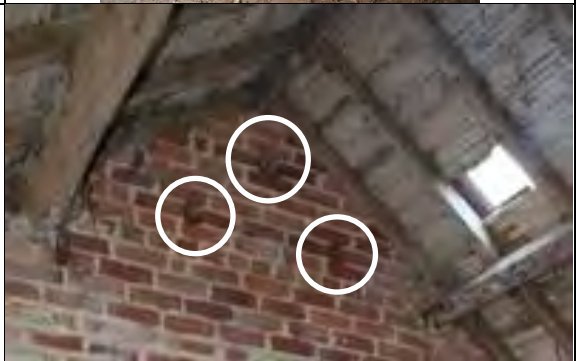
2106	Ventilation holes	Three square ventilation holes at the apex of the gable of the dividing wall to facilitate airflow.		Early 20th century	Moderate evidential value

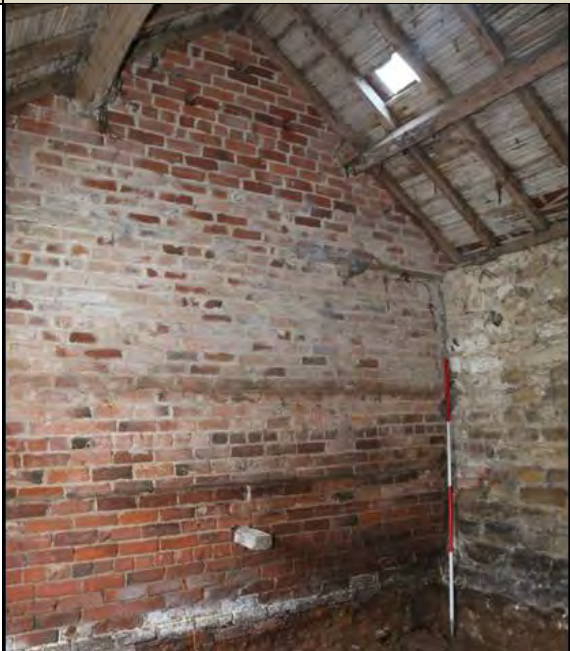
No.	Name	Description	Related Feature	Date	Significance	Photo
2107	Horizontal timbers	Structural timbers (relieving support) on east wall of room aligned with the top of the north and south walls. May be associated with the construction of the hay rack.	2108 horizontal timbers	Early 20th century	Moderate evidential value as part of original fabric of building.

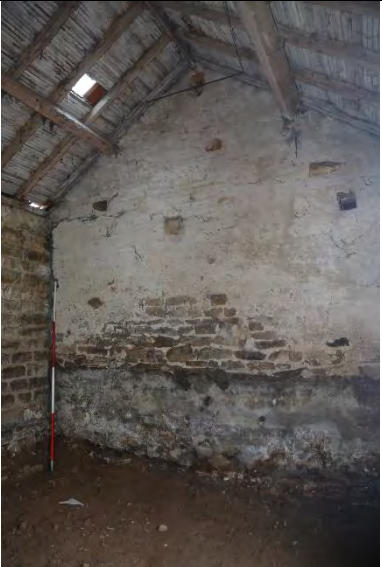
No.	Name	Description	Related Feature	Date	Significance	Photo
2108	Horizontal timbers	Barely visible beneath the limewash are two horizontal timbers aligned with the top of the north and south walls extending into the west wall.	2107 horizontal timbers	Early 20th century	Moderate evidential value as part of original fabric of building.

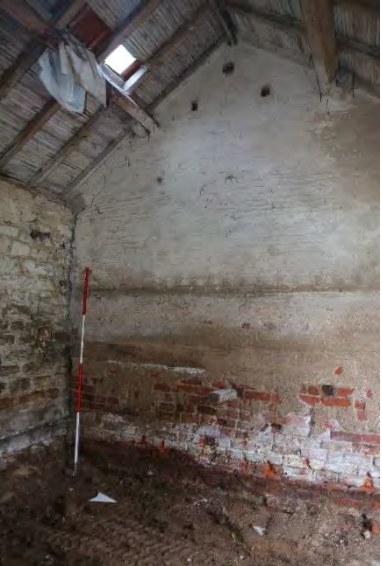
2200	East room	Same layout as the West room.	2100 west room 2106 ventilation holes 2201 east door 2202 east louvre window 2203 trough remains 2204 hay rack wall scar 2205 horizontal timbers 2210 west wall 2220 north wall 2230 east wall 2240 south wall	Early 20th century	High evidential value as part of the original fabric of the building.

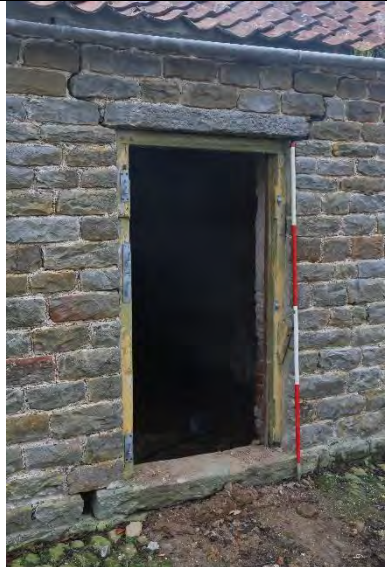
No.	Name	Description	Related Feature	Date	Significance	Photo
2201	East door	Door with a stone lintel and stone threshold. The interior lintel is of wood. The doorway currently has a wooden frame but no door.	2101 west door	Early 20th century	High evidential value as evidence of the original fabric of the building.

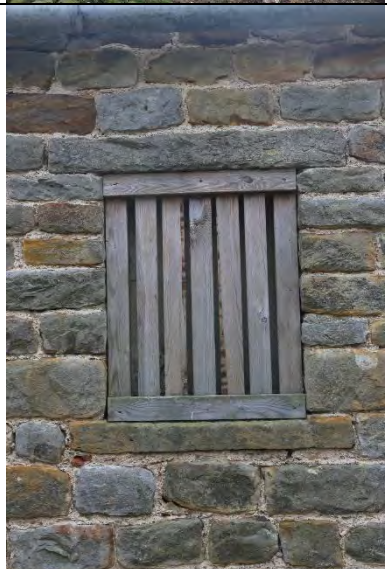
2202	East louvre window	A wooden louvre composed of seven vertical slats held by two horizontal slats on either end.	2202 east louvre window	Early 20th century	Moderate evidential value as evidence of the original use of the building for horses.

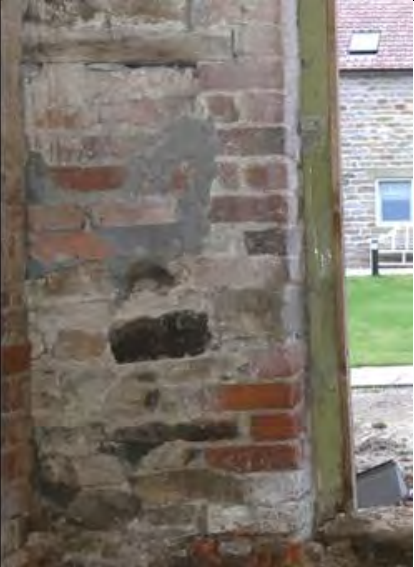
No.	Name	Description	Related Feature	Date	Significance	Photo
2203	Trough remains	An upside-down semi-trapezoid of wood fit into the bricks in the walls. It would have spanned the whole length of the wall with the help of a wooden support extending from the centre of the wall. A scar can be seen running along the length of the wall.	304 trough remains 403 trough remains 503 trough remains 2103 trough remains 2204 hay rack wall scar	Early 20th century	Moderate evidential value as evidence of use of the building.

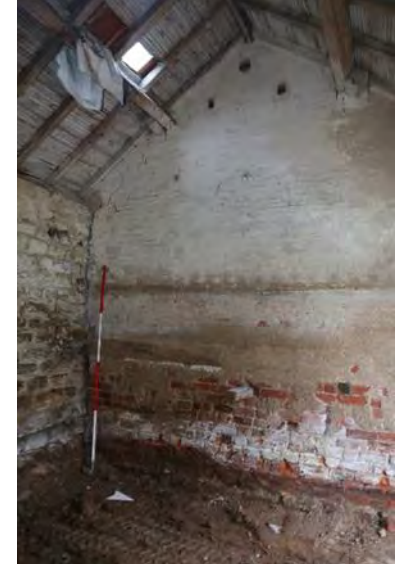
2204	Hay rack wall scar	Two wall scars can be seen. The top one is associated with a hay rack.	2105 hay rack scar	Early 20th century	Moderate evidential value as provides evidence for the presence of a hay rack.

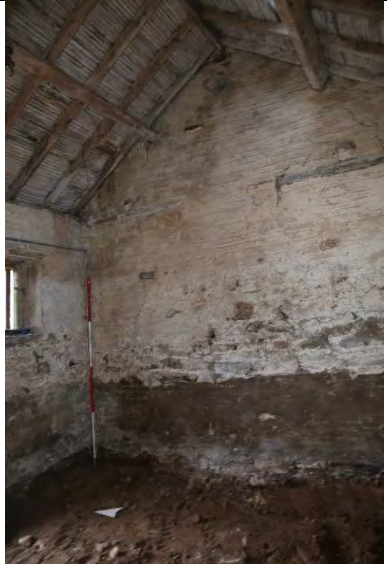
No.	Name	Description	Related Feature	Date	Significance	Photo
2205	Horizontal timbers	Horizontal timbers within the east wall of room aligned with the top of the north and south walls. Extending into the east wall.	2107 horizontal timbers	Early 20th century	Moderate evidential value as part of the original fabric of the building.

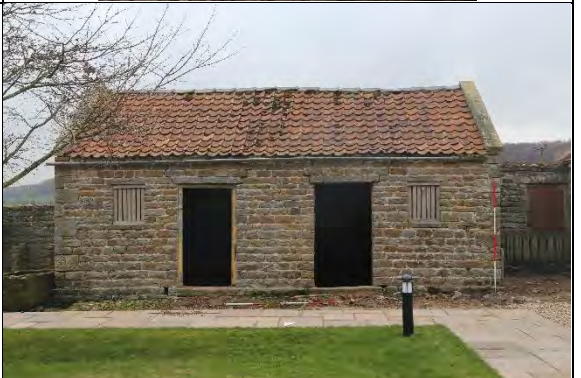
2300	North elevation	The front of the building overlooks the central foldyard Two doors (2101 and 2201) and two louvre windows (2102 and 2202).	2101 west door 2102 west louvre window 2201 east door 2202 east louvre window 2301 cobbles 2302 post	Early 20th century	High evidential and aesthetic value as the front, and original, façade of the building.

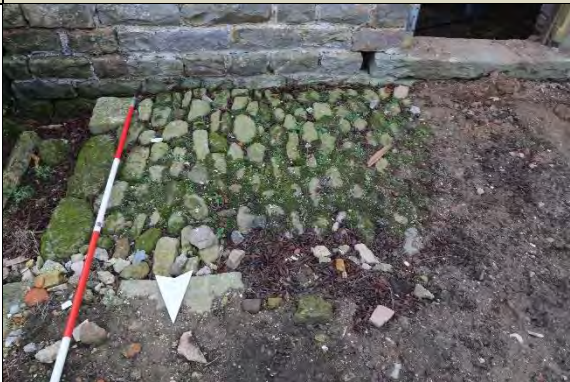
No.	Name	Description	Related Feature	Date	Significance	Photo
2301	Cobble surface	A section of cobble surface that runs across the front of the building.		Early 20th century	High evidential value as a demonstration of the original floor surface in this area – indicative of stabling.

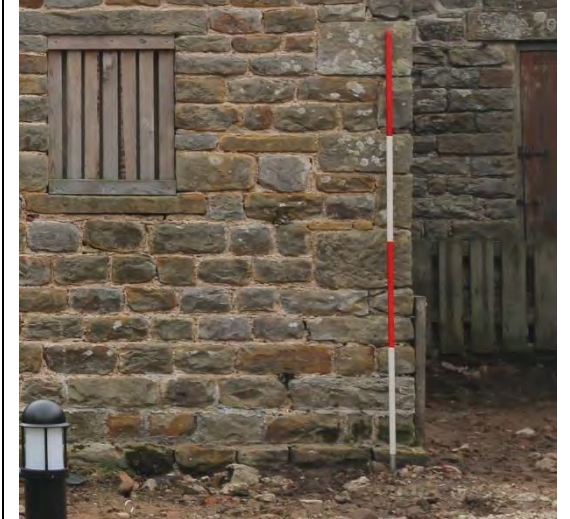
2302	Post	A square wooden post that stands 75cm high against the west quoins of the building. Possible tethering post.  The post can be seen at the end of the building near to the ranging rod.  See also 'north elevation 2300' on Figure 7.	1012 wooden remains 2303 wooden remains	Early 20th century	Low–moderate evidential value.

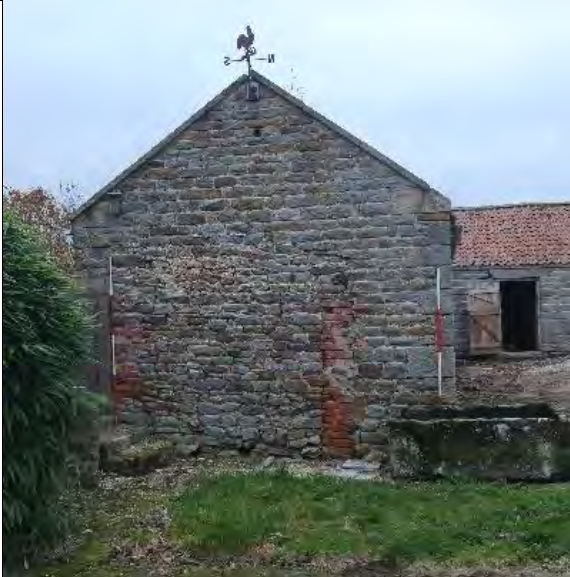
No.	Name	Description	Related Feature	Date	Significance	Photo
2400	West elevation	This elevation would originally have been partially obscured by another building, the evidence for which is still evident in the visible wall scars (2401). A vent (2402) at the top of the gable provided airflow.	2401 wall scars 2402 ventilation holes 2403 rubble infill	Early 20th century	High evidential value as part of the original fabric of the building and evidence of the later development of the site.

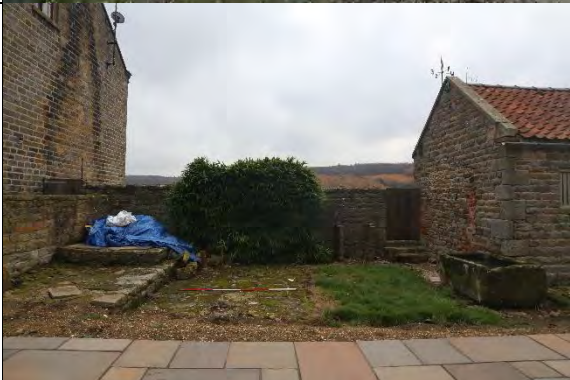
2401	Wall scars	A pair of wall scars that have been partially infilled with brick.  The footings of the associated building extending east remain visible to the east of the south range.	2403 rubble infill	Early 20th century - removed late 20th century	High evidential value associated with former layout of the south range.

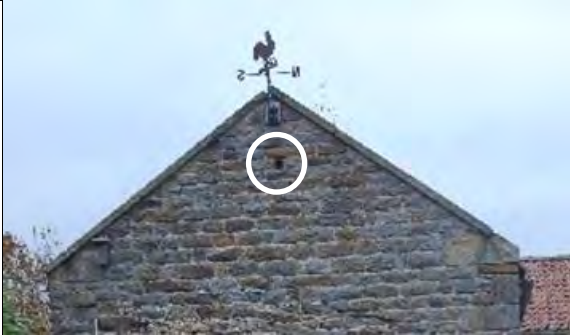
No.	Name	Description	Related Feature	Date	Significance	Photo
2402	Ventilation holes	There is a single tile ventilation hole which can be seen at the top of the gable. However, there is evidence that there may originally have been three in total, two of which are now blocked.	2601 ventilation holes	Early 20th century	Moderate–low evidential value as part of the original fabric of the building.
