Preliminary Ecological Appraisal and Bat Survey Report

20 Dikes Lane, Great Ayton TS9 6HA

August 2019

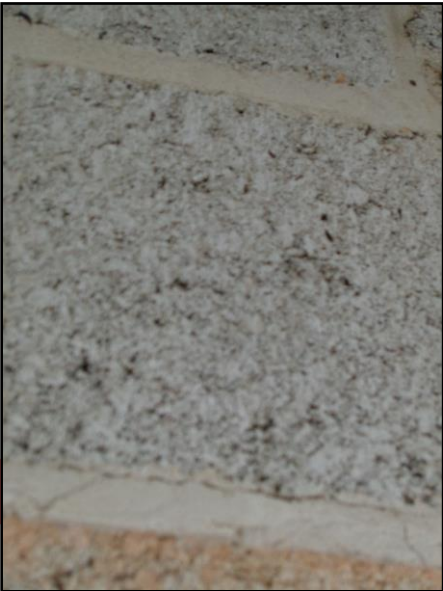
Figure 37. Bat droppings across walls in the corner of south eastern barn below possible roost entrance

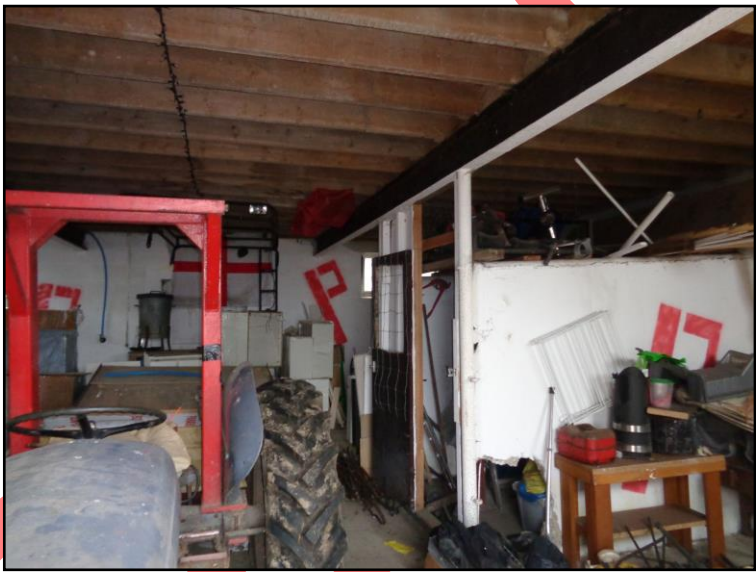
The wooden boarded floor is in good condition and the premises are dusty and in a poor state of repair. Droppings from bats, bird and potentially rodents were noted scattered around the walls, wall tops and floor.

Figure 38. Main room on the ground floor
