Forge Valley Woods NNR, Seavegate, East Ayton
Consultee: West Ayton Parish Council
Date: 4/09/2019

Additional information for Planning Committee

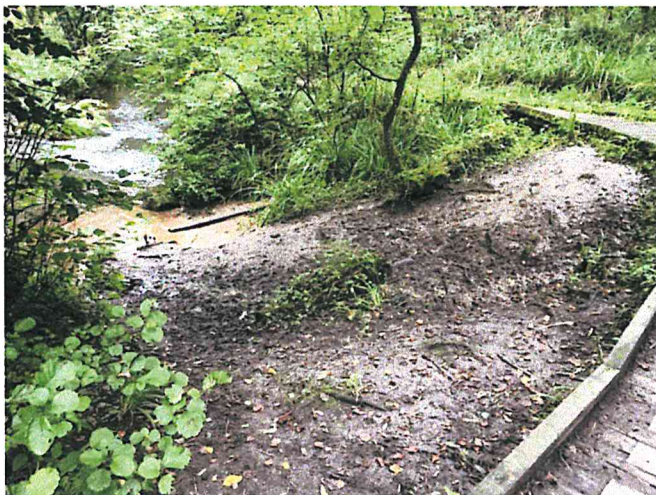
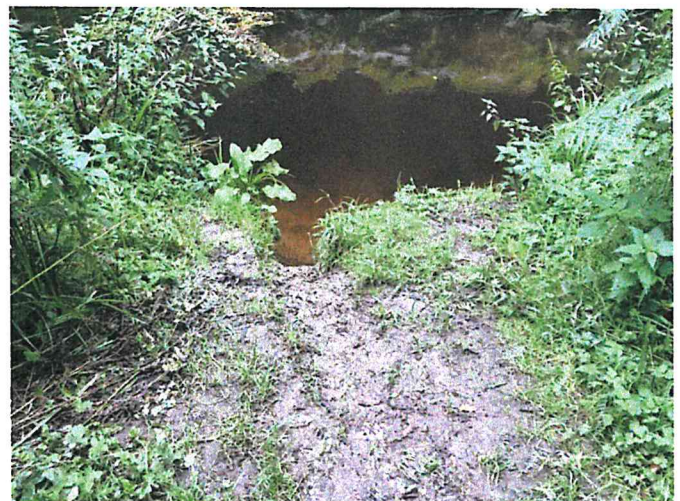
Forge Valley - riverbank erosion next to boardwalk
(metres affected at each erosion point 1 - 87)

- Riverbank erosion in Forge Valley was assessed on 28/08/19. There are 87 point sources of erosion from the south end of the boardwalk to the north end.
- The total length of riverbank affected is approx. 454 metres, 20% of the length of the boardwalk.
- The length of the erosion points varies from 0.6 to 64.8 metres, with the most affected areas close to the footbridge. In places, the erosion is starting to undermine the boardwalk.
- The vast majority of erosion points are caused by dogs, as pawprints are evident.
- Silt can be seen on the riverbed at each access point. The River Derwent is a high priority river for sediment issues in the River Humber Basin Catchment under the European Water Framework Directive and is a drinking water protected area under WFD.
