**STRUCTURAL ADVICE IN
RESPECT OF A
PLANNING APPLICATION
FOR CONVERSION OF
THE BARNs TO LIVING
ACCOMMODATION
NEWGATE ESTATE
HIGHDALES
HACKNESS
YO13 0JU**

**PROJECT NO.
MCB/PS/JC/43078 Rpt001**

Date: 22nd October 2019

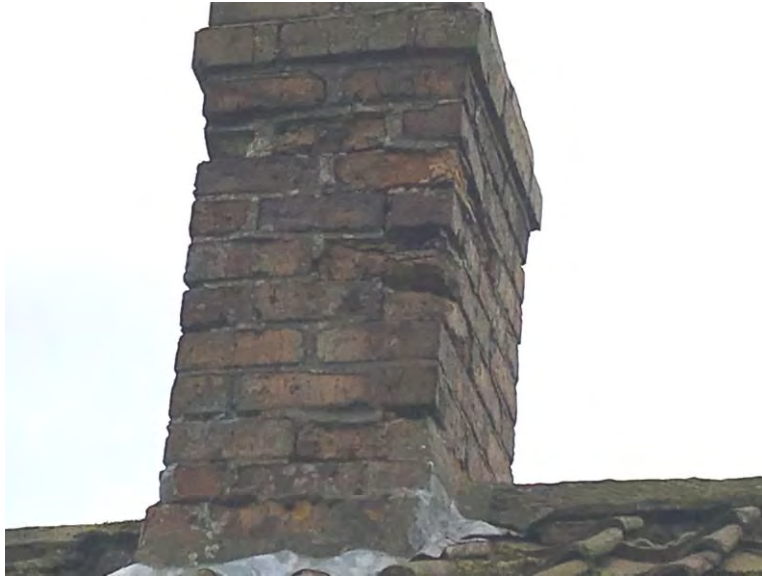
Photograph No. 8

- 3.10 There is poor pointing and minor stone erosion with pattress plates evident. (See photo 7)
- 3.11 There is stone erosion and pointing issues. Existing openings have been infilled and roofing failures are evident. This also is typical for Rooms C and D. (See photo 8)
- 3.12 The chimney brickwork has spalled and the pointing and flashings are damaged. (See photo 9)
- 3.13 The lintels are in poor condition with woodworm and rot visible. Cracking is evident to the walls. (See photo 10)
- 3.14 There is cracking to the gable, fireplace and external wall. Roof spread is evident. (See photos 11 and 12)
- 3.15 Bulging to the wall is evident along with multiple cracks. (See photo 13)
- 3.16 The WC room has been decorated recently possibly covering damage. Mould spores are evident. (See photo 14)
- 3.17 The Bitumen felt roof is showing signs of degradation.

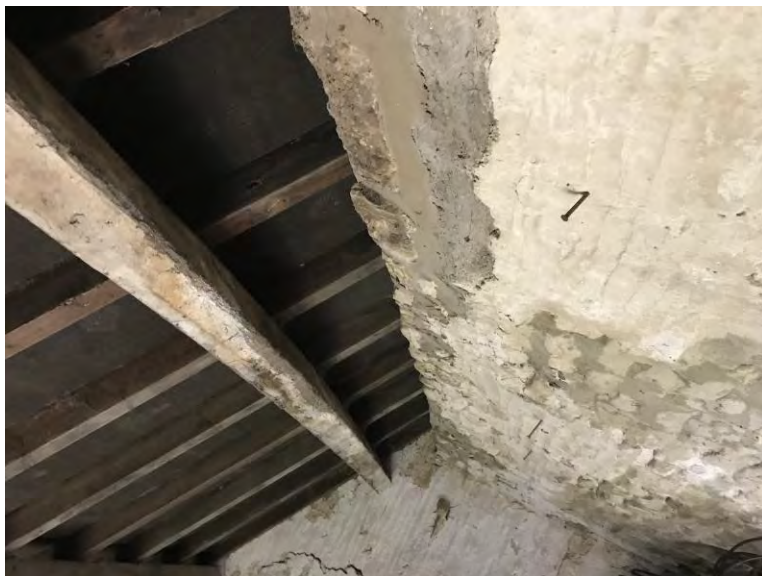
Photograph No. 19

- 3.21 The lintel shows signs of infestation and there is cracking to the wall. (See photo 17)
- 3.22 The kingpost truss is in reasonable condition.
- 3.23 The Bitumen felt roof is showing signs of degradation. (See photo 18)
- 3.24 There is cracking to the wall and roof movement is evident. (See photo 19)
- 3.25 The wall has had previous poor repairs undertaken and the purlins have a distinct 'bow'. (See photo 20)
- 3.26 Cracking is evident to the existing gable but note previous 'repair'. Pointing and mortar joint washout is evident. (See photos 21 and 22)

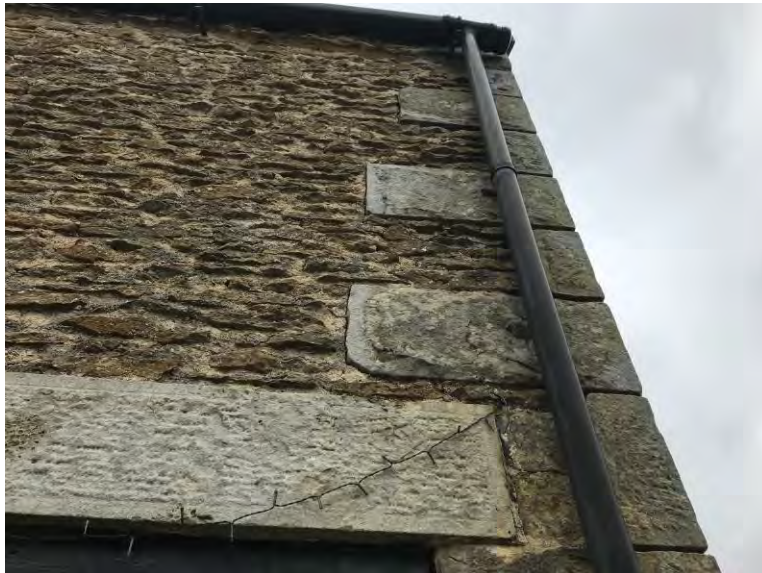
Photograph No. 27

-
- 3.31 Further typical cracking is noted near the doors. (See photos 27 and 28)
 - 3.32 Pointing and render repairs are evident though spalling and cracking are still evident to the top side wall and gable. Previous lean-to roof noted. (See photo 29)
 - 3.33 The internal aspects to the ground floor have been recently refurbished. (See photo 30)
 - 3.34 The floor edge to the first floor is not supported or tied to the external wall. (See photo 31)
 - 3.35 First floor floor joists have been excessively notched. (See photo 32)
 - 3.36 Walls are typically cracked but have received some minor 'repairs'. (See photos 33 and 34)
 - 3.37 The trusses are in good order but some infestation is noted. Note gap around the floor. (See photo 35)
 - 3.38 The truss bearing location is poor and a crack is evident. (See photo 36)
 - 3.39 The Bitumen type felt to the roof shows signs of degradation.

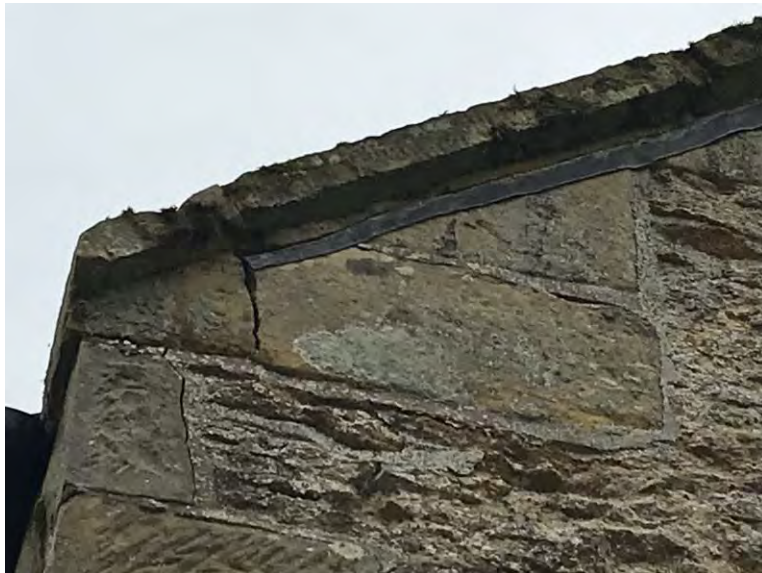
Photograph No. 37

- 3.40 The lintel to the first floor has been replaced recently. (See photo 37)
- 3.41 There is stone failure to the water table. (See photo 38)
- 3.42 The gable has been partially repointed and the door has been replaced recently. (See photo 38)
- 3.43 The timber lintel has shrunk and there is multiple cracking evident to the gable. (See photo 39)
- 3.44 The pointing has eroded or is missing and there is cracking evident. This is typical throughout. (See photo 40)

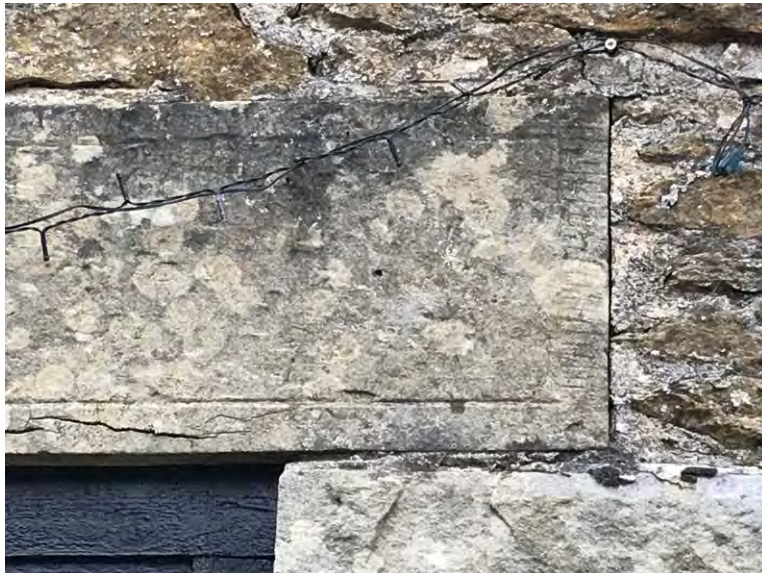
Photograph No. 41

-
- 3.45 Mortar fillet flashing has been used and there is a crack to the wall. (See photo 41)
- 3.46 There is cracking to the lintel jamb. (See photo 42)

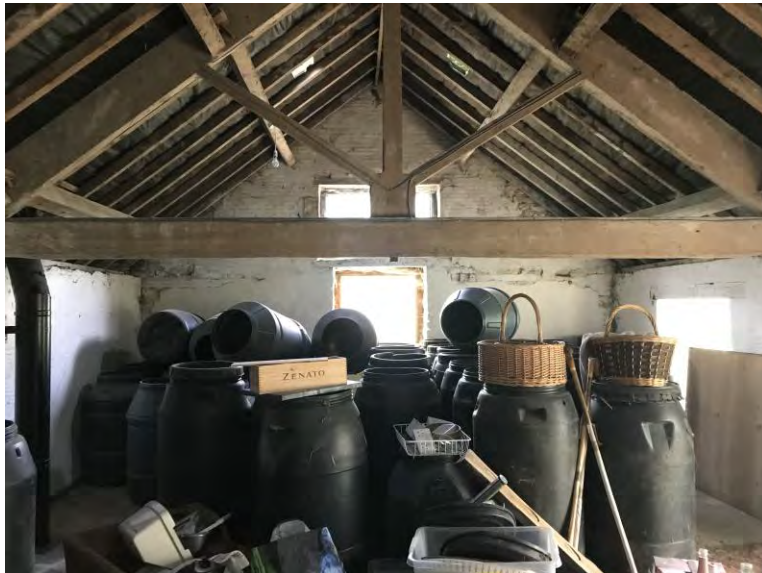
Photograph No. 47

- 3.49 Previous poorly repaired cracks and other minor cracks are evident. (See photo 46)
- 3.50 The redundant window cill shows signs of infestation and rot. Mould is also noted to the furniture. There is a crack to the wall. (See photo 47)

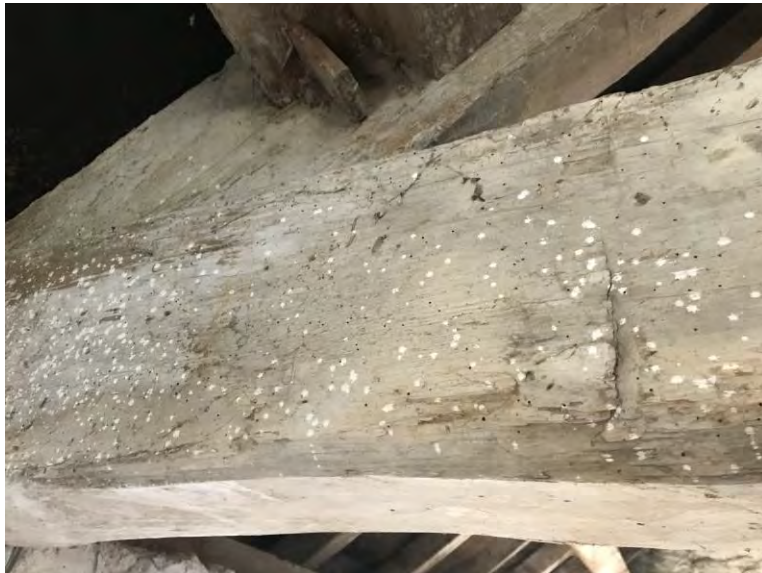
Photograph No. 49

- 3.51 The trusses appear to be in good order but the Bitumen felt is showing signs of degradation. (See photo 48)
- 3.52 The walls are lime rendered but cracking is noted over the windows. Timber infestation is noted generally. (See photos 49, 50 and 51)

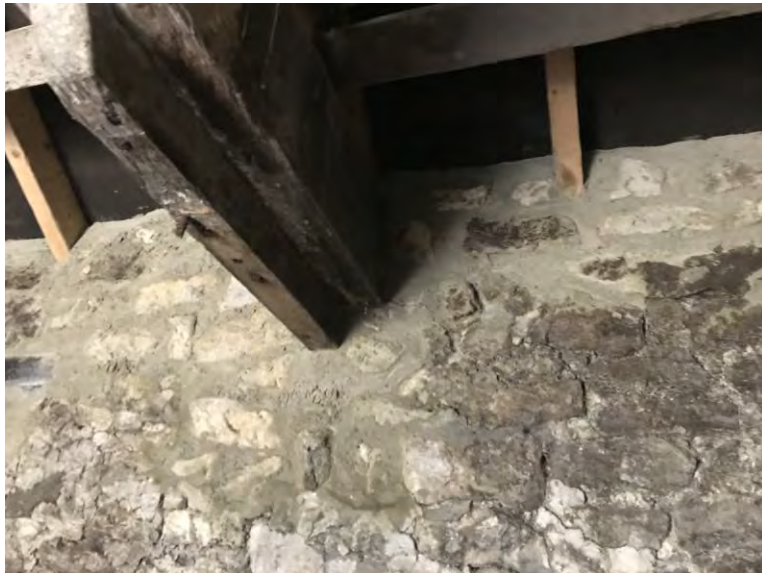
Photograph No. 59

-
- 3.59 The room has been repointed internally locally. Note purlin sag. (See photo 58)
- 3.60 The wall has been rebuilt up to the underside of the felt. Note previous crack repair at purlin to the wall. (See photo 59)
- 3.61 The truss bearing has been rebuilt but a new crack is evident. (See photo 60)
- 3.62 The walls are typically repointed/rebuilt locally but cracking and mortar wash-out is evident. (See photo 61)
- 3.63 Cracking to western gable noted. (See photo 62)
- 3.64 Timber infestation and rot noted. Localised masonry has been rebuilt. (See photo 63)
- 3.65 Cracking is noted to the new wall at truss bearing. (See photo 64)
- 3.66 The Bitumen type felt which is laid on new rafters is showing signs of degradation.

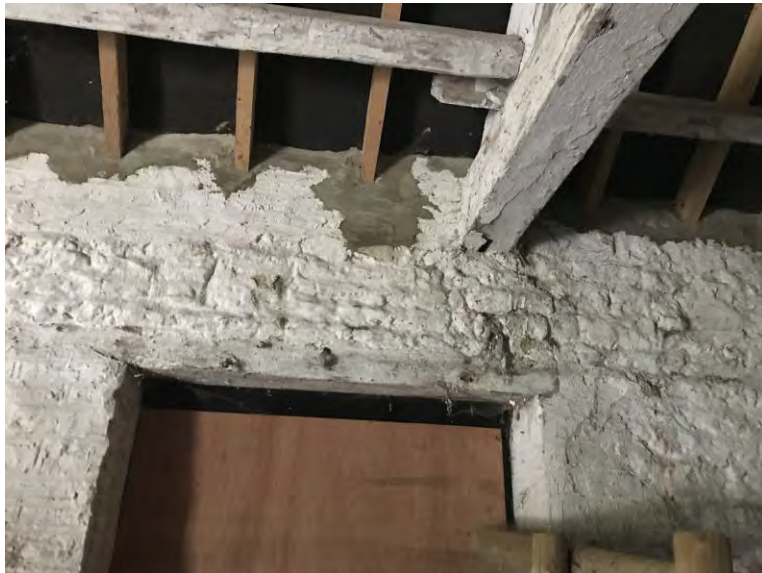
Photograph No. 71

-
- 3.74 Cracking is evident to the walls and the masonry has been rebuilt locally up to the felt. (See photo 71)
- 3.75 The Bitumen felt is showing signs of degradation.
- 3.76 The truss bears onto the opening and there is cracking evident. (See photo 72)
- 3.77 Cracking is noted to the concrete floor. (See photo 73)
- 3.78 There is typical cracking to the byre, through render and to the wall. (See photo 74)
- 3.79 The gable walls have cracks evident, emanating from the purlin positions. (See photo 75)

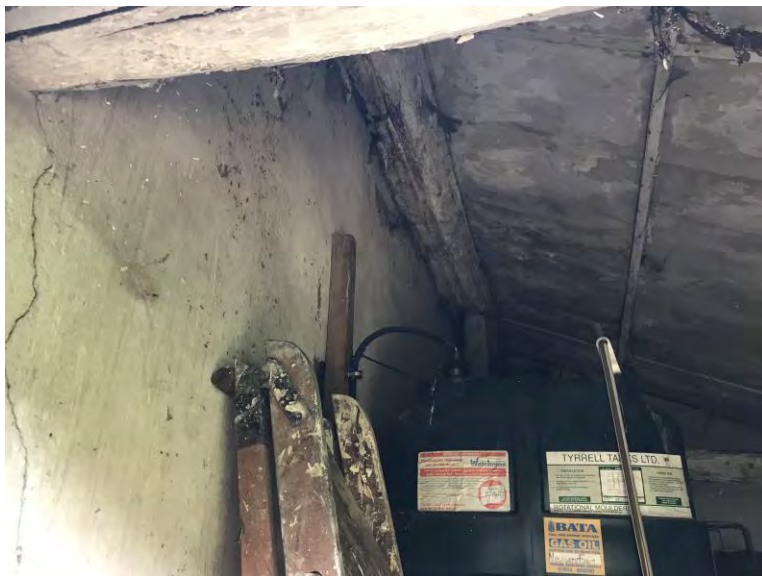
Photograph No. 78

- 3.80 The pointing is poorly executed. Some areas have been rebuilt. Note exposed concrete slab and eroded masonry. (See photo 76)
- 3.81 There is oil staining evident to the floor. (See photo 77)
- 3.82 Cracking to the walls is evident. (See photos 78 and 79)
- 3.83 The generator exhaust is not terminating properly. (See photo 80)
- 3.84 The water table flashing is not long enough. There is pointing missing and the masonry is cracked and eroded. (See photo 81)
- 3.85 Cracking to the wall is evident to the gable. (See photo 82)
- 3.86 There is a straight joint crack between the two buildings. (See photo 83)

- 4.30 The wall to Building K has not been infilled to sufficient standard and it is considered that this would be best to be rebuilt, especially in view of the cracking also evident to this small building.
