## **Proposed Sustainable re-development at Meadowcroft, Raw, Whitby, YO22 4PP.**

**Meadow Croft  
Dark Lane  
Raw, Robin Hoods Bay  
Whitby  
YO22 4PP**

**Meadowcroft, Raw**  
**Bat and Bird Survey Report**  
**16<sup>th</sup> December 2020**

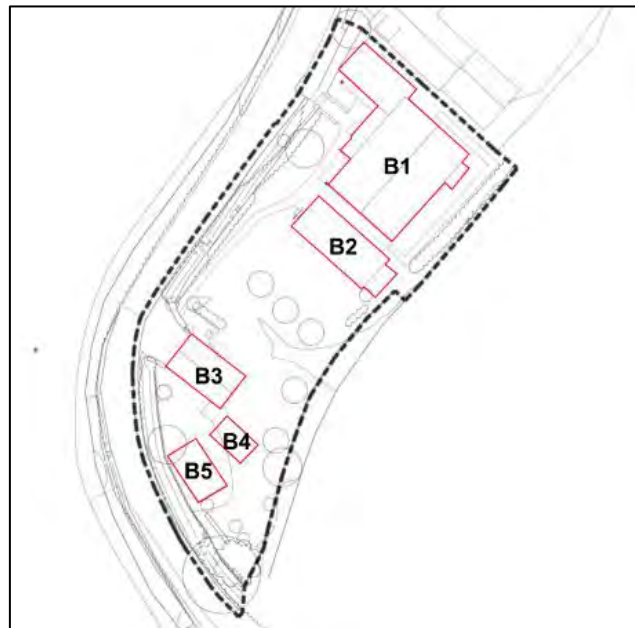
**Figure 2. Building numbering plan**

- 5.2.1 For the purpose of aiding description, site buildings have been numbered, with building numbers shown on Figure 2.
- 5.2.2 A small accumulation of probable pipistrelle droppings was recorded beneath a ridge tile on B1. No other signs of roosting bat presence were recorded from the site.
- 5.2.3 The dwelling (B1) was considered to offer a low-moderate level of bat roost potential whilst all outbuildings (B2-B5) were considered to offer no more than a negligible level of bat roost potential. No features offering greater than negligible roost potential were recorded from site trees.
- 5.2.4 No signs of bird nesting were recorded from the surveyed buildings although trees and boundary hedgerows have potential for this use.

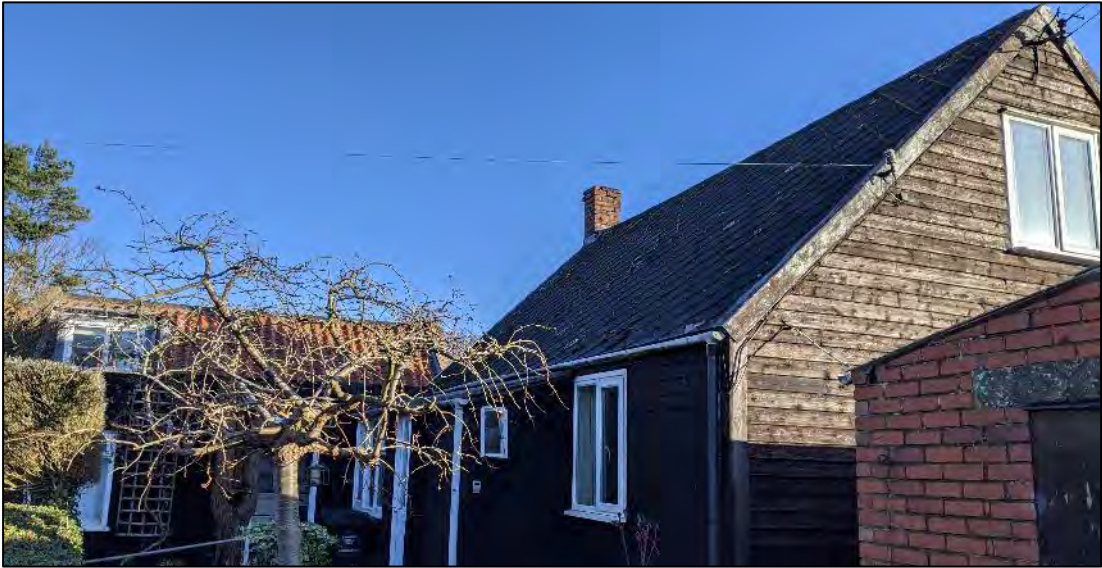
**Plate 3. Western corner of B1**

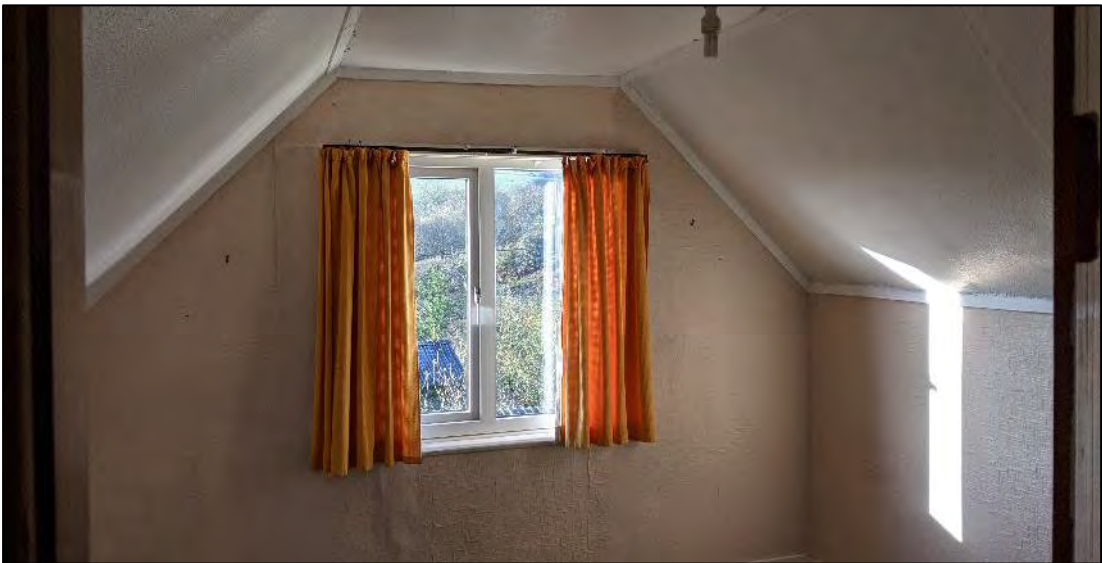
- 5.2.8 The roof space of B1 mainly comprises living space (Plate 4), with a small 0.5m high roof-void above this (Plate 5) and a 1m high eaves space at either side of the bedrooms. The roof is underlined with wood sarking suspended on rafters and a ridge beam. No insulation is present in the roof void. The southeast eave-space is insulated with 100mm of glass fibre insulation whilst the northwest eave-space is uninsulated. Occasional scattered mouse (*Mus musculus*) droppings were recorded from the southeast eave space.

**Plate 4. Room within roof of B1**

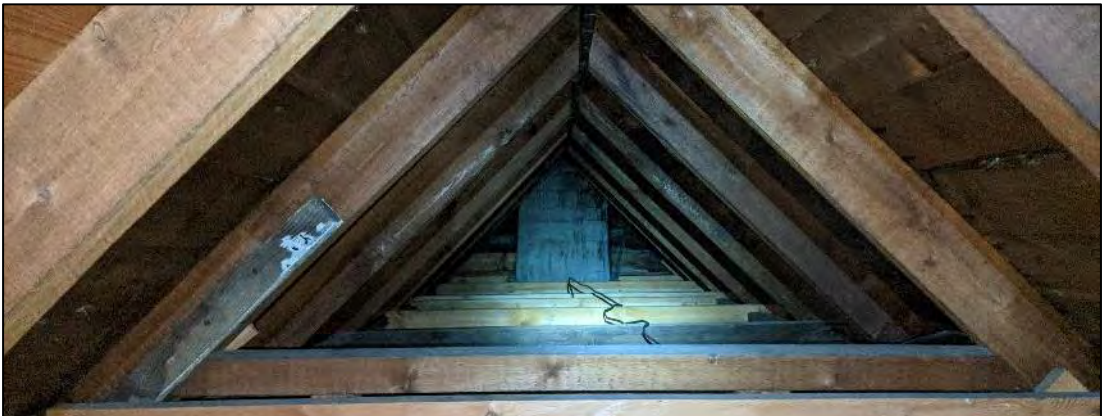
**Plate 5. Small void (0.5m high) present in B1**

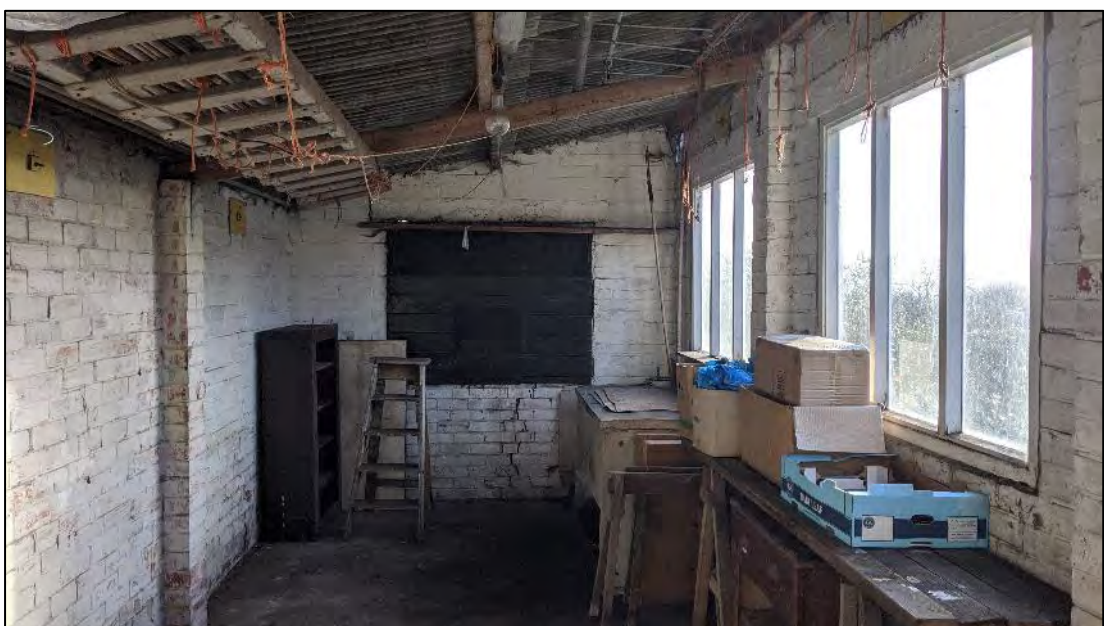
- 5.2.10 Building 2 comprises a single-storey brick outbuilding with a sloping corrugated asbestos cement sheet roof. This building has single paned wood framed windows in its southwest elevation with metal ventilation panels above.
- 5.2.11 No features offering greater than negligible bat roost potential were recorded from the exterior of this building.
- 5.2.12 Internally the roof of B2 is open to the underside of the corrugated panels and it is suspended on simple wood beams. The walls are whitewashed. No signs of bat presence were recorded from B2 and the building was considered to offer negligible bat roost potential.

**Plate 7. Interior of B2**

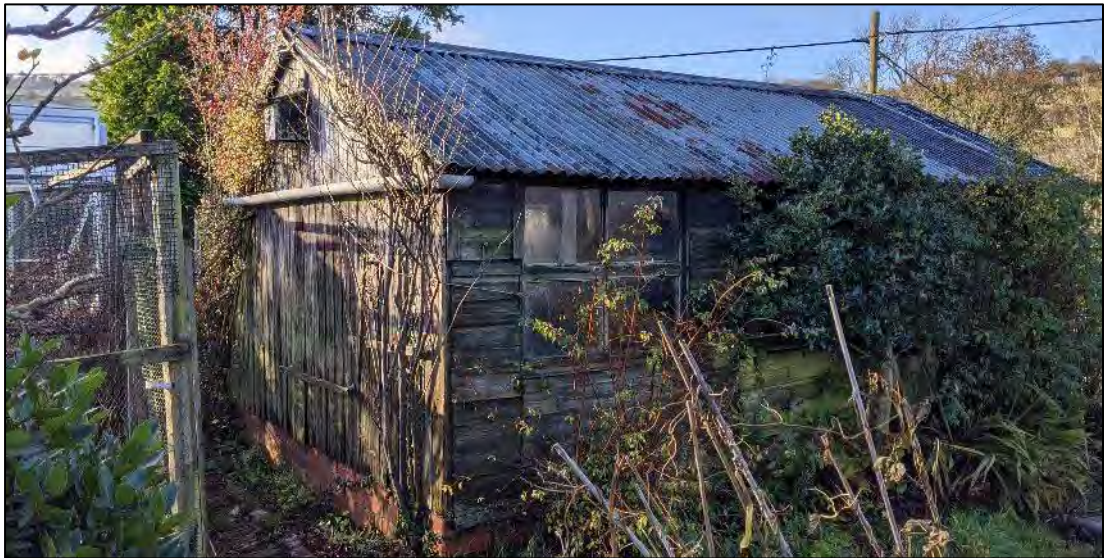
5.2.13 Building 3 comprises a single-skin wood framed and clad garage with a pitched corrugated galvanised steel sheet covered roof and ridge. Single-paned wood-framed windows are present.

**Plate 8. East corner of B3**

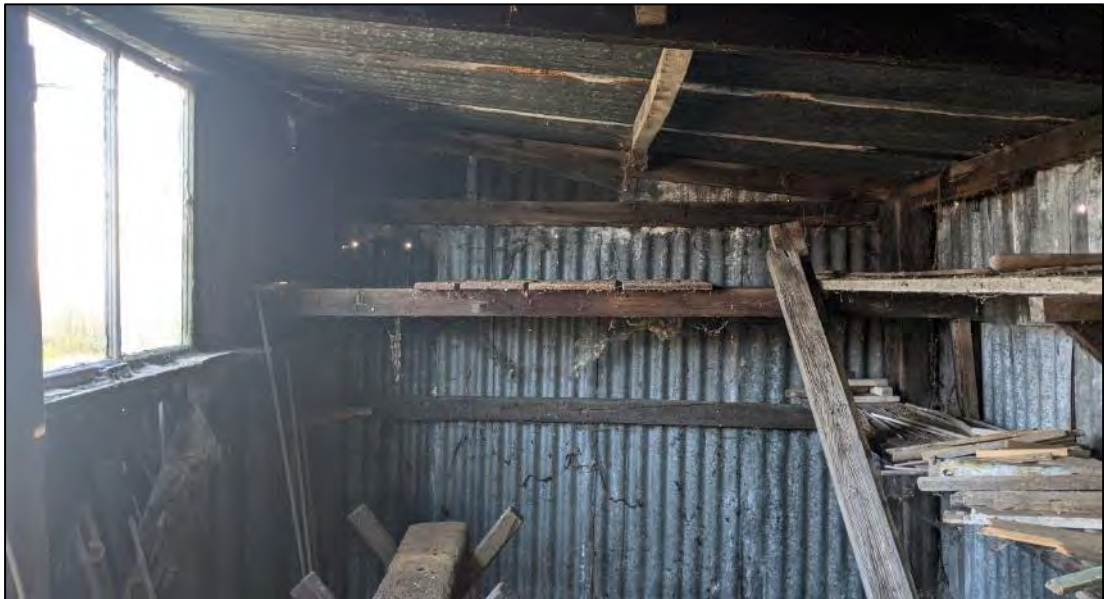
Plate 12. Interior of B5
