**Archaeological Standing Building  
Recording**

**Lodge Hill Farm**

**Egton Grange**

**July 2021**

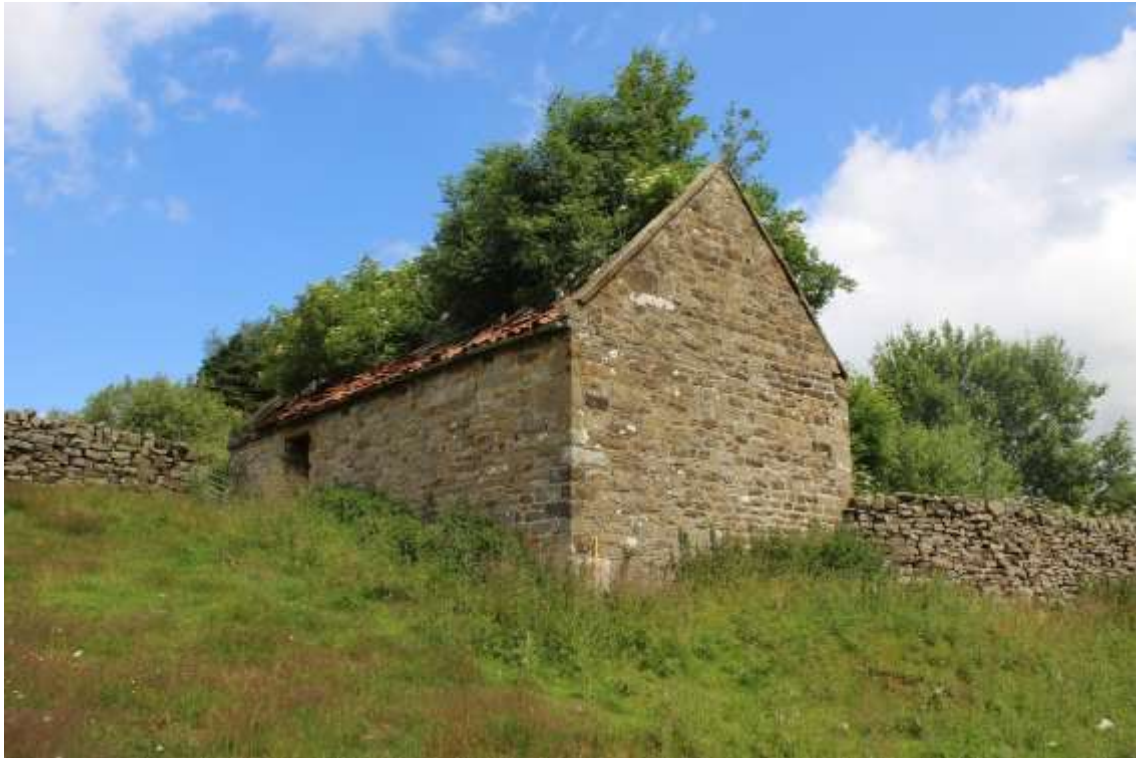
*Plate 113: External oblique view of W and S-facing elevations of Building No. 3*

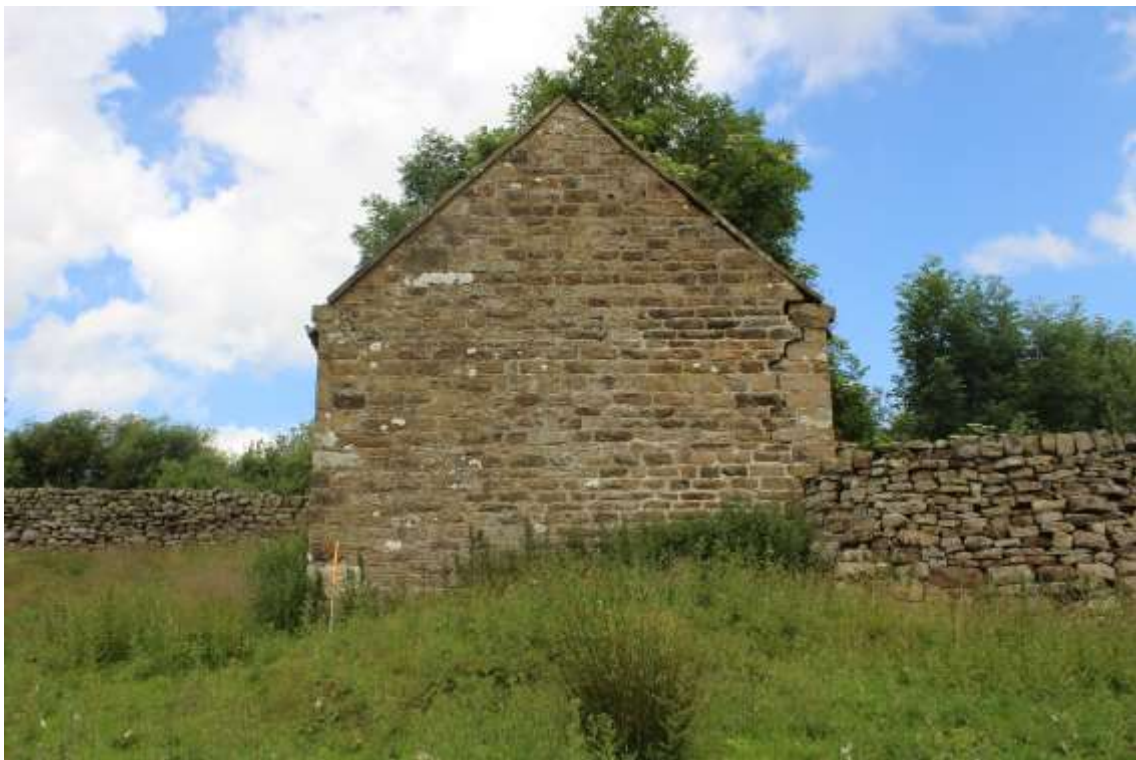
*Plate 114: External view NNW of S-facing gable end of Building No.3*

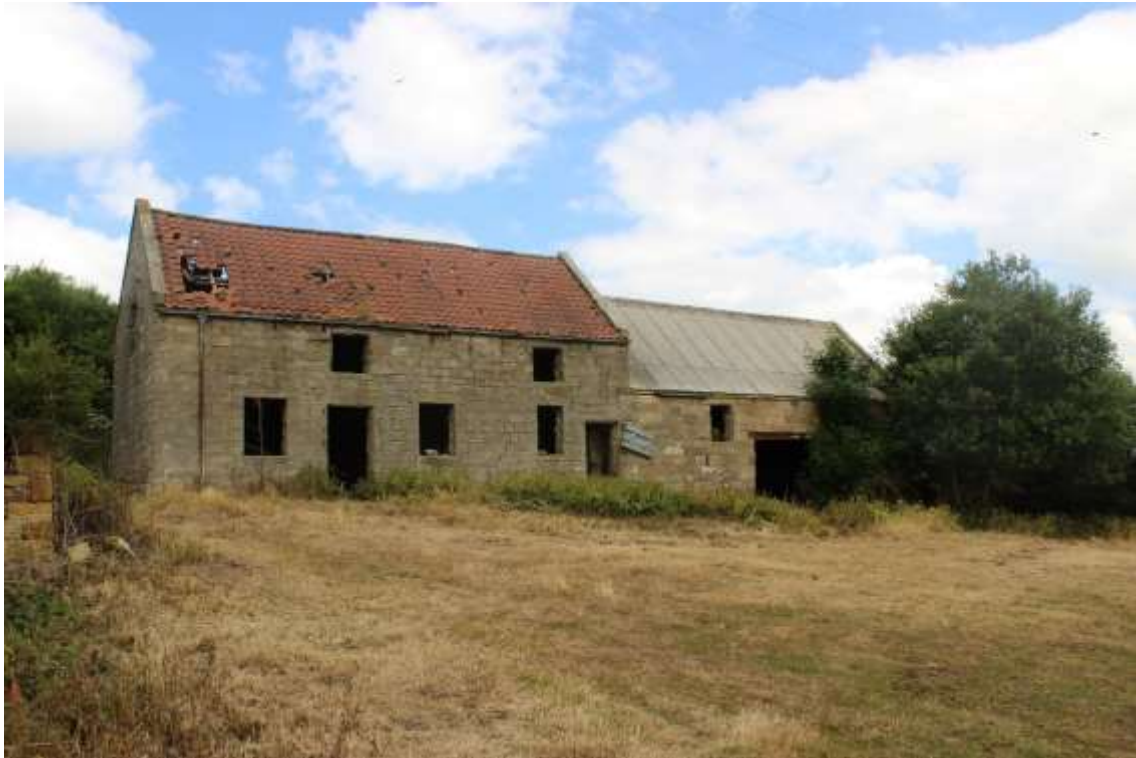
Building No.4 to the NE of the farmhouse (Building No.1) is a gable-ended combination barn with staggered roofline built on an E-W alignment over three levels to incorporate an eastward falling slope (*Plates 117-126*). As a result of its construction, the barn comprises three distinct sections, which, W to E, may be described as a stable with second-storey storage space and loose box with second-storey storage forming the first section; a mid-section comprising an open-plan barn with cart entrance; and a derelict third section. The barn is of coursed dressed sandstone block construction with a pantile roof E and W and central corrugated panelling.

*Plate 117: External oblique view NNE of the principal S facing elevation and W-facing elevation of Building No.4*

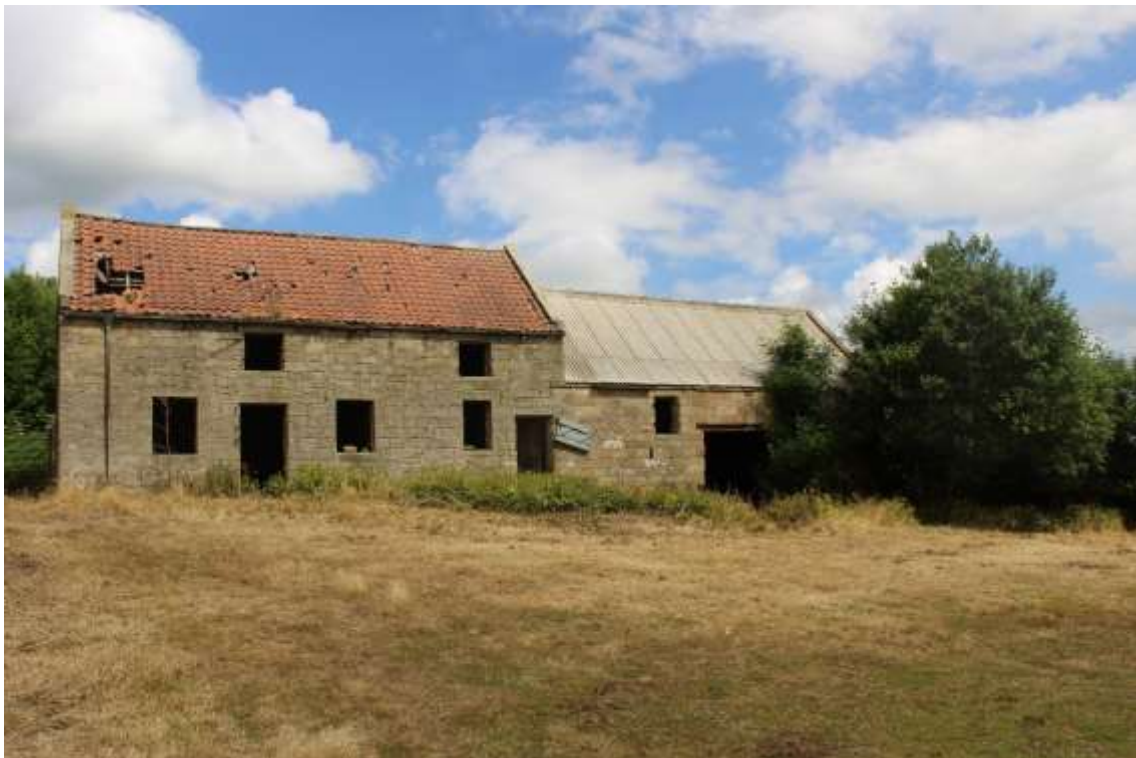
*Plate 118: External view N of principal S-facing elevation of Building No. 4*

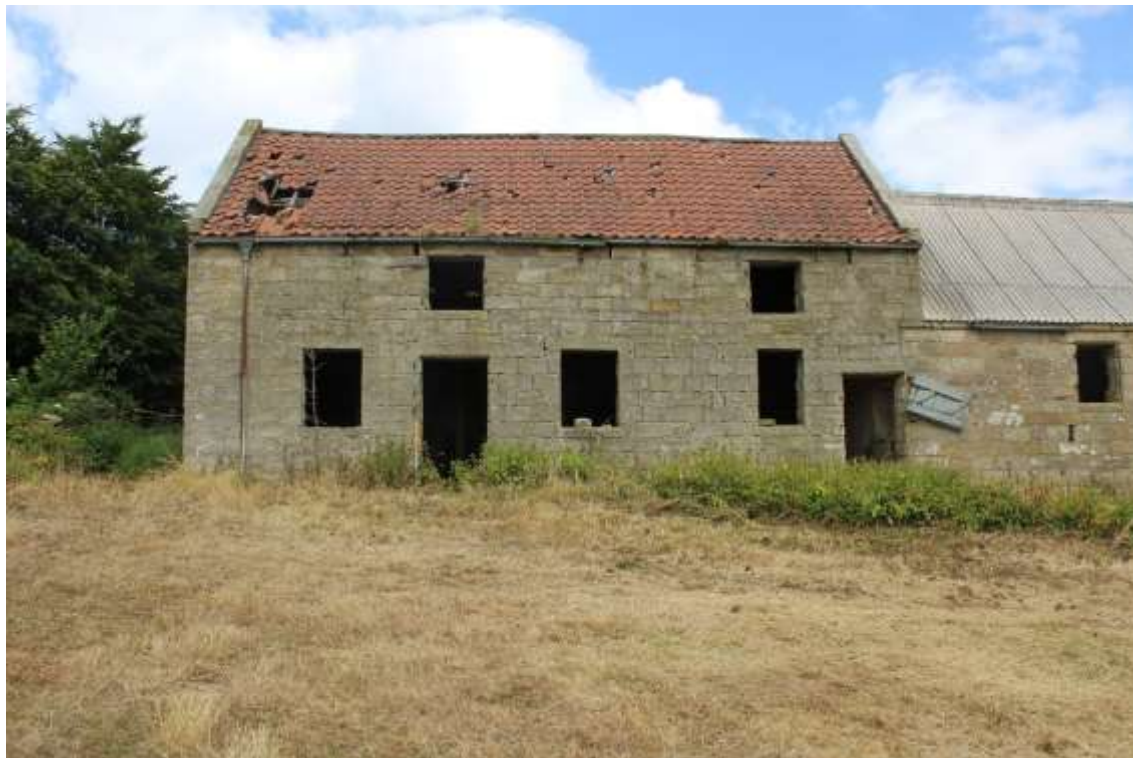
The principal S-facing elevation is split across the three sections built at different levels. From W to E at ground level, (*Plate 119*) a central doorway is flanked by two windows with a loading hatchway with iron hinge brackets set above the doorway; a stable door at ground level has a window with iron hinge brackets to the left of the door and a second loading hatchway with iron hinge brackets above the window. The next section (*Plates 120-121*) has a wide cart entrance with a steel girder lintel and two evenly spaced windows close to the roofline set either side

*Plate 119: External views N of the first section of the S-facing principal elevation*

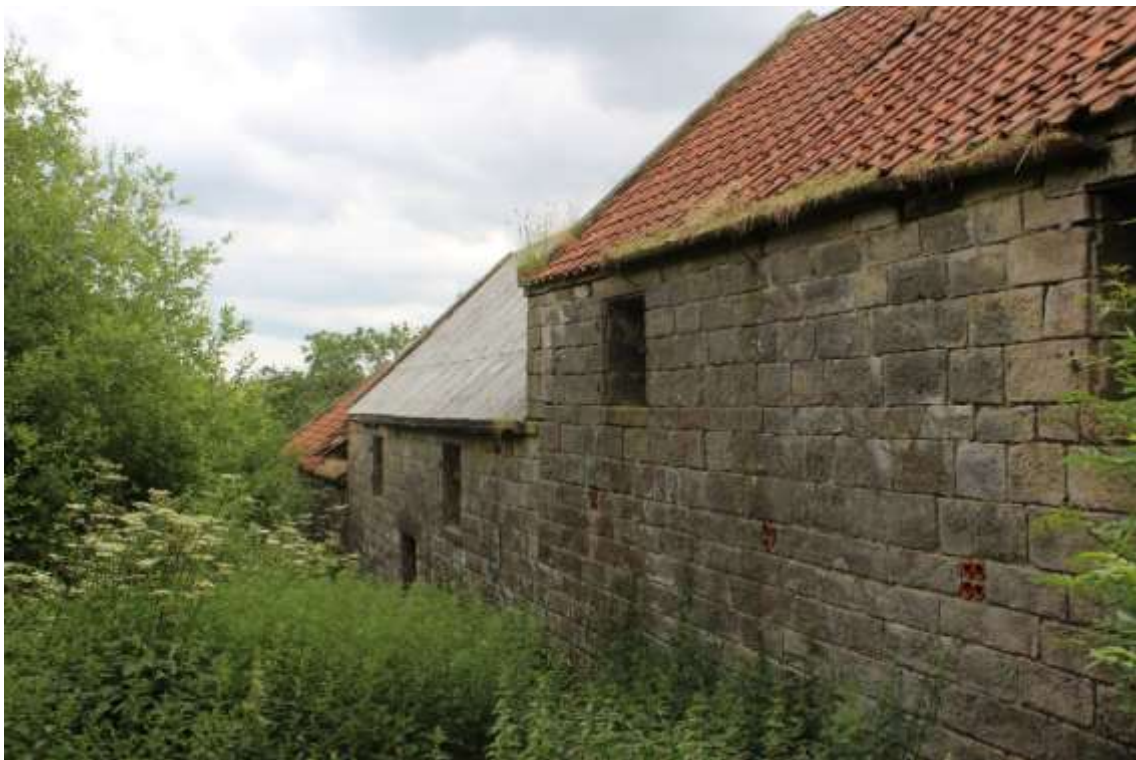
The N-facing elevation (*Plates 124-126*) is similarly staggered over three levels representing the different portions of the barn. The first section has two windows at either end of the roofline with a line of vents beneath (*Plate 124*). The second section (*Plate 125*) has a doorway and wooden lintel with two windows either side of the door at the roofline. A series of ventilation holes were noted beneath the eaves of the roof and a tie pin is located towards the W end of the building section. No features of note were seen within the third section of the building (*Plate 126*). The E elevation was entirely obscured by the tree-line but a widow or loading hatchway could be seen. Earlier aerial photography shows a nesting hole and roosting ledge on the E-facing gable end of the building.

*Plate 124: Oblique external view ESE of N-facing elevation of Building No.4*

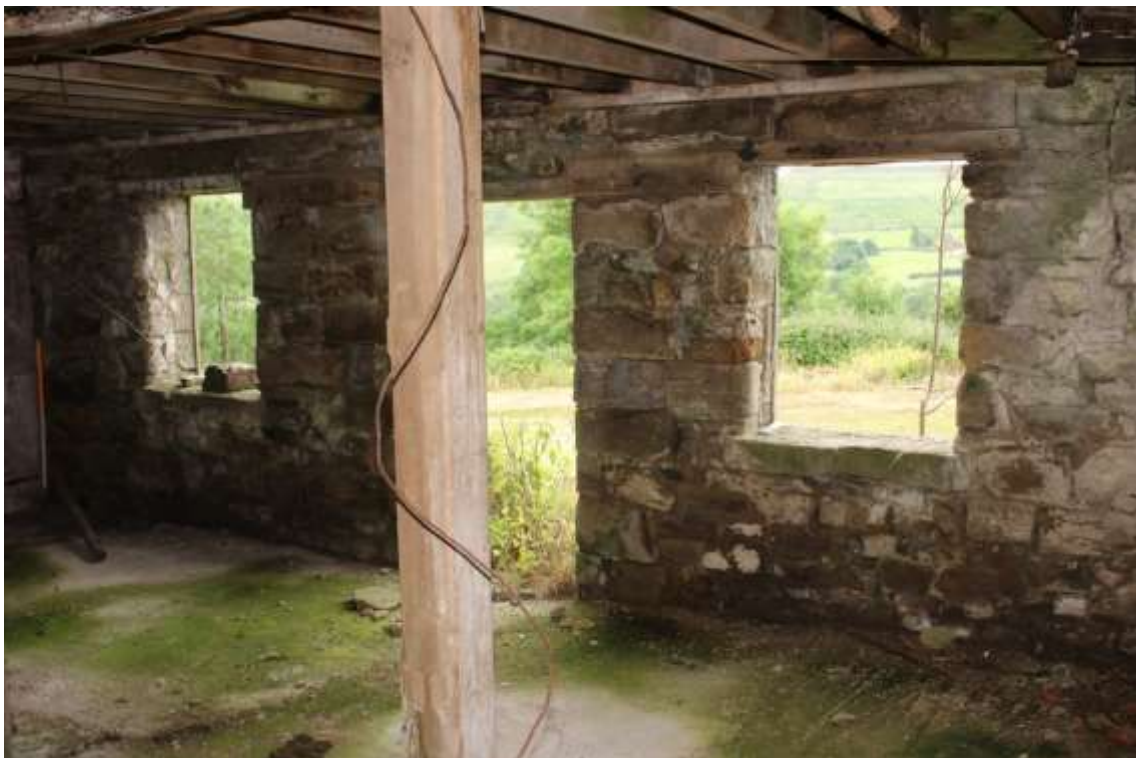
The first compartment opens N (*Plates 127-135*) from the main farmyard and is lit by two windows within the S wall (*Plate 130*). A second door within the SE corner of the room leads into the adjacent compartment (*Plate 127*). It has a concrete floor, whitewashed walls and three timber struts supporting an upper-floor storage area that was inaccessible for health and safety reasons (*Plates 131-132*). The roof structure visible through holes in the ceiling is of a simple king-post truss construction. A hole in the E wall had evidently relatively recently been knocked through into the adjacent compartment (*Plate 134*). Fixtures on the N wall align with the struts, suggesting the room was subdivided to form three bays (*Plate 135*).

*Plate 130: Internal view SSE of the first compartment of Building No.4 showing windows and doorway within S wall*

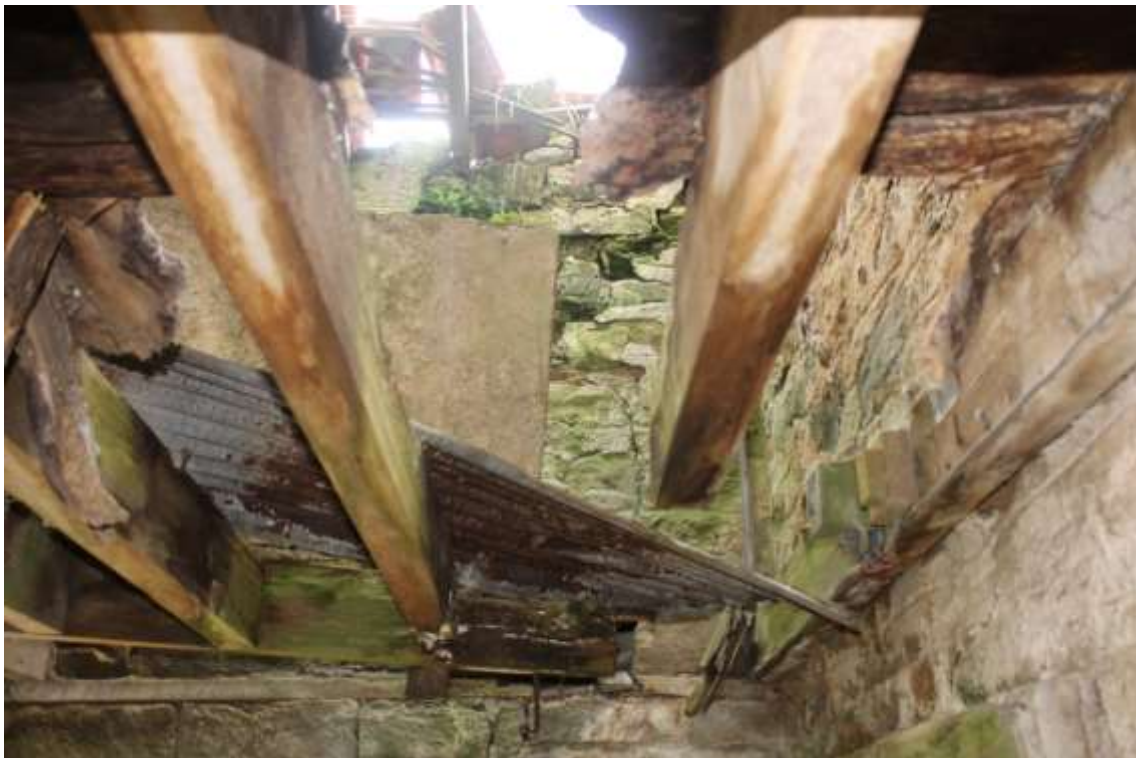
*Plate 132: Internal view S of rotten ceiling timbers within the first compartment of Building No.4*

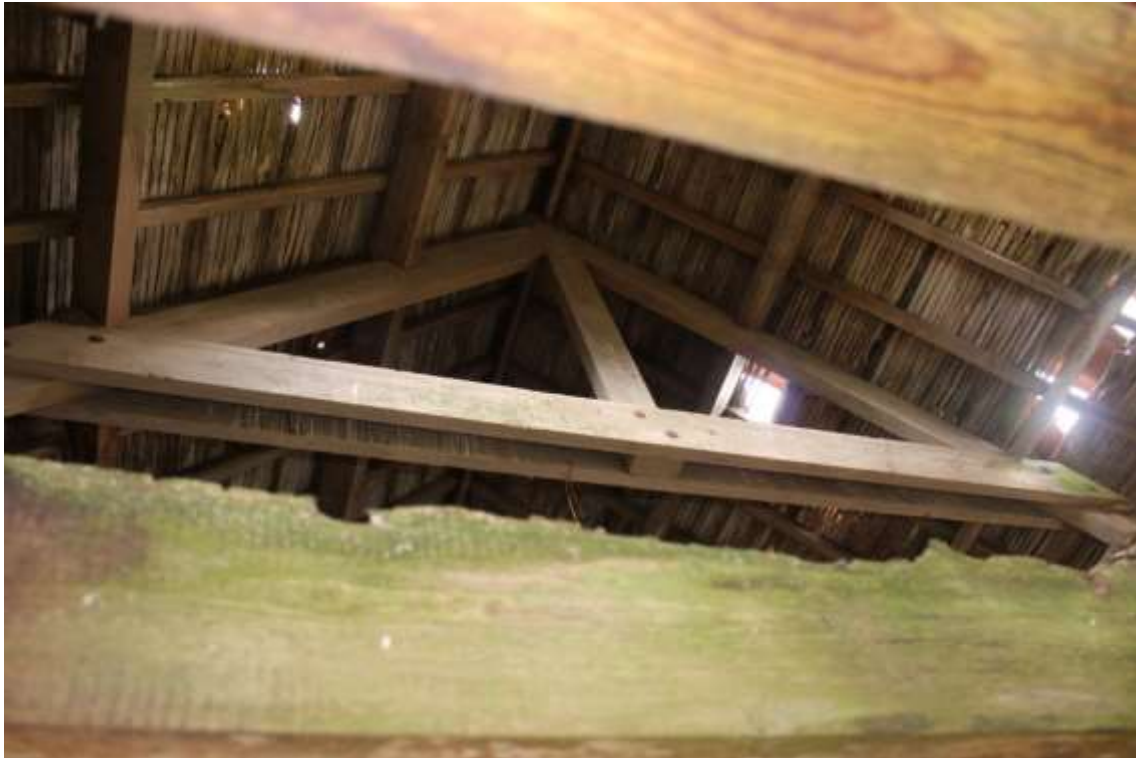
*Plate 133: Internal view ESE of king post roof truss within the first compartment of Building No.4*

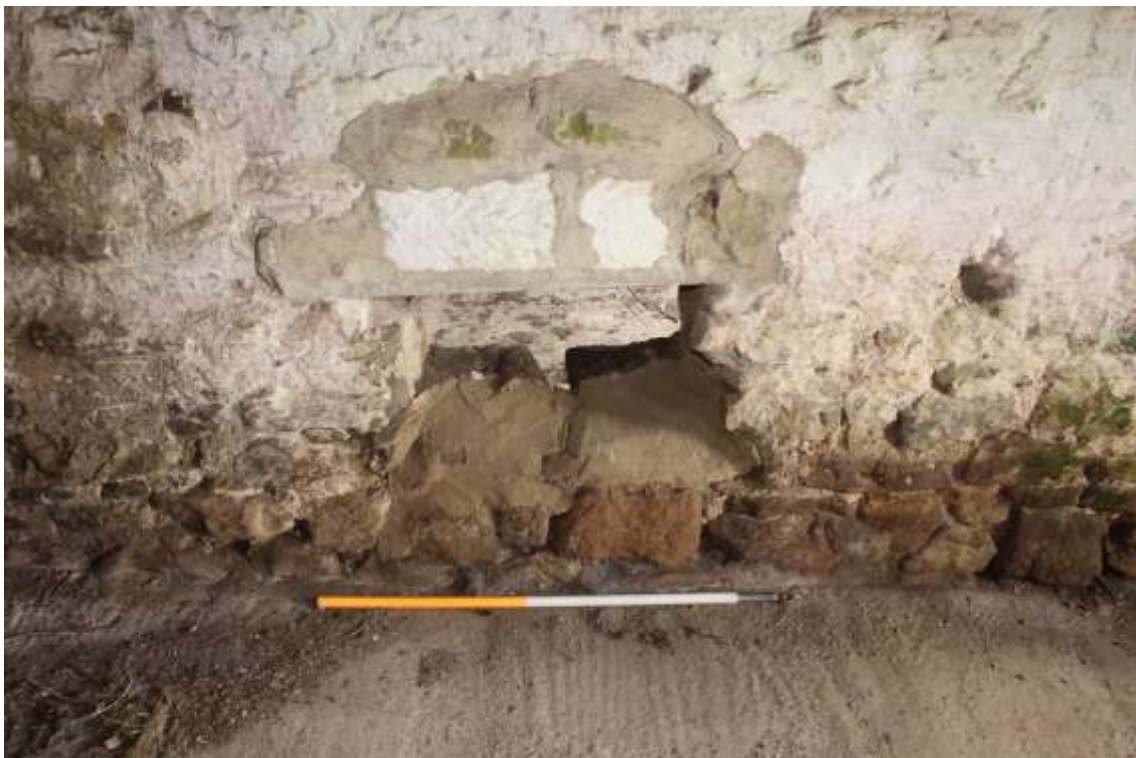
*Plate 134: Internal view E of hole in E wall within the first compartment of Building No.4*

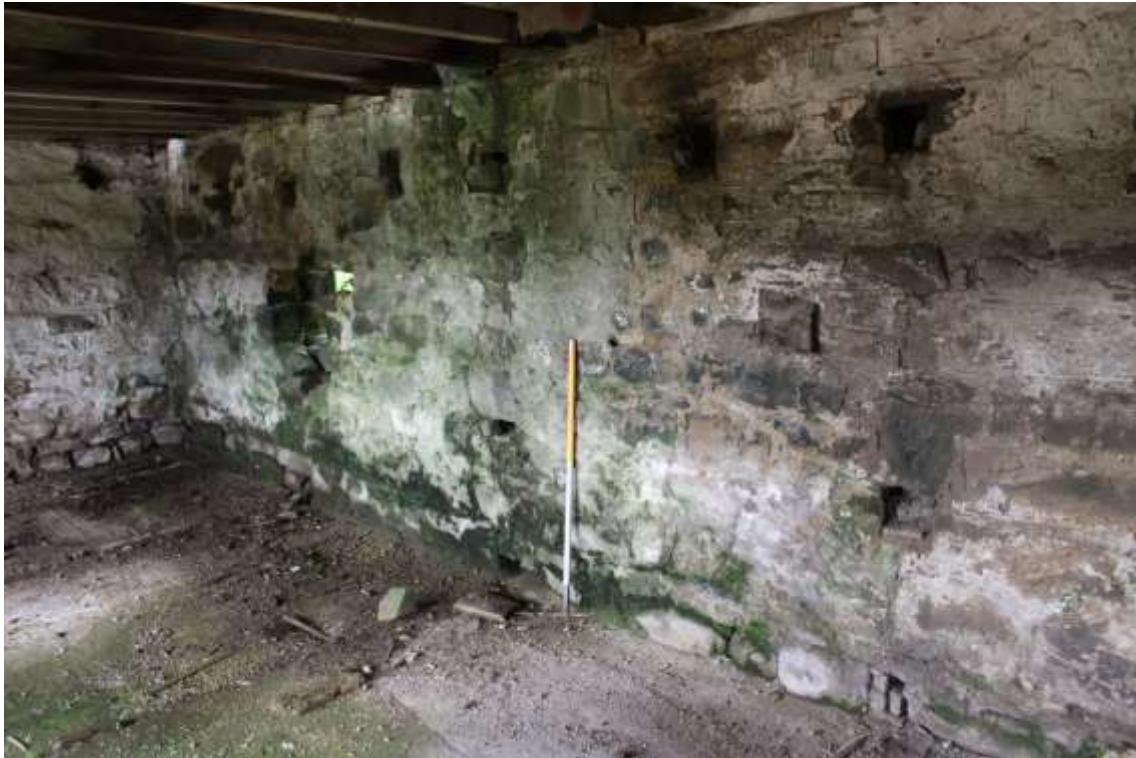
*Plate 135: Internal view NW showing fixtures on the N wall aligned with the struts within the first compartment of Building No.4*

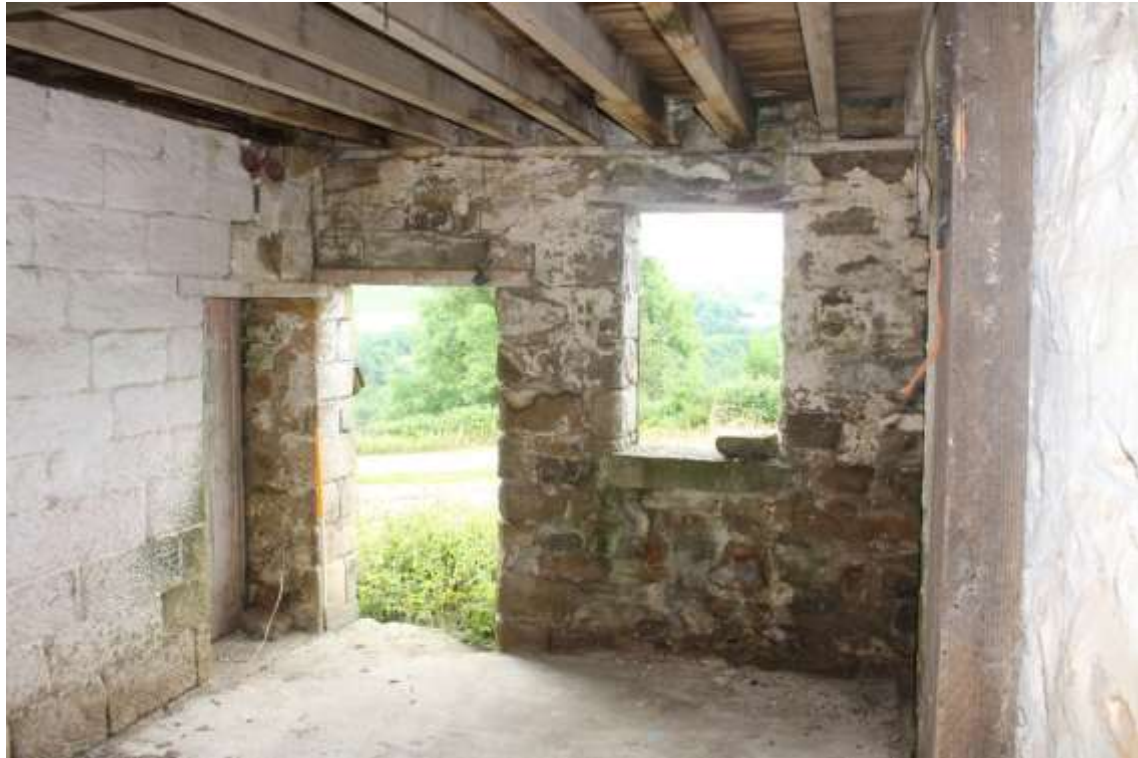
The second compartment (*Plates 136-141*) opens N from the main farmyard and connects with the adjacent compartments by means of doors in the SW and SE corners of the room. A surviving stable door and wooden trough (*Plate 137*) at the rear of the room suggest it was used as a loose box. The room has a concrete floor, whitewashed walls and two timber struts supporting an upper storage area which could not be accessed for health and safety reasons. The room is lit by a window in the S wall (*Plate 139*). An internal window looks into the adjacent compartment to the E (*Plate 140*).

*Plate 139: Internal view S of the second compartment of Building No.4*

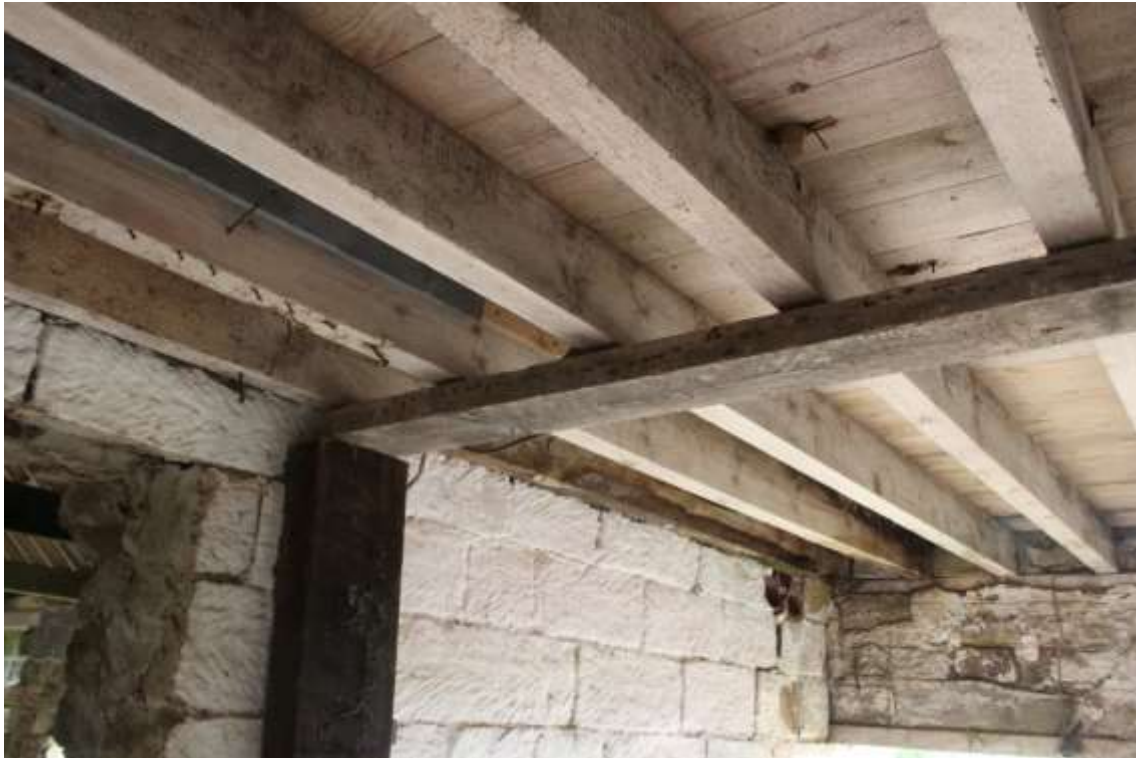
*Plate 141: Internal view SSE of the roof timbers within the second compartment of Building No.4*

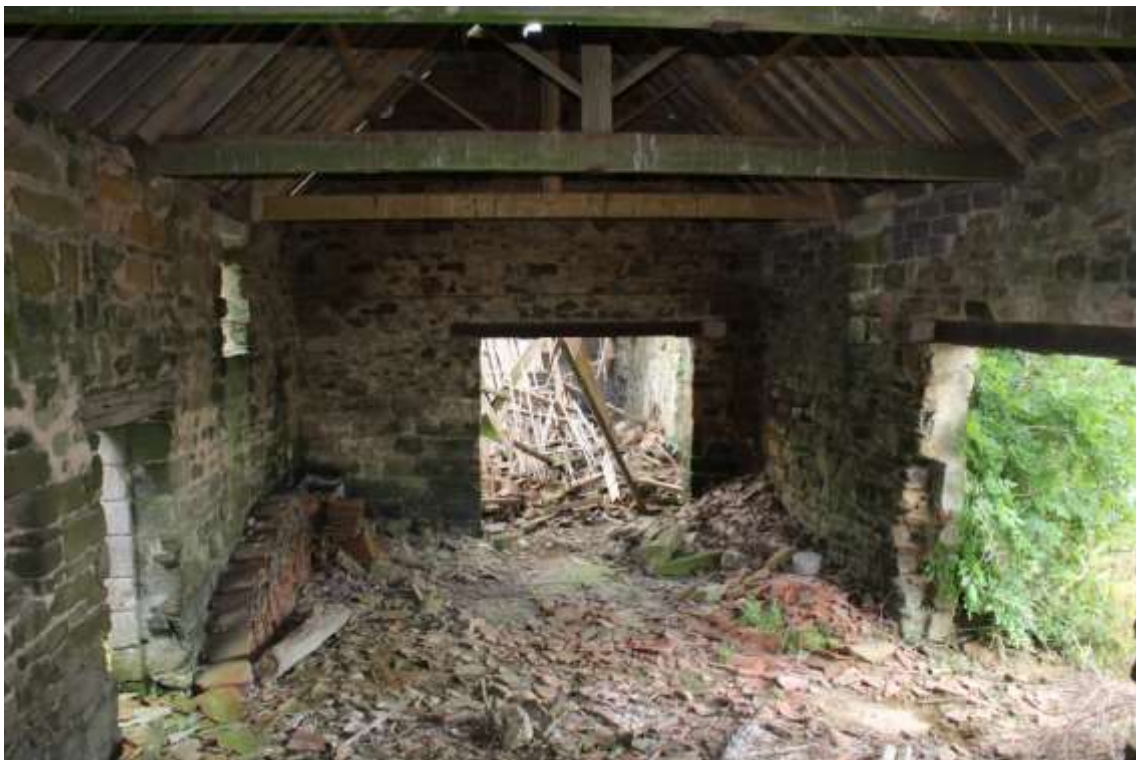
*Plate 142: Internal view E of the third compartment of Building No.4*

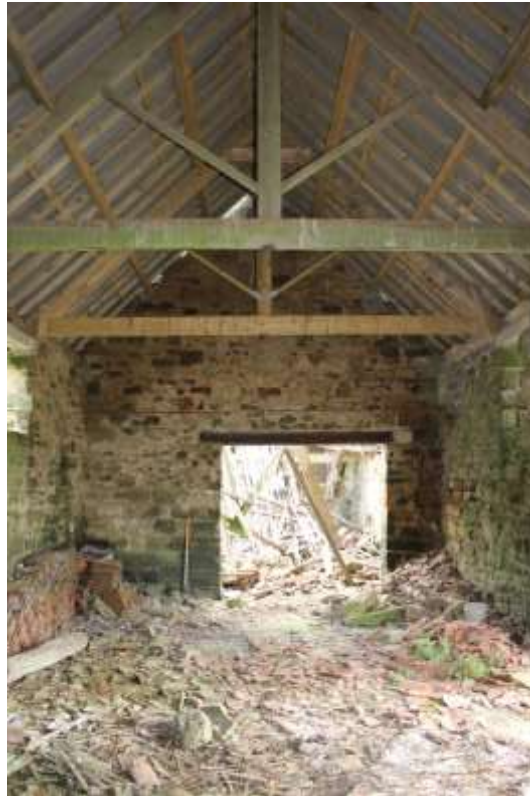
The third compartment (*Plates 142-151*) opens N from the farmyard through a wide cart entrance (*Plate 149*). It is a large open-plan barn with an open roof structure (*Plate 143*). A wide passageway leads into the adjacent E compartment and a short flight of stone steps in the SW corner leads to a door into the compartment to the W (*Plate 148*). A third doorway in the N wall leads to the rear exterior of the barn (*Plate 146*). The room has concrete floors and bare stone walls. The three roof trusses are of a simple king-post construction with angled struts. The room is lit by two pairs of windows in the S and N walls, close to the roofline.

*Plate 143: Internal view E of the third compartment of Building No.4*

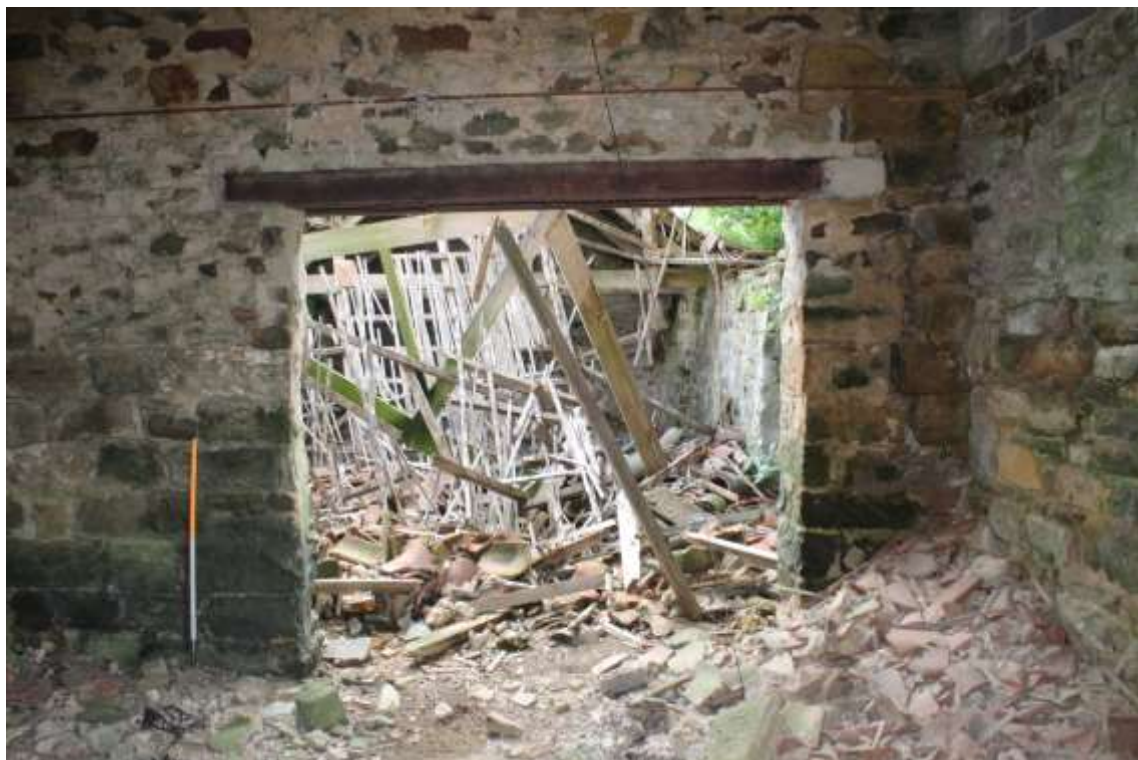
*Plate 144: Internal view E of the third compartment of Building No.4*

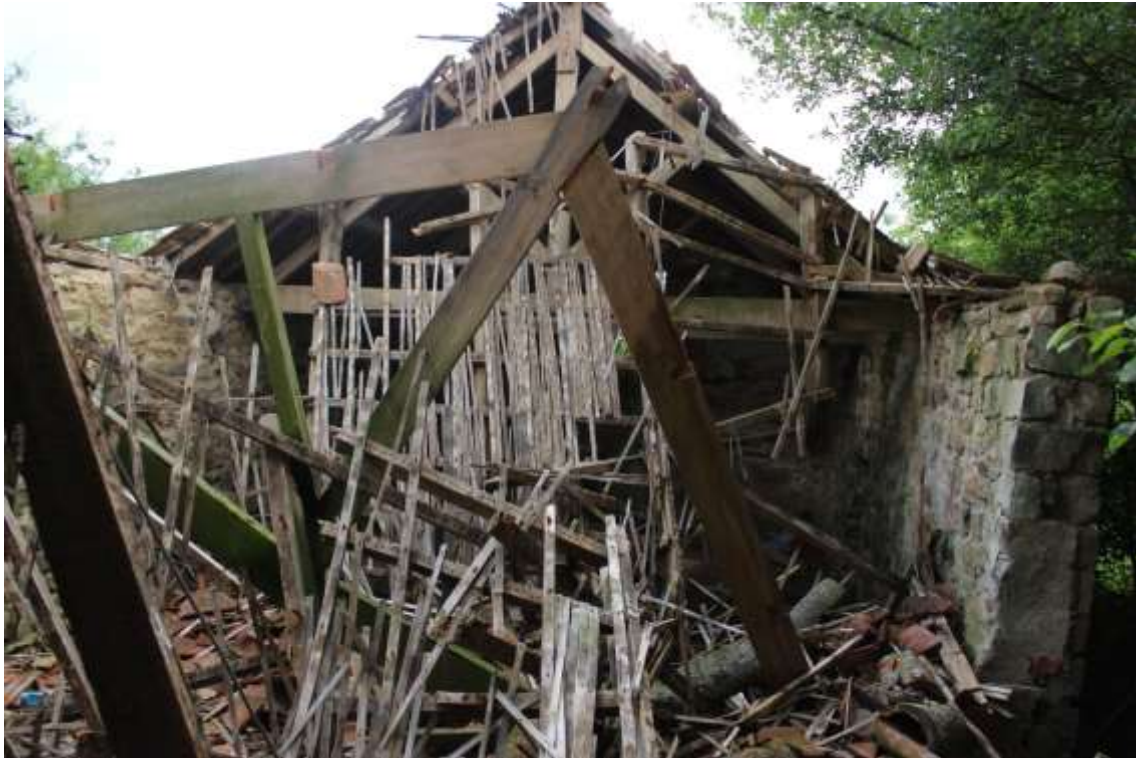
The fourth compartment was inaccessible due to recent roof and wall collapse (*Plate 145*). An earlier photograph supplied by the client shows the compartment to be open plan with a single-light window and two doors in the E wall, which it corroborated by the architects' drawings (*Fig. 9*)

*Plate 145: Internal view E from the third compartment into the fourth compartment of Building No.4*

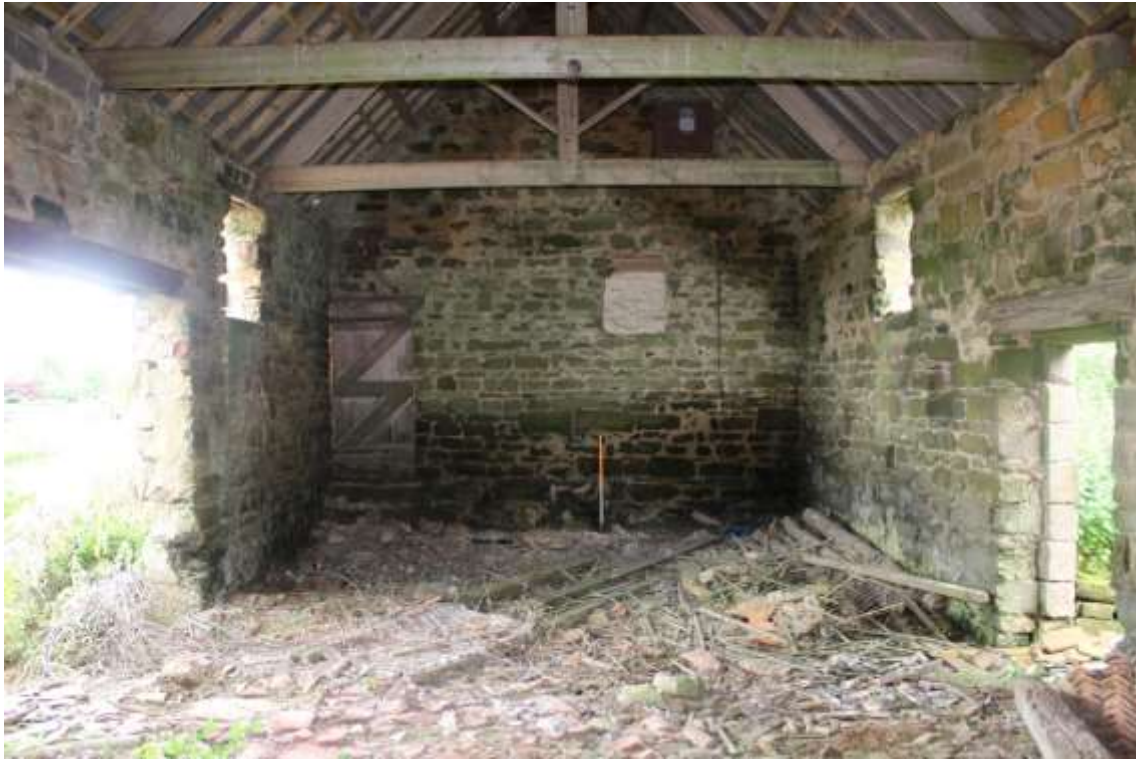
*Plate 147: Internal view W of the third compartment of Building No.4*

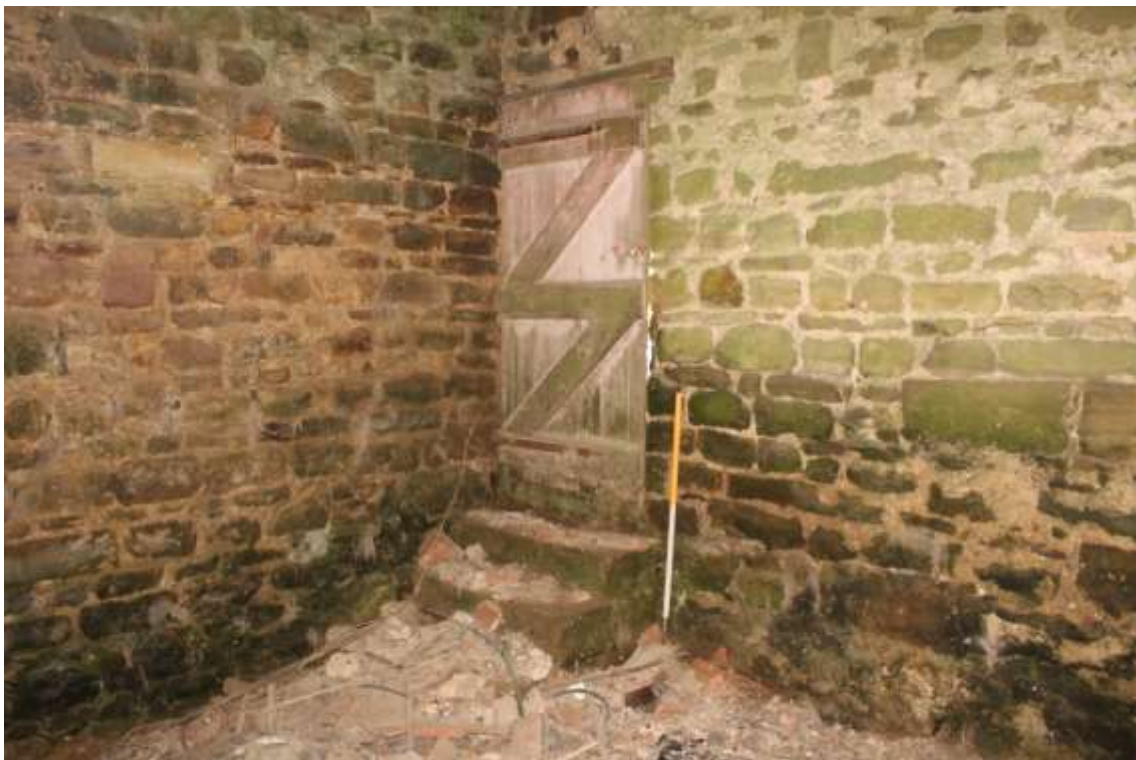
*Plate 148: Internal view SW showing steps and doorway with the third compartment of Building No.4*

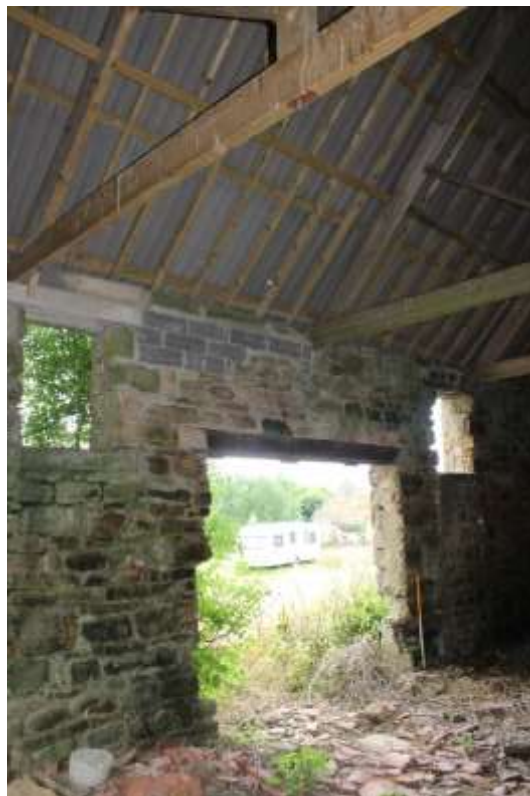
*Plate 150: Internal view SW of the third compartment of Building No.4*

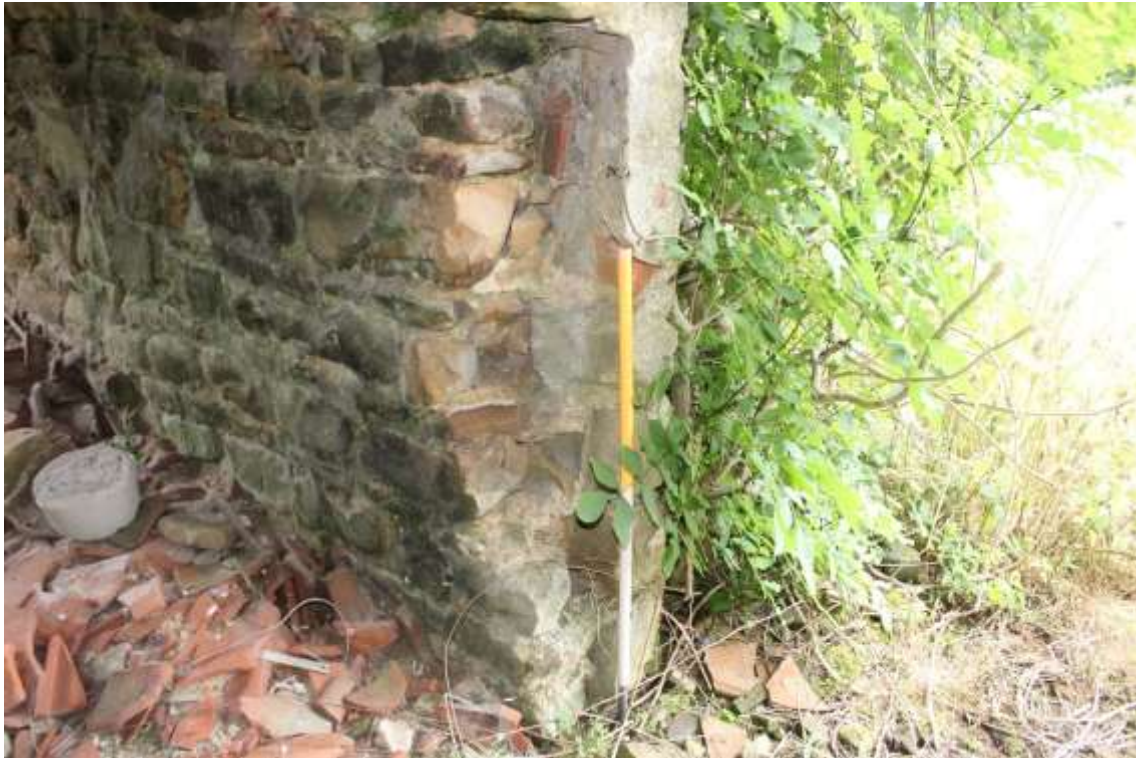
*Plate 151: Internal view SE showing wall construction within the third compartment of Building No.4*
