Old Carriage House,

Mowthorpe Road,

Arboricultural Report

Report reference	1598
Revision	2
Prepared by	James Blades
Approved by	James Stacey
Issue date	18 th November 2021

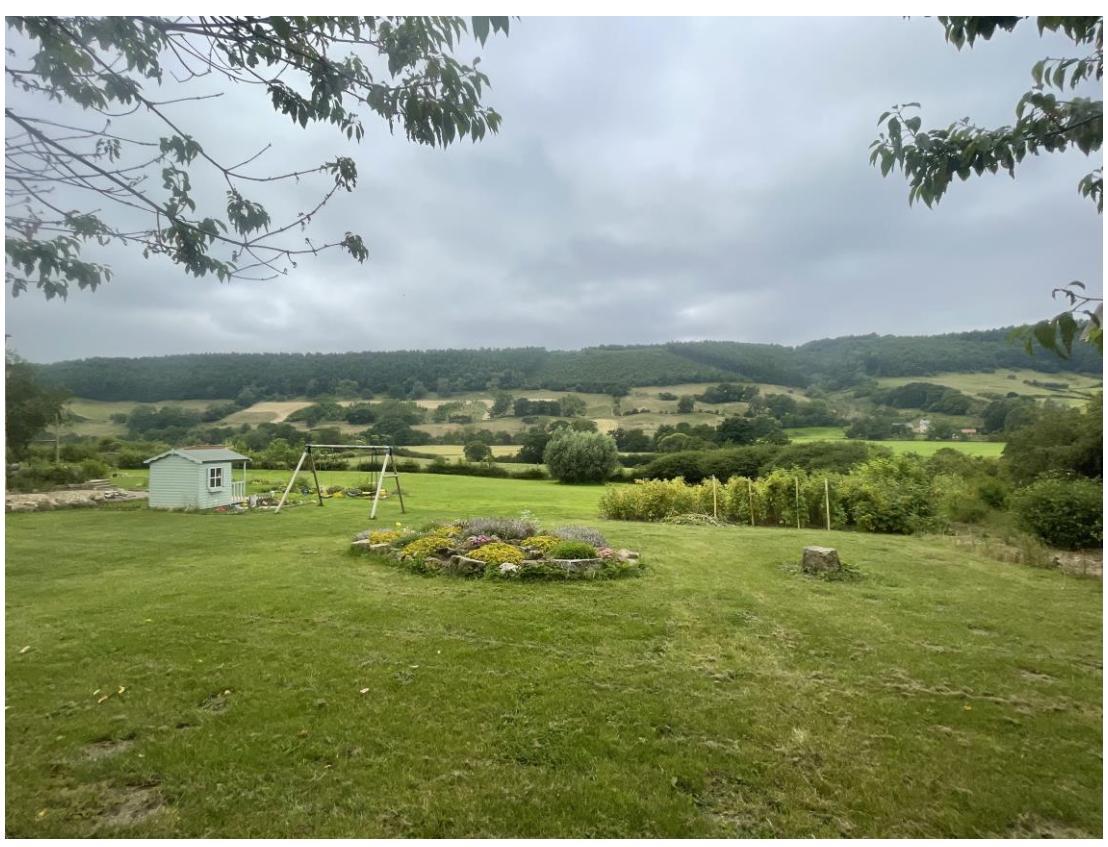
Image 5 – Looking north to G1 along the northern site boundary.

Image 6 – Looking west, a generaly high landscape canopie cover can be seen.
