Proposed Conversion of outbuildings to form  
Garage and Holiday Cottage

Oak Tree House, Egton Bridge, Whitby, North Yorkshire, YO21 1XE

**STRUCTURAL CONDITION SURVEY  
of  
THE OUT BUILDINGS  
AT  
OAK TREE HOUSE  
EGTON BRIDGE  
WHITBY  
YO21 1XE  
prepared on behalf of  
J Money  
Project No P26\_22\_07.01**

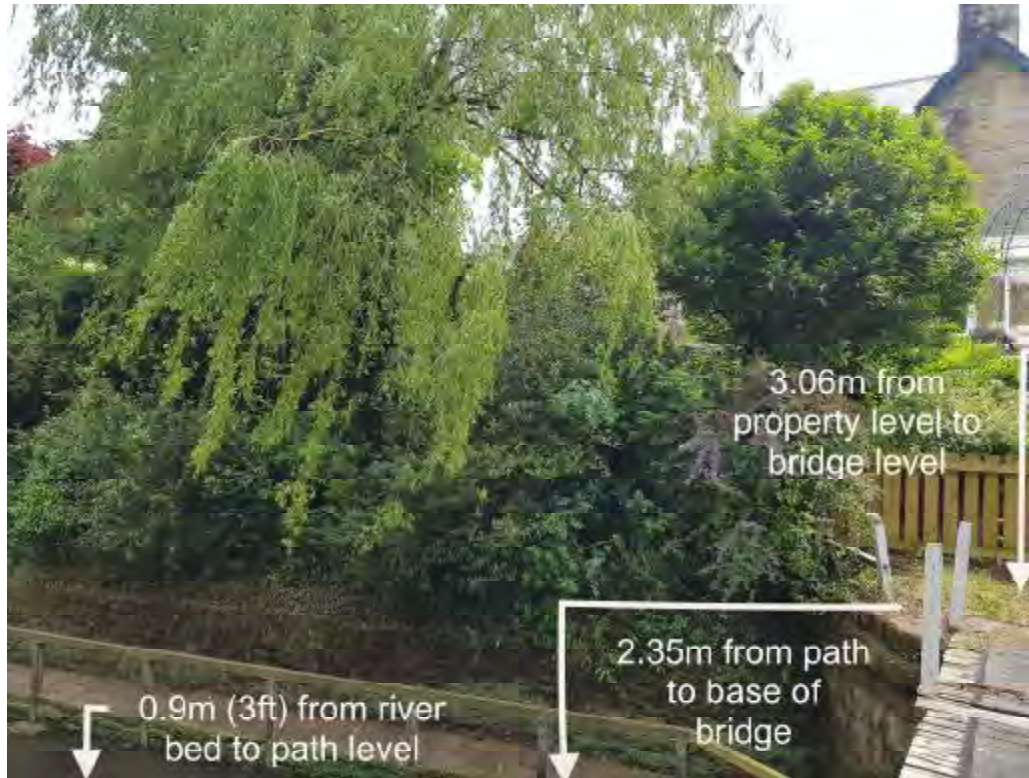
The below image is provided to help illustrate the difference in property level versus the river. The photo is taken of the back of the property, where there is a public pathway that leads to stepping stones across to the other side of the river.

Increased river levels, due to heavy rainfall, will tend to reach as far as the top of the handrail. The distance between the level of Oak Tree House, plus its outbuildings, and the path is roughly 5.41m. This means that a huge (and highly unlikely) increase in river levels would be necessary to reach building levels. Furthermore, the opposite river banks are lower and any flood water would spread out across those banks first.

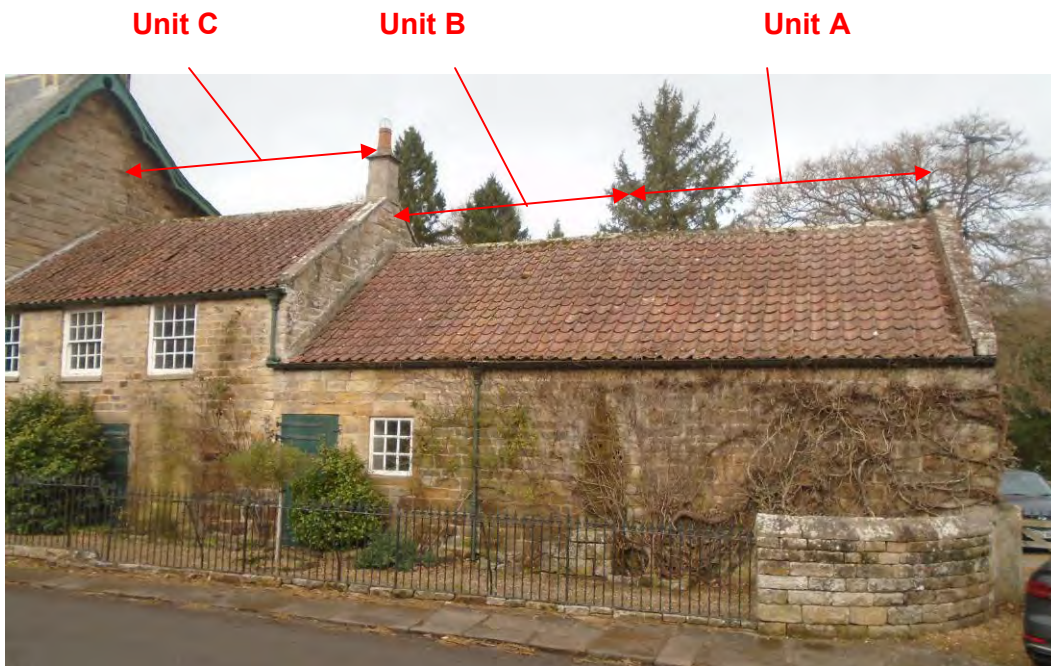
**Plate 1**

2.1.2 Unit A (refer to Plate 1) is constructed as follows:

- a. A dual pitched roof that spans between the front and rear elevations
- b. The roof is covered with tiles (refer to Plate 1)
- c. The roof is formed with a primary timber king post truss at the approximate mid length of the roof (refer to Plate 2). The bottom chord of the truss spans between the front and rear elevation

2.1.3 Unit B (refer to Plate 1) is constructed as follows:

- 2.1.4 Here Unit C (refer to Plate 1) is constructed as follows:
- a. A dual pitched roof that spans between the front and rear elevation
  - b. The roof is covered with tiles (refer to Plate 1)

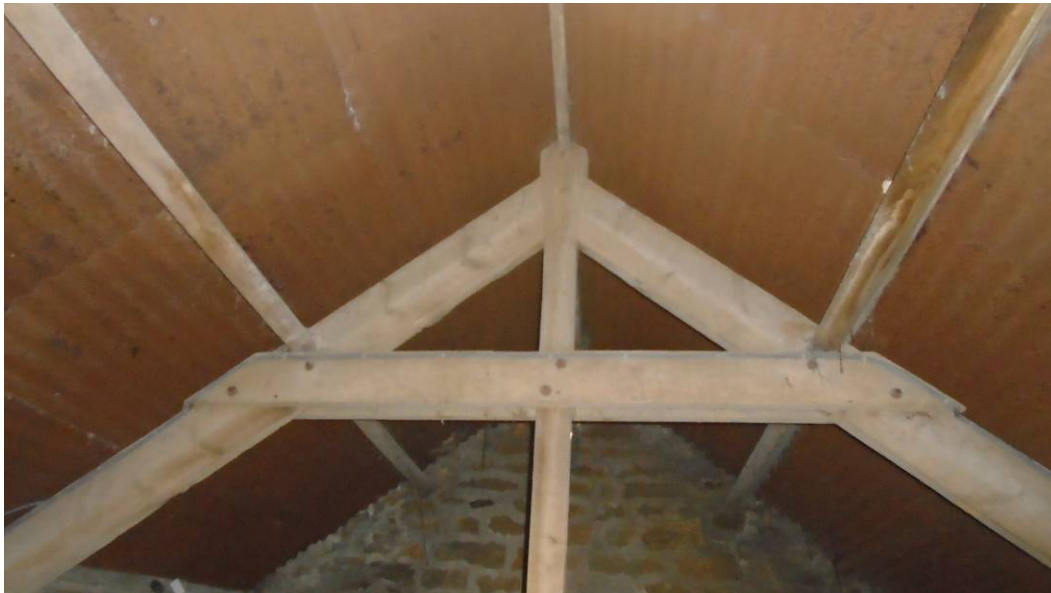
**Plate 2**

- d. The truss supports timber purlins and a ridge board (refer to Plate 2) that span between the eastern gable end and the party wall that separates unit B

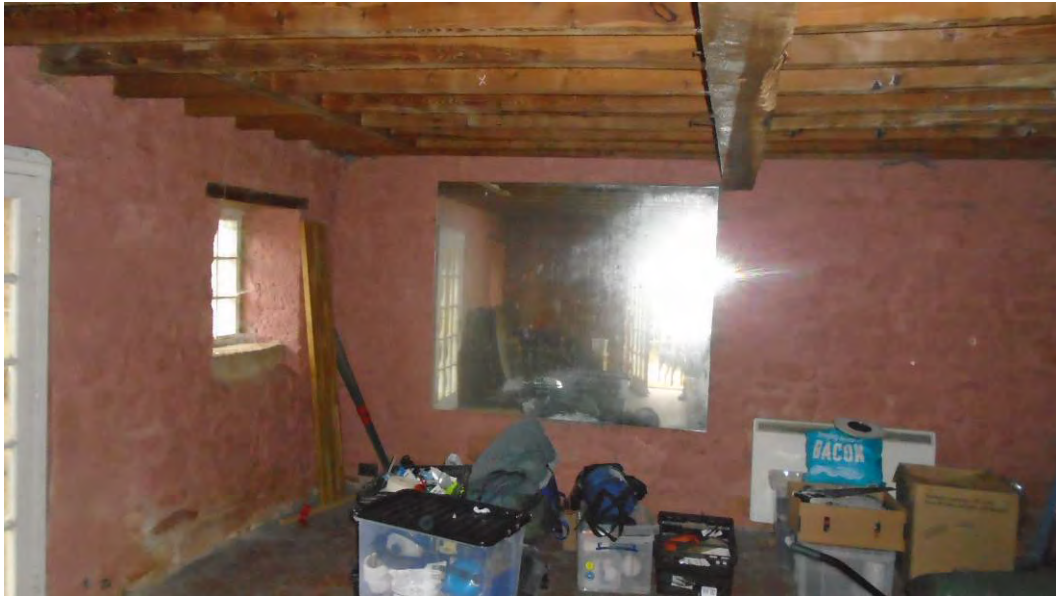
Plate 3

- e. The purlins support corrugated sheeting and above this are the tiles
- f. The first floor is formed from timber joists that span in an east to west direction and also bear onto a timber beam at mid way between the east and western walls of the unit. The timber beam spans between the northern and southern elevation (refer to Plate 3). Access above the floor is limited

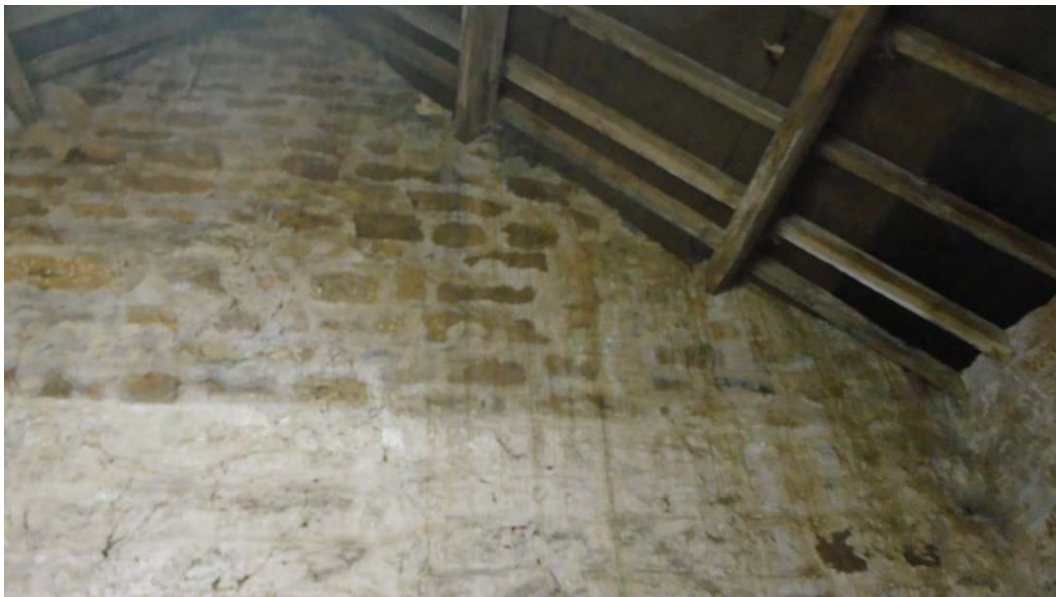
Plate 4

- d. The trusses support timber purlins
  - e. The purlins support timber rafters (refer to Plate 4) and above this are the tiles. A number of the rafters have a horizontal tie beam at the approximate same height as the bottom boom noted in item c above (refer to Plate 7)

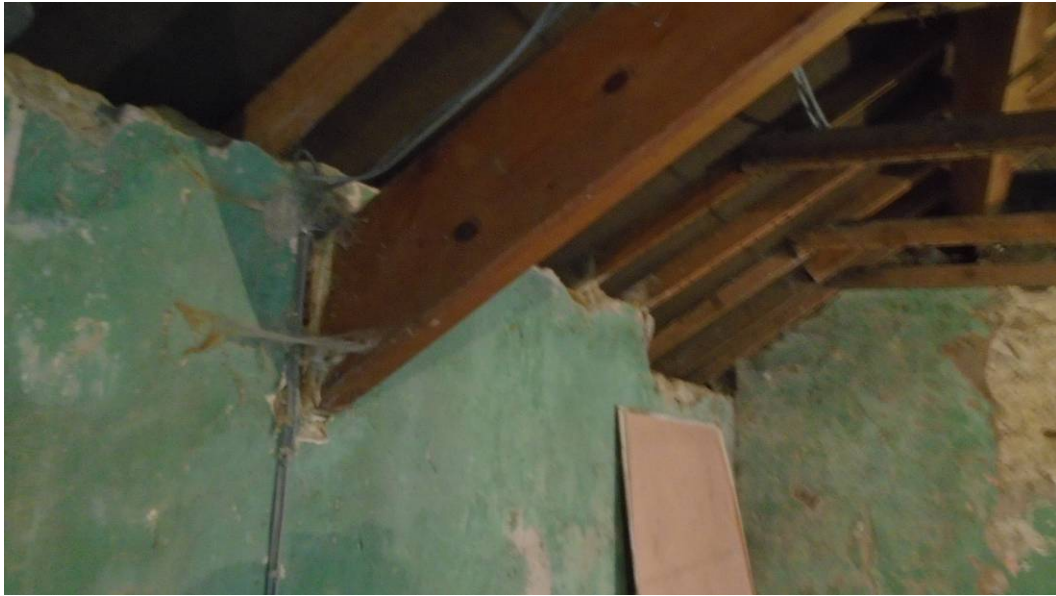
**Plate 5**

- c. The roof is formed with a number of primary raised bottom boom timber trusses, at regular centres, between the east and west elevations. The rafters of the trusses are supported on the external walls (refer to Plate 5) between the front and rear elevations. One of the trusses has had a make-shift repair on a masonry pillar, that has been added to the front elevation (refer to Plate 6)

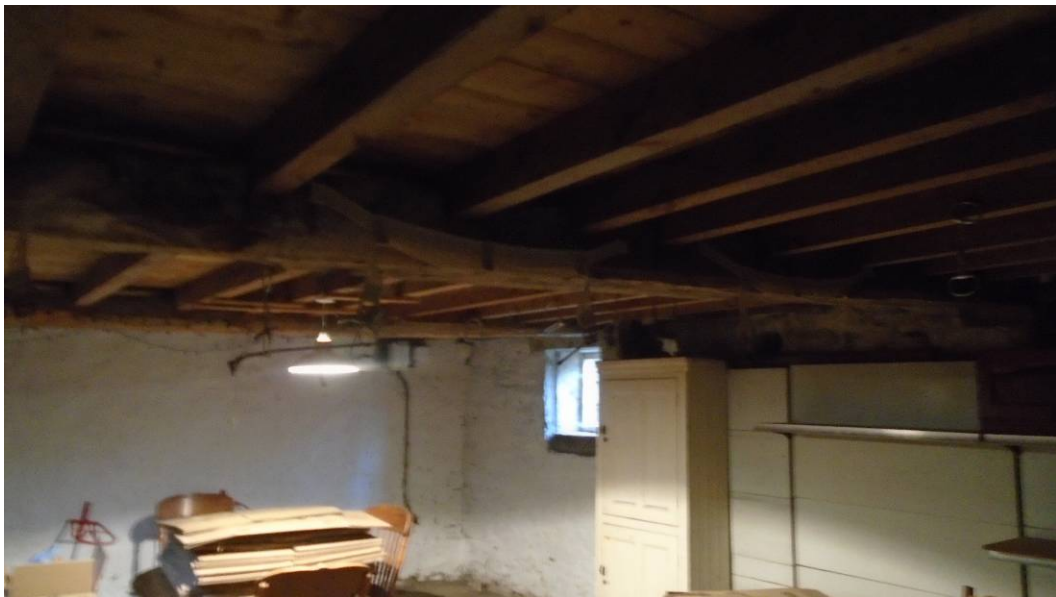
**Plate 8**

- f. The first floor is formed from timber joists that span in an east to west direction and also bear onto two timber beams. The timber beams span between the northern and southern elevation (refer to Plate 8)

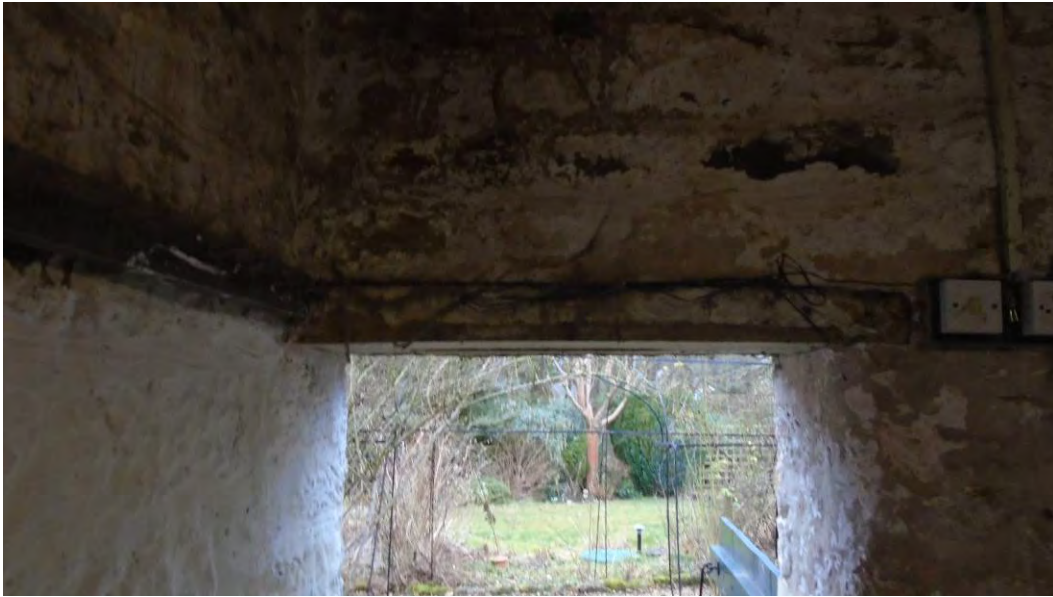
**Plate 21**

- c. A high level of wood worm has affected the timber lintel on the inner face of the door opening on the northern elevation (refer to Plate 21). Consideration should be given to replacing this lintel with a suitably sized element

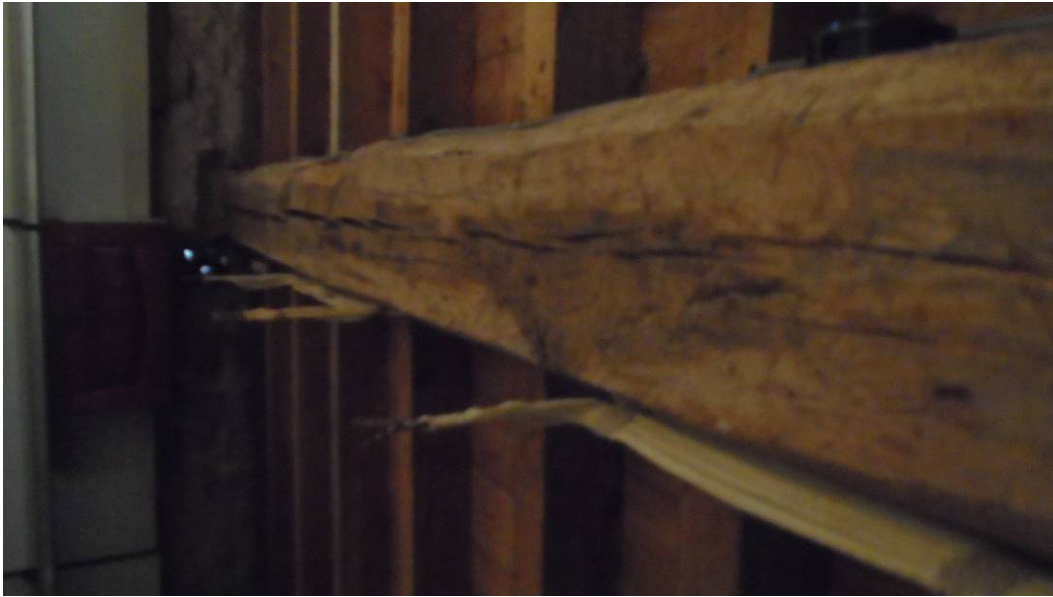
**Plate 25**

- a. The timber first floor, when trafficked, deflected to a significant degree. In addition to this a number of shakes existed in the primary timber beams (refer to Plate 25). Consideration should be given to strengthening the floor in a format to retain the character of this unit

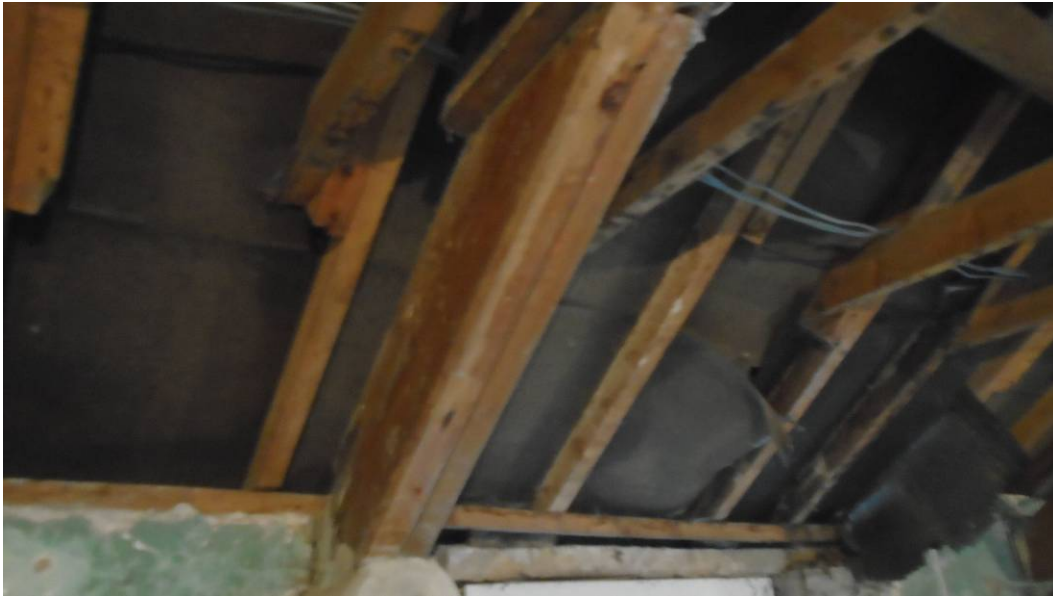
**Plate 27**

- b. The trusses at first floor level will need to be assessed for their load carrying capacity. The truss at the eastern end of the unit is supported on a pillar (refer to Plate 26). The pillar appears to have been introduced to support the rafter at this end of the truss, where it has decayed (refer to Plate 27), possibly from a leak in the fabric of the building. In addition to this the lintel above the window, near this area has been removed and the rafters are bearing on a deflected wall plate (refer to Plate 28). Furthermore, the timber floor has decayed locally (refer to Plate 29) and the pillar, that supports the truss has been poorly constructed and may not have a foundation. This area will need an overview from a structural perspective to strengthen the defective areas

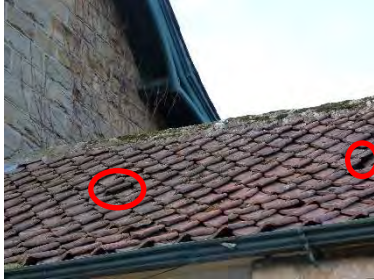
<p>Photo 4: Gaps between roof tiles, southern aspect</p>

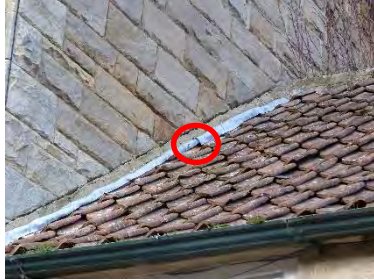
<p>Photo 5: Gap in flashing, southern aspect</p>	<p>Identified in external masonry gaps and crevices, and internally between roof lining and roof, along wall tops, in masonry crevices and in the chimney.</p> <p>Access and further roosting habitat under lifted roof tiles.</p>

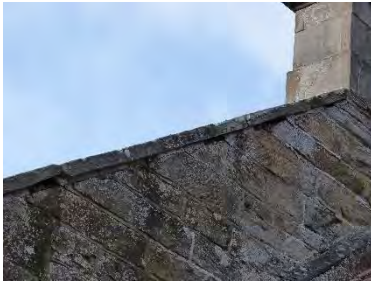
<p>Photo 6: Gaps in gable end wall top, southern aspect</p>

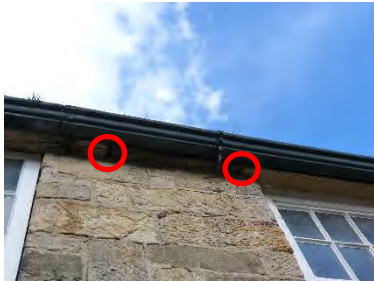
<p>Photo 7: Gaps along wall top</p>

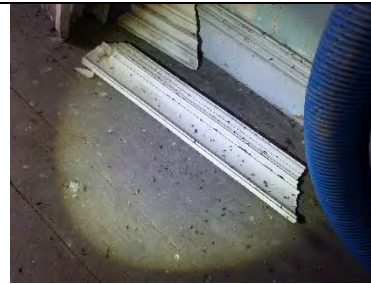
Photo 10: First floor, bat droppings

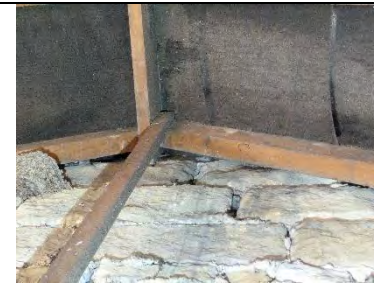
Barn swallow nests were identified in roof timbers (Photo 11).

Photo 11: First floor, gaps above bat droppings

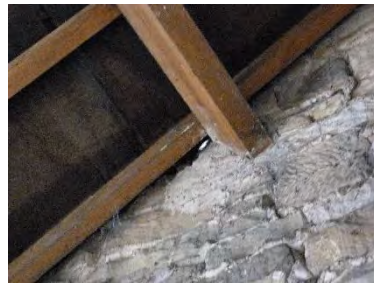
Photo 12: First floor, potential access in above bat droppings through flashing seen in Photo 5

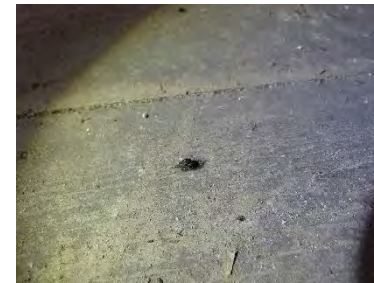
(Photo 14), were found across the first floor as well as feeding remains (Photo 16). The ground floor offered little PBRH, however droppings were seen on a chair (Photo 18).

Photo 14: First floor, fresh bat droppings

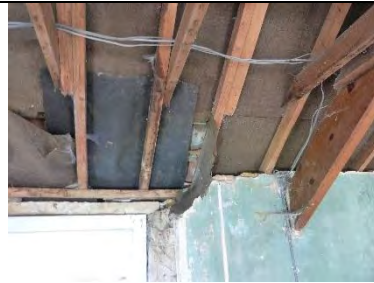
**Photo 15: First floor, tares in roof lining**

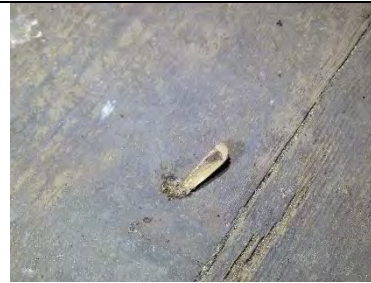
**Photo 16: bat feeding remains**

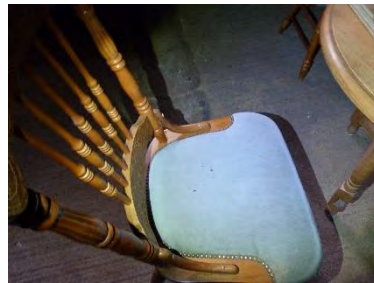
**Photo 18: Ground floor, chair with bat droppings on**

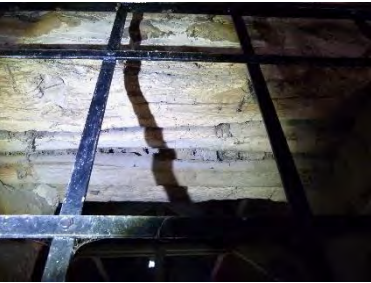
<p><b>Photo 27: Gaps in lintel</b></p>	<p>Gaps in lintel above wooden ladder.</p> <p>Between roof lining and roof, and along wall tops and crevices.</p>

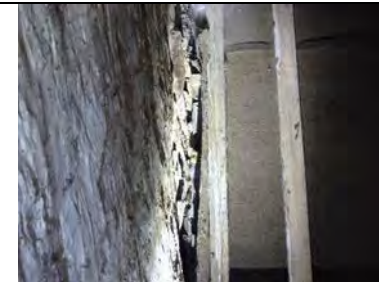
Photo 30: Gaps between roof and gable end

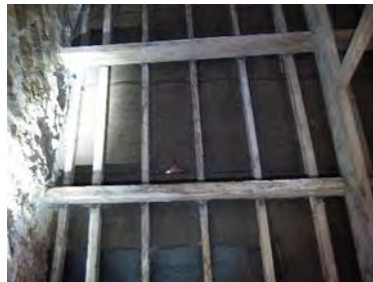
Photo 31: Gap in roof/lining

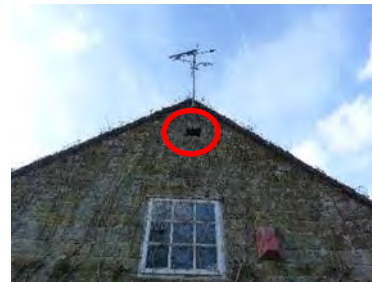
Photo 32: Hole in gable end masonry
