Bat, Breeding Bird and Barn Owl Scoping Survey
Mill Inn, Harwood Dale

February 2023

Mill Inn
Harwood Dale
Scarborough
YO13 0LA

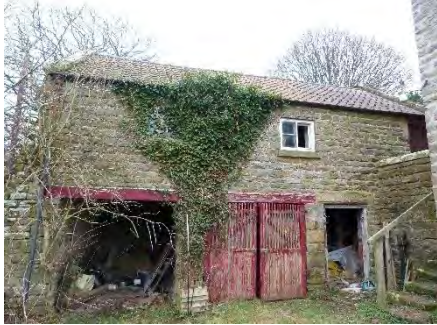
<p>Two storey stone-built building with lined clay pantile roof. An adjoining toilet block on the eastern aspect.</p> <p>Some external masonry crevices, particularly under a window ledge (Photo 2).</p> <p>Roof has some lifted tiles – the roof of the toilet block is in poor condition and part has degraded.</p> <p>Internally, the liner is torn in places but is in relatively good condition. the ridge is generally cobweb-free. There are so gaps along gable end wall tops.</p> <p>Accumulated bat droppings were identified under the ridge in the centre of</p>	<p>Masonry crevices (internal and external).</p> <p>Wall top gaps.</p> <p>Between roof tiles and liner.</p>

<p>Photo 1. Southern aspect</p>	<p>Photo 2. Masonry crevices under window ledge on southern aspect</p>	<p>Photo 3. Toilet block on eastern aspect – roof degraded</p>
