Planning Statement

Property: Prospect House Farm, Suffield, Scarborough, YO13 0BH

Proposal: Conversion and Change of Use of Agricultural Outbuildings into Holiday Letting Accommodation

Structural Condition Report

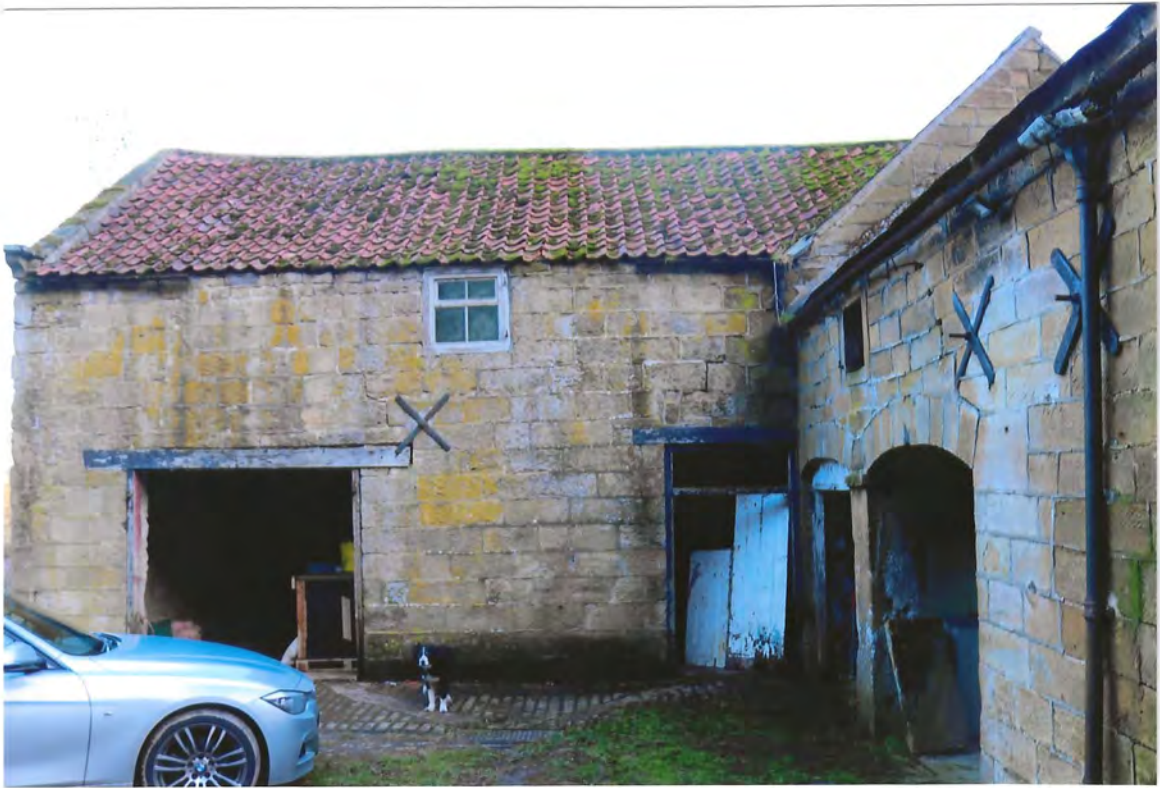
7. UNIT 3, - INNER COURTYARD

Noted that sections of the roof in Unit 3 have previously collapsed.

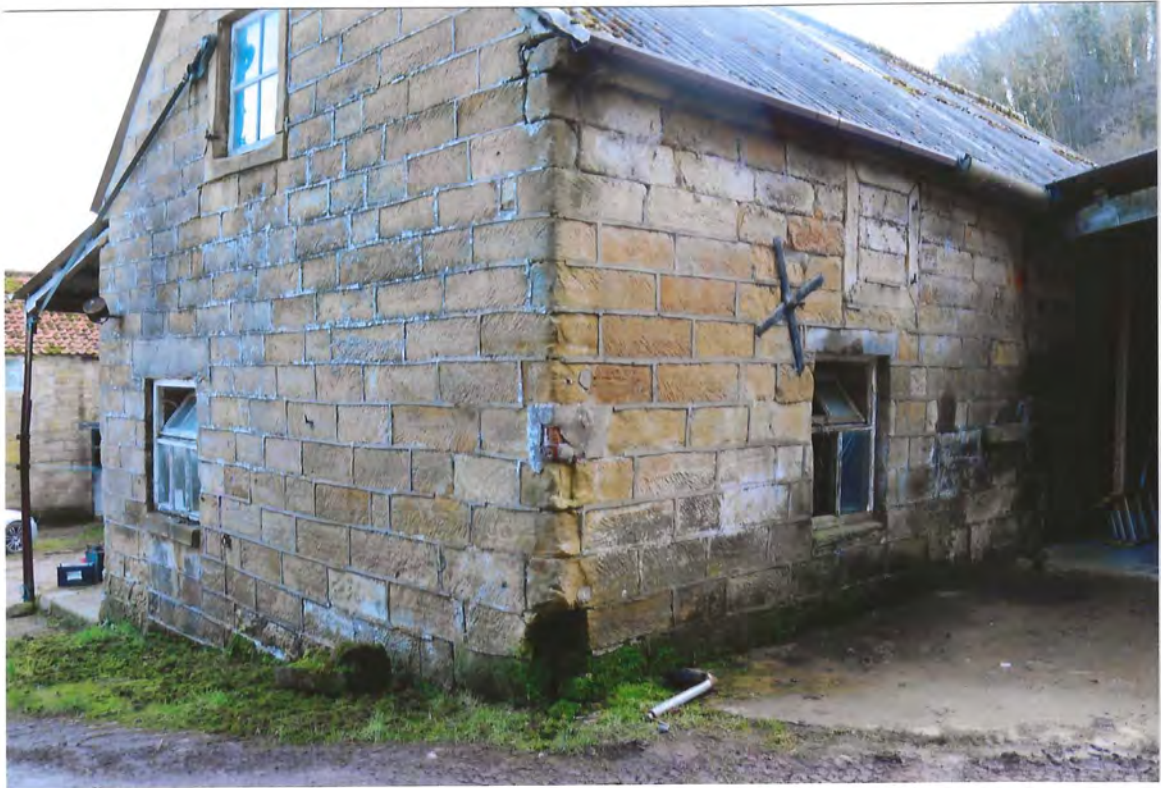
9. GABUE, REAR WALLS TO UNIT 1.

- (viii) The north west external corner of Unit 1 has suffered localised low level vehicle impact damage in the past.
- (ix) Two cross walls in Unit 2 are constructed in 100mm thick brick and appear, subject to further cleaning down for better inspection, to be in a questionable condition. Again, these cross walls appear to be not tied or bonded to abutting external walls.
