Proposed:
REPLACEMENT WINDOWS
at
YORK HOUSE, KING STREET
ROBIN HOODS BAY

Drawing:
EXISTING
WINDOW SCHEDULE W1.

Drawing No. 423/05 A
Date: AUGUST 2023
Scale: 1/20 Print at A3

Drawing:
EXISTING
WINDOW SCHEDULE W2.

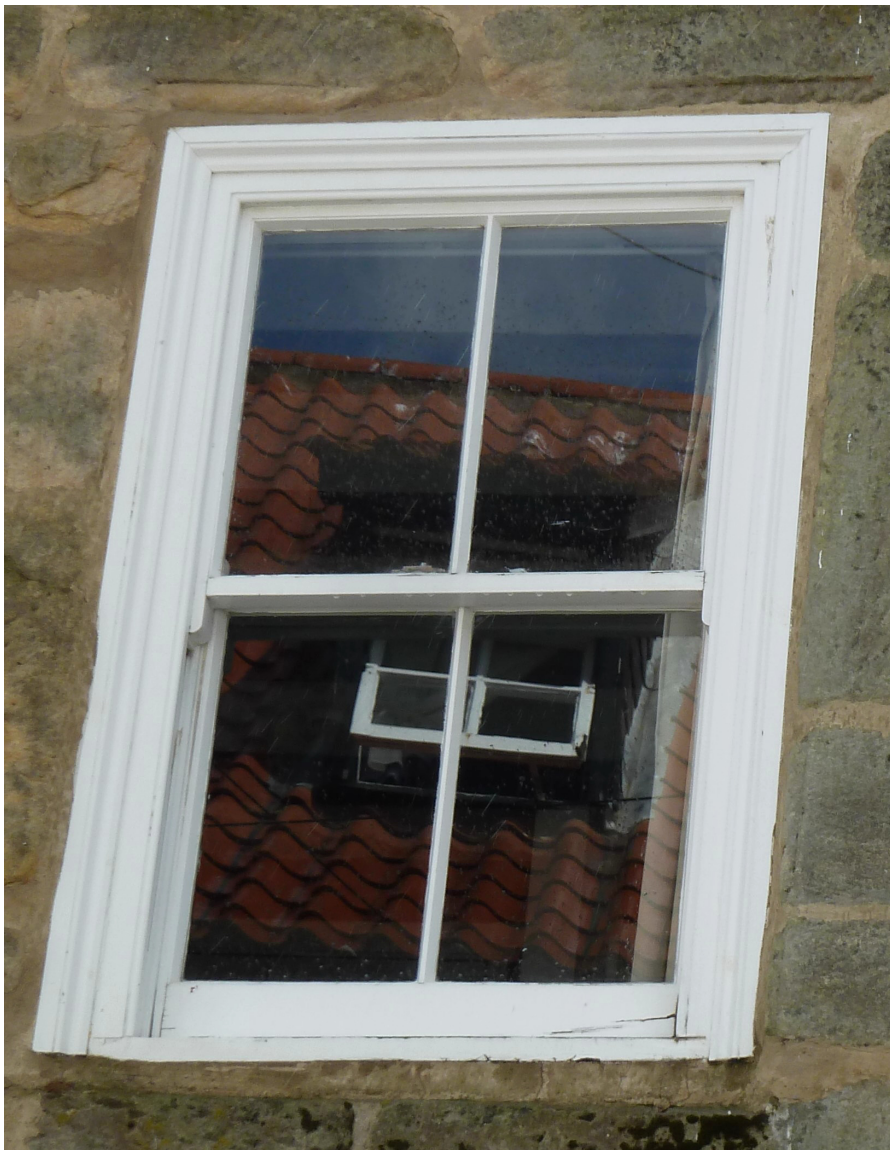
W1

Main visible defects:
Sill, bottom rail and meeting rail rotted.
Staining to rhs upper sash jamb.

FIRST FLOOR LEVEL BEDROOM (LHS Viewed Externally).

Cracked paint and surface mould indicates general state of decay throughout the frame components internally & externally. Details of the sash and meeting rails as for W2.

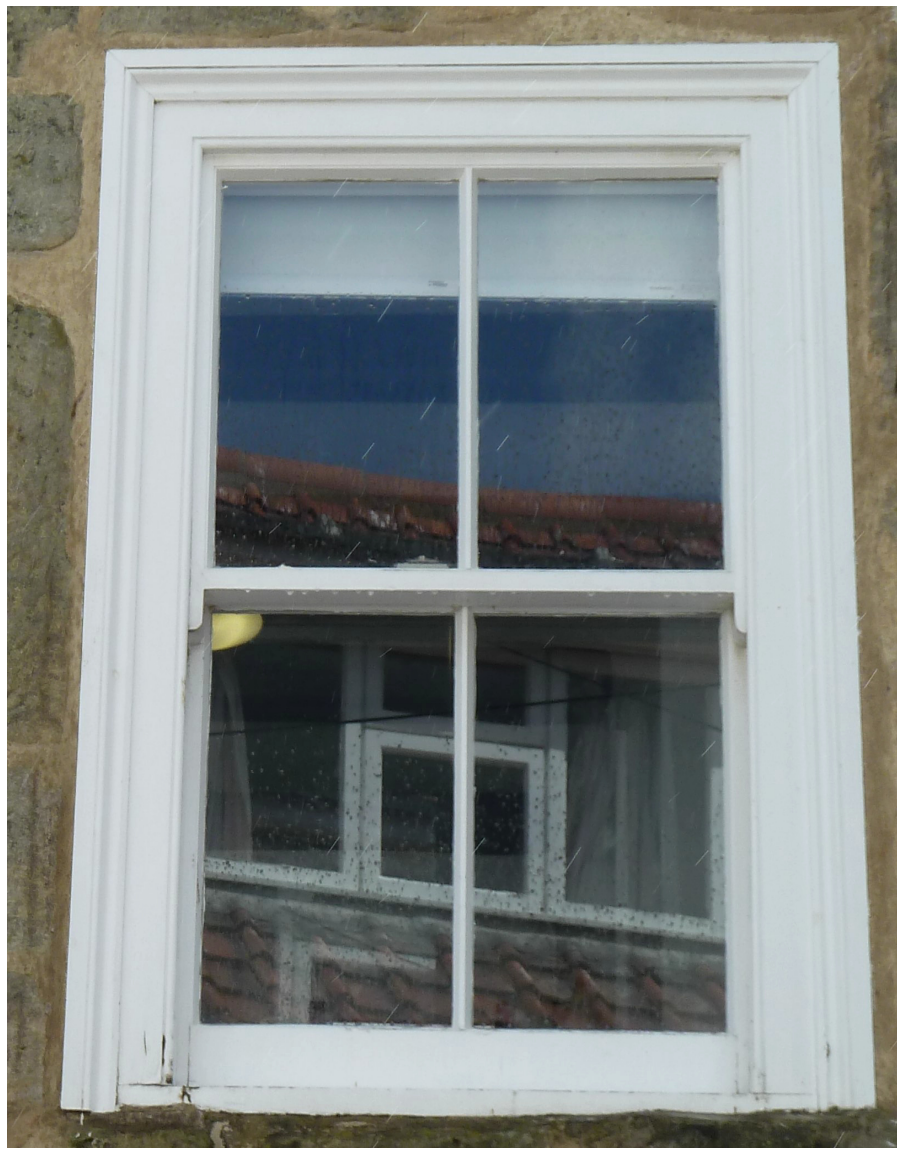
W2

FIRST FLOOR LEVEL BATHROOM. (RHS Viewed Externally).

Cracked paint and surface mould indicates general state of decay. Details at sash horn non-vernacular particularly composite planted sections to sash cord channel. These details also apply to W1.
