Structural Report

Barn

Beacon Hill Farm

STRUCTURAL REPORT ON BARN AT BEACON HILL FARM, RAW WHITBY YO22 4PP

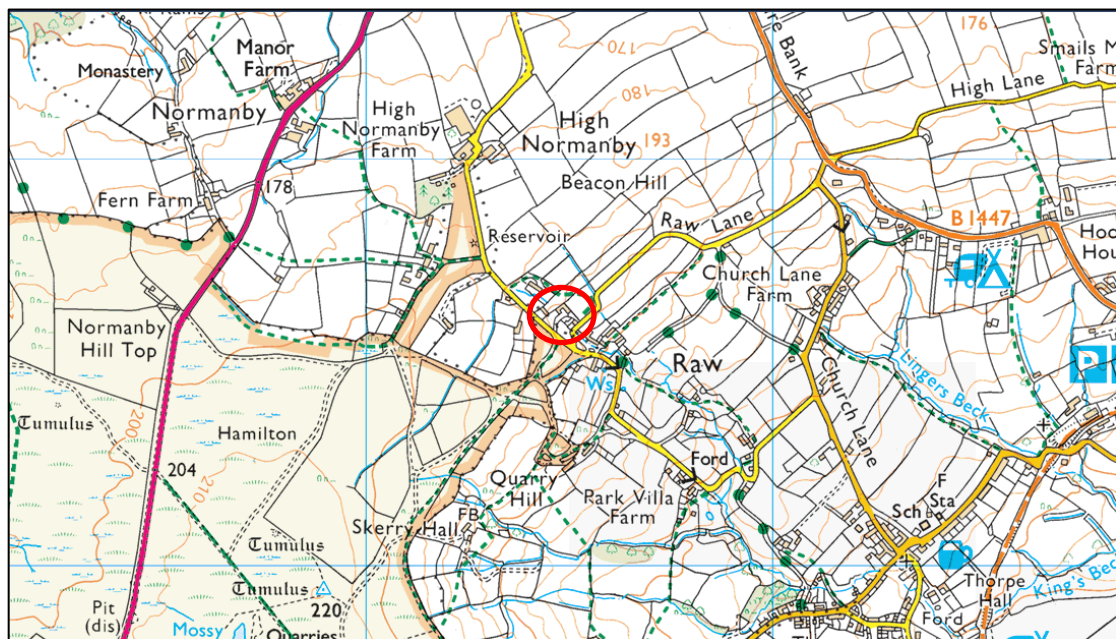
Figure 1: Site location.

The site is located in Raw, Whitby (Central grid reference: NZ93480560). The location of the site is shown on Figure 1 below.

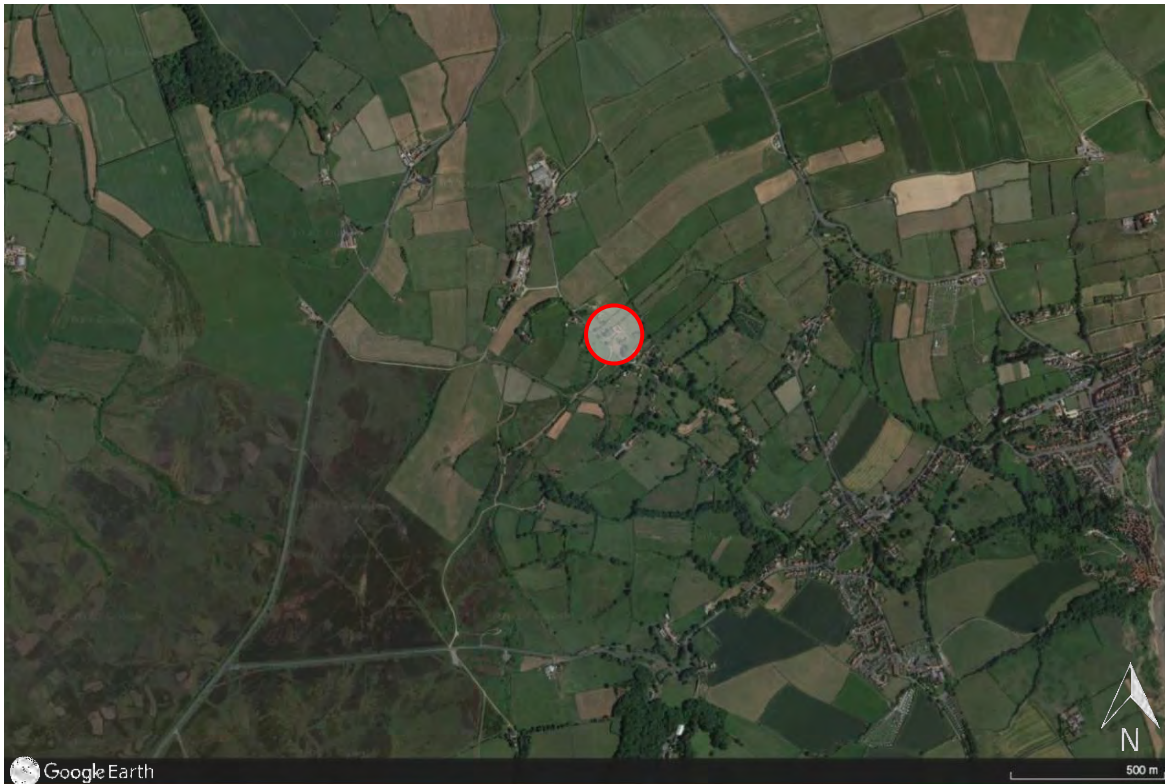
Figure 2. Aerial view of the surrounding landscape. Google Earth 2023.

The area surrounding the site comprises mainly of agricultural fields, with strip woodland and hedgerow lining fields in the immediate surroundings. Some further areas of woodland are located to the south of the site, specifically surrounding Thorpe Beck and Raw Beck, as well as to the northeast surrounding Mitten Hill Beck. Further afield, to the north are agricultural fields with little hedgerow or woodland and to the east is an area of moorland. Overall, this site provides some areas of optimal foraging and commuting habitat through the areas of woodland and waterways, though this is not as well reflected in the wider area.
