3.0 HISTORY OF CLIFF HOUSE

Mason Clark Associates (MCA) was commissioned by Shaw & Jagger Architects, on behalf of the property owner, to provide an initial structural opinion relating to the proposal to construct a two-storey extension at the rear (east elevation) of the property.

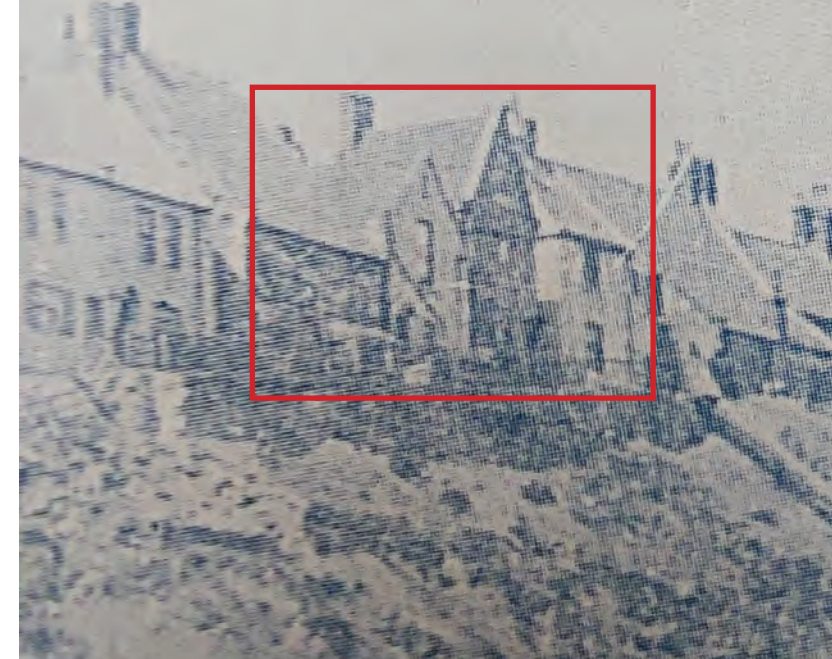
Image showing the house next door before being demolished and rear extension to Cliff House in 1891

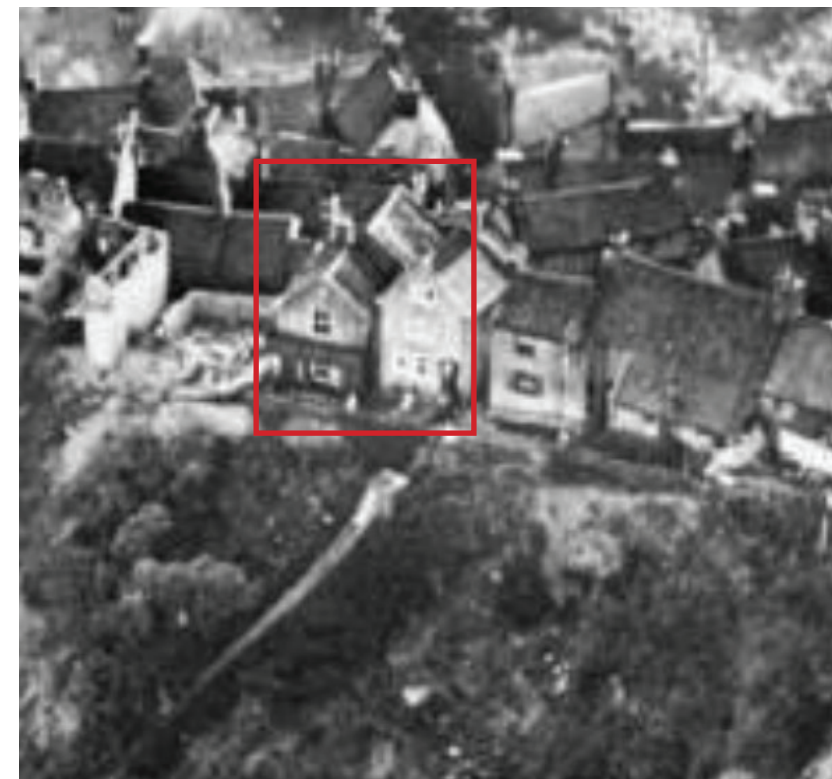
Image showing the loss of the adjoining house and rear extension to Cliff House

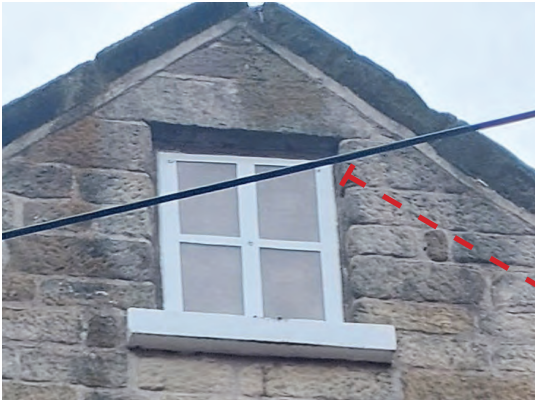
Blocked window to the front

- Finally, within the roof there are two blocked Windows which would be interesting to know how they were blocked up and if the blocking up has caused problems the roof would reinstated in the 1990s but it has been built in a way that is not breathable and so the roof space is sweating it would benefit ventilation or upgrading.

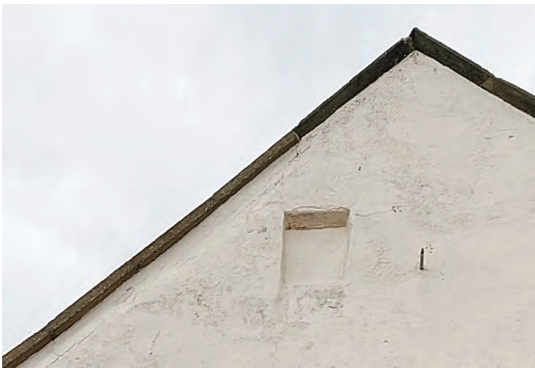
Blocked window to the rear

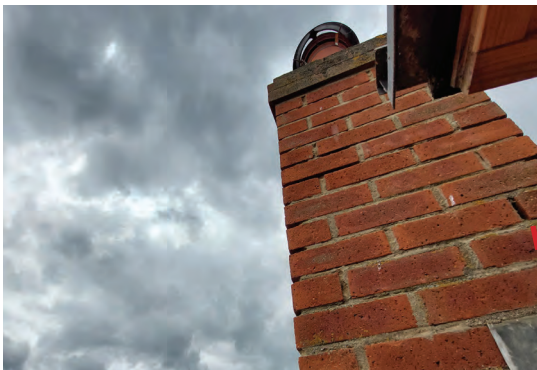
Modern chimney (a rebuild)

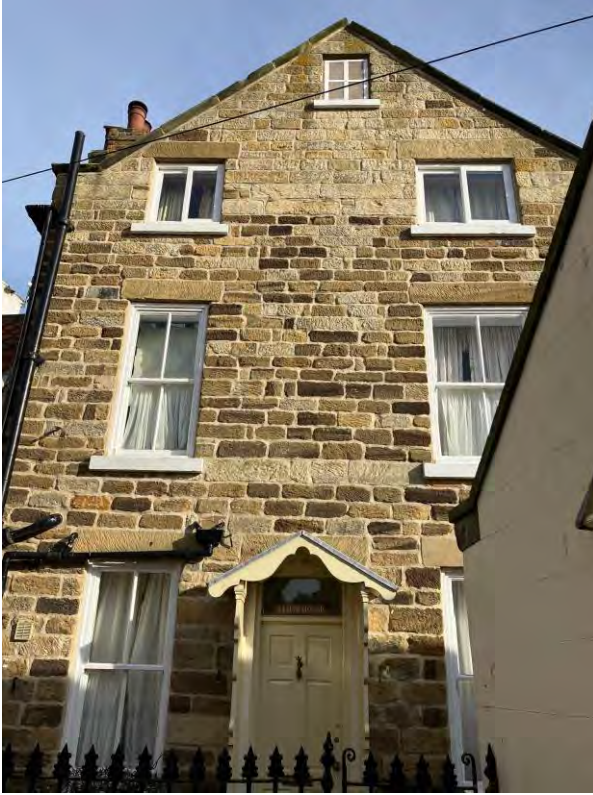
Photo 1. Western elevation of Cliff House – view looking east.

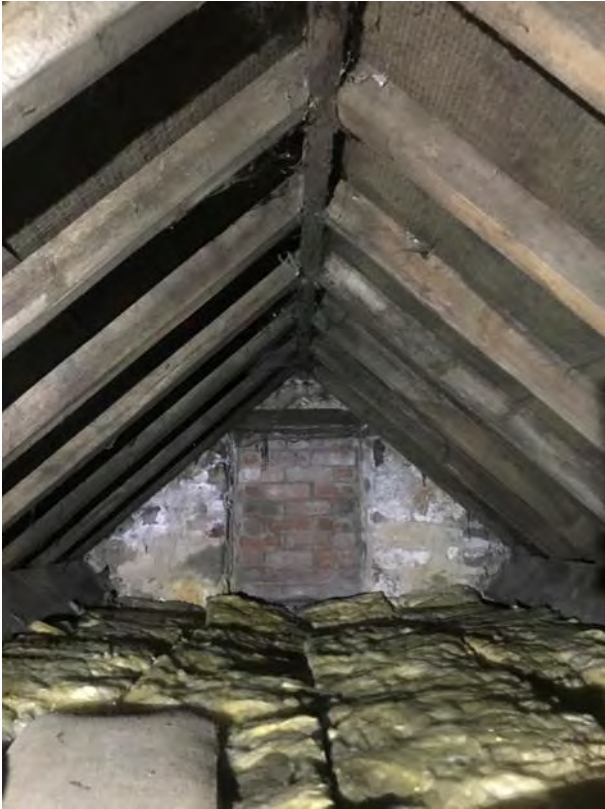
- 3.2.2.1 No direct evidence (i.e., bat droppings, staining) to indicate bat roosting activity was recorded on the external elevations or within the interior of the property (including the enclosed loft space) during the daytime inspection.

Photo 3. Cliff house internal loft space – view to western elevation.

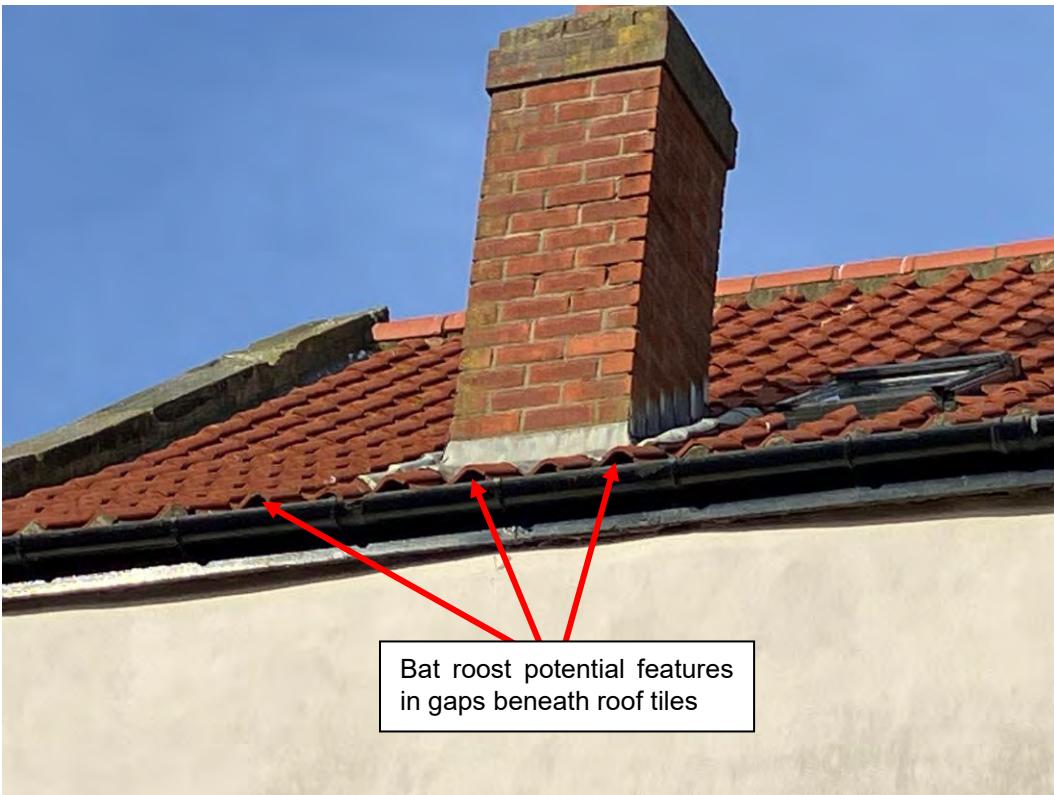
Photo 4. View of southern roof elevation.

4.2.1.1 In order to ensure legal compliance and in accordance with current guidelines⁴, prior to any work affecting the roof, eaves, flashing or masonry gaps on the main building at the site (Cliff House), it is recommended that a minimum of 1x dusk emergence or dawn return bat survey should be undertaken during the optimal survey period of 1st May to 31st August inclusive.

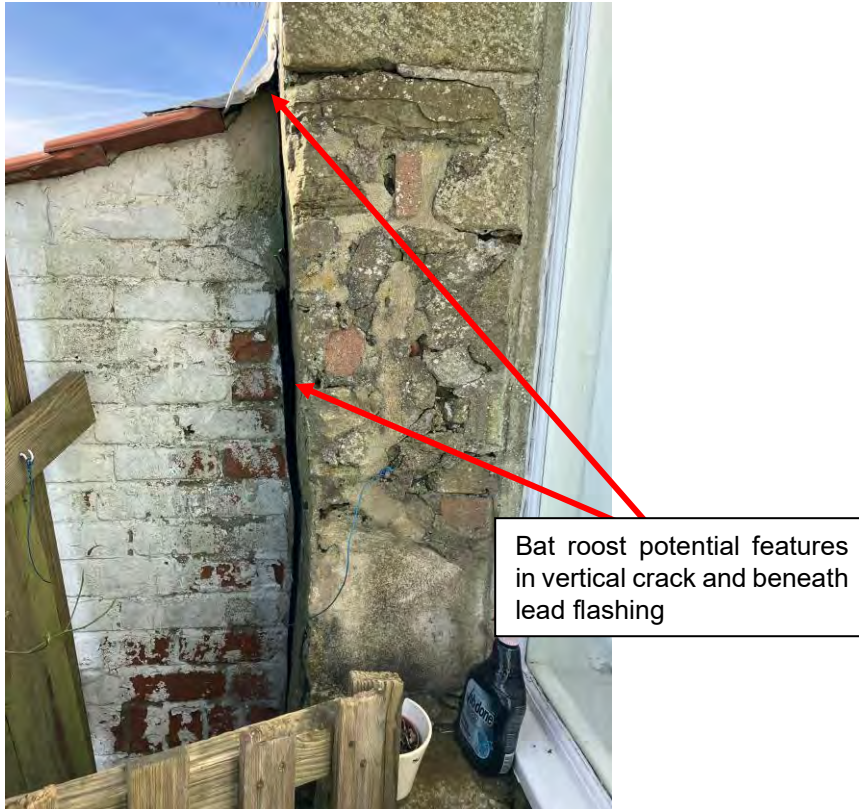
Photo 5. View of southern building extension adjoined to main building – view west.

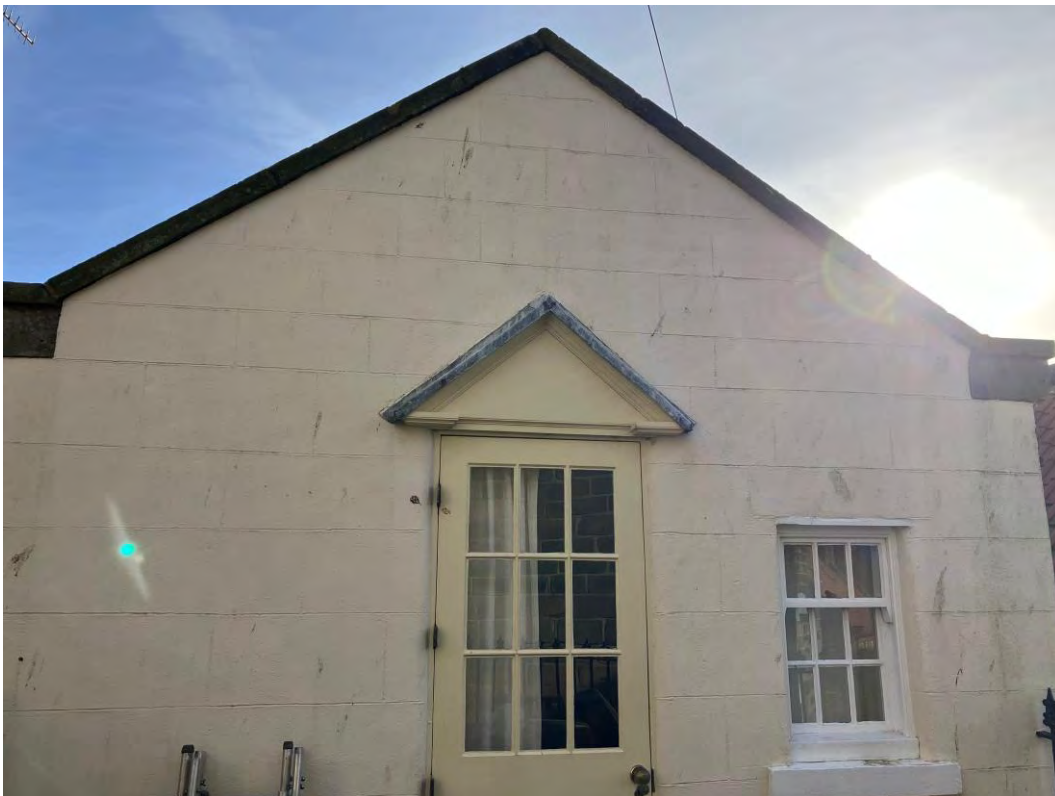
Photo 8. Northwest elevation of Annex building – view south.

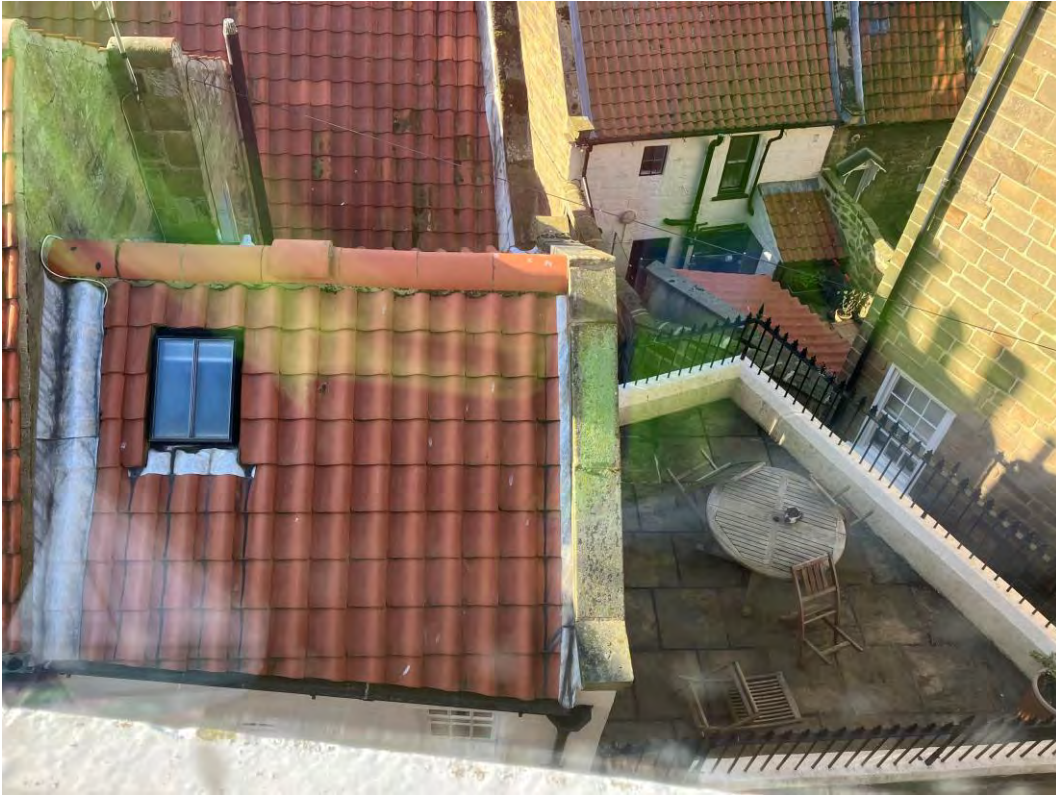
Photo 9. View of northeast roof elevation of Annex building.

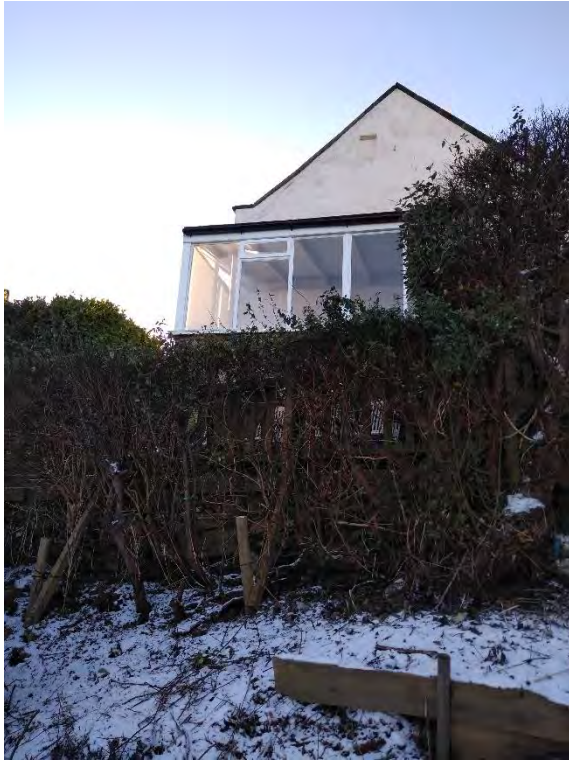
05 View from top of the coastal slope. Vegetation screening to lower patio. Ad hoc supports stabilising surface of the bank.

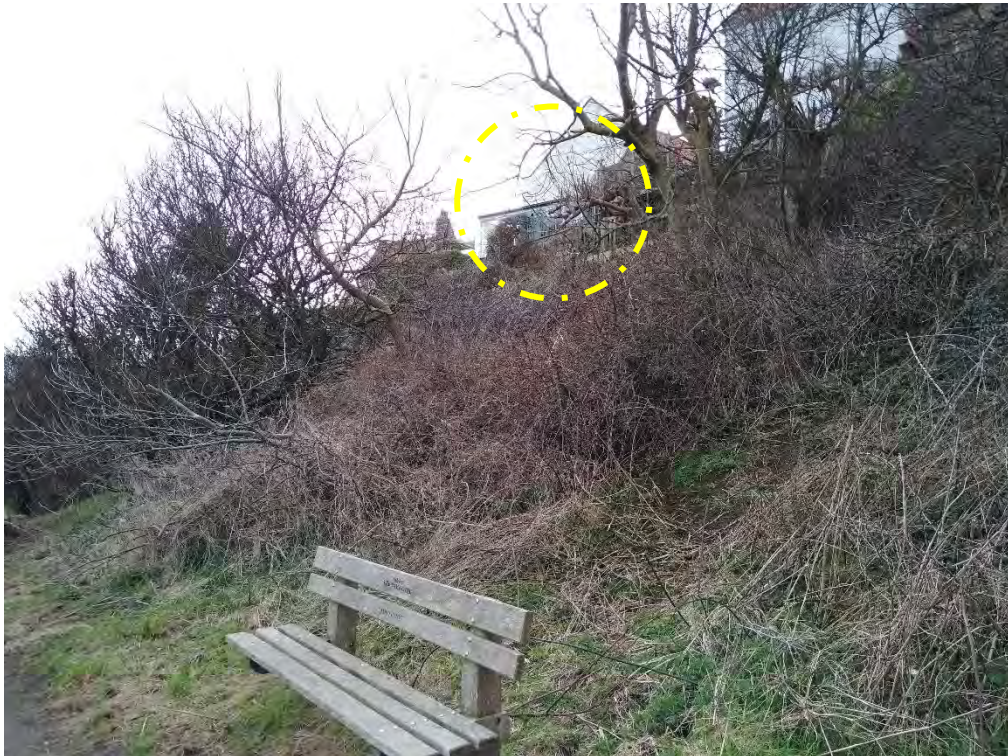
08 View from bottom of coastal slope looking towards the east elevation of Cliff House.

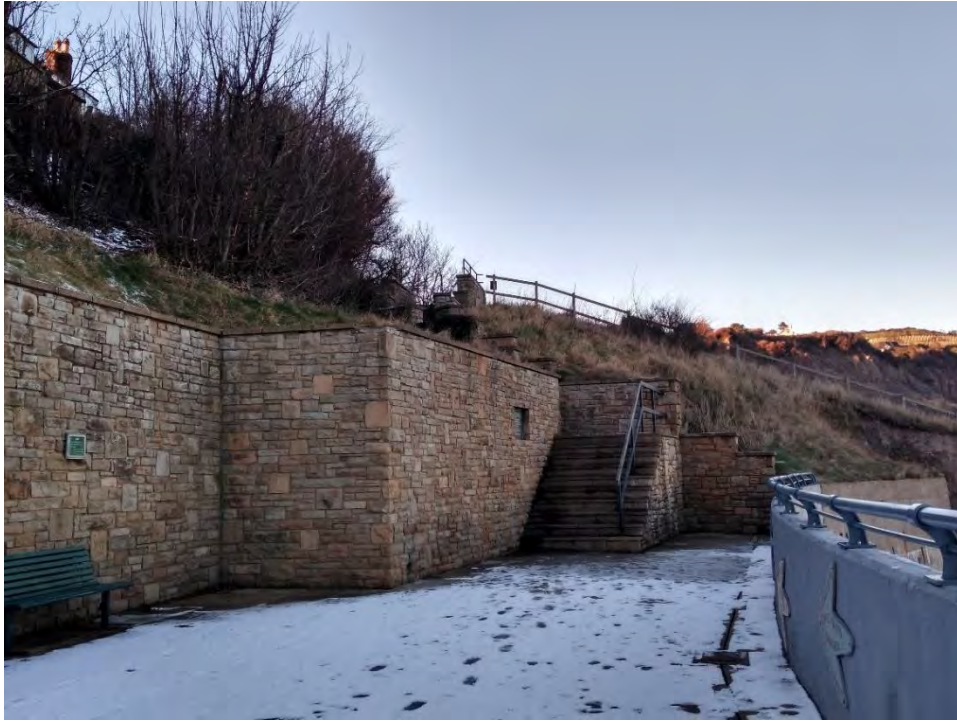
09 View of the stepped access from the coastal slope footpath on to the sea wall (north end).

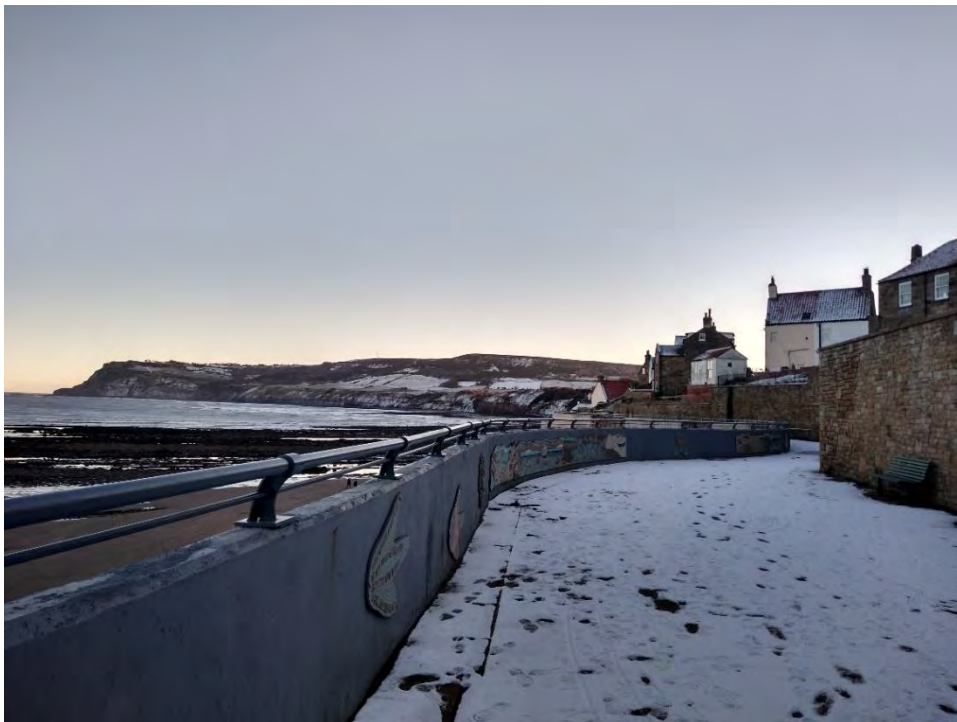
10 View looking south along sea wall. No vehicle access.
