Contracting & Consulting Arborists

Your Ref March 2022

Our Ref Egton Yo211UT

Arboricultural survey on Highway Trees adjacent to the public footpath and roadway

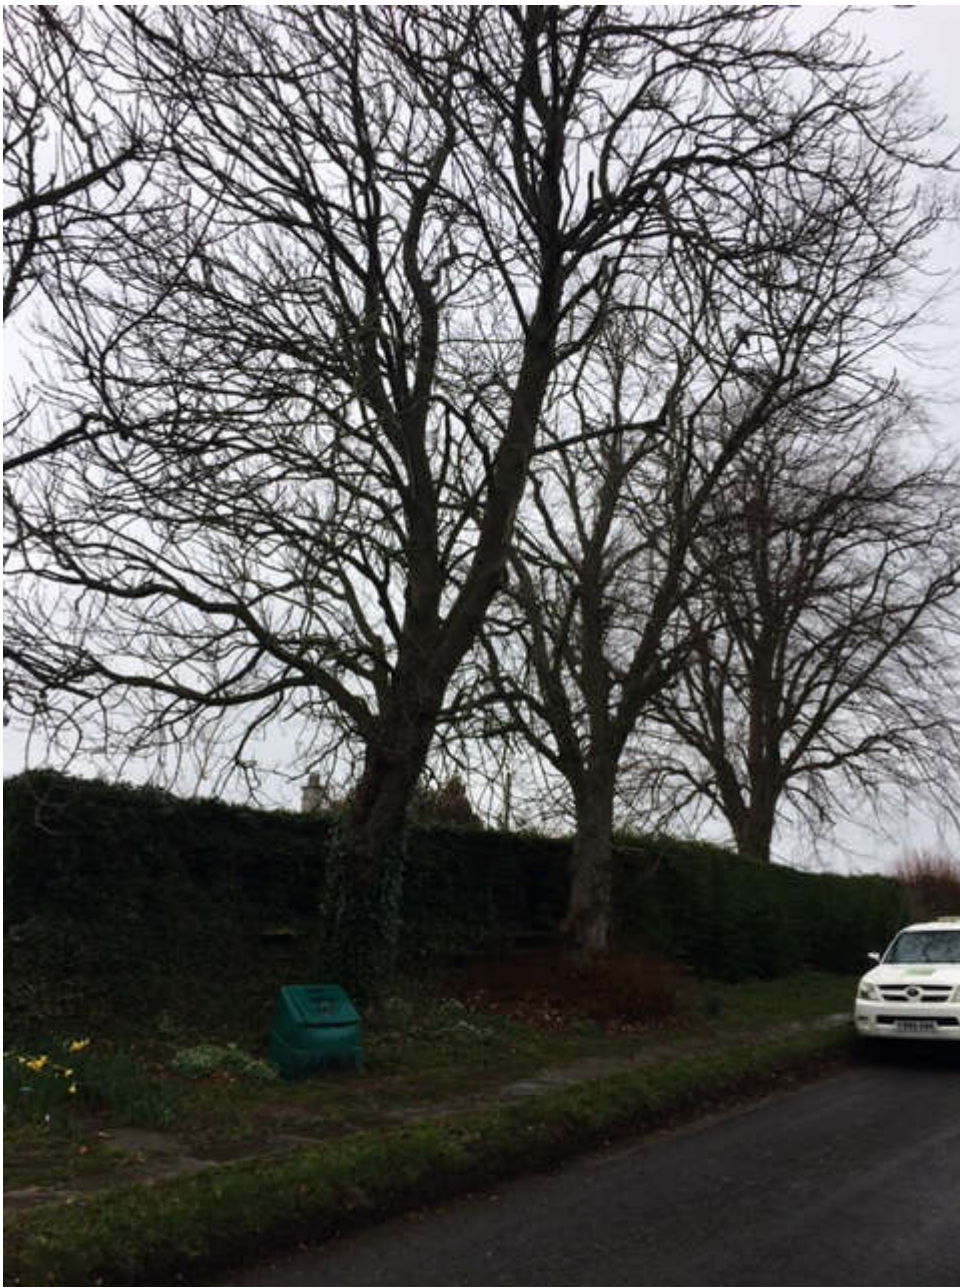
- T3 Horse chestnut 12m S/Mature leaning form Dysfunction Fungii & Galls **REMOVE TREE & Grind Stump**
- T4 Lime S/mature 14m **Crown lift and basal cut back epicormic growth**
