elliottconsultancy ltd.
arboricultural consultants

Location:
**Woodleigh House
Main Road
Aislaby**

Survey Type:
Arboricultural Survey

Ref:
ARB/AE/2543

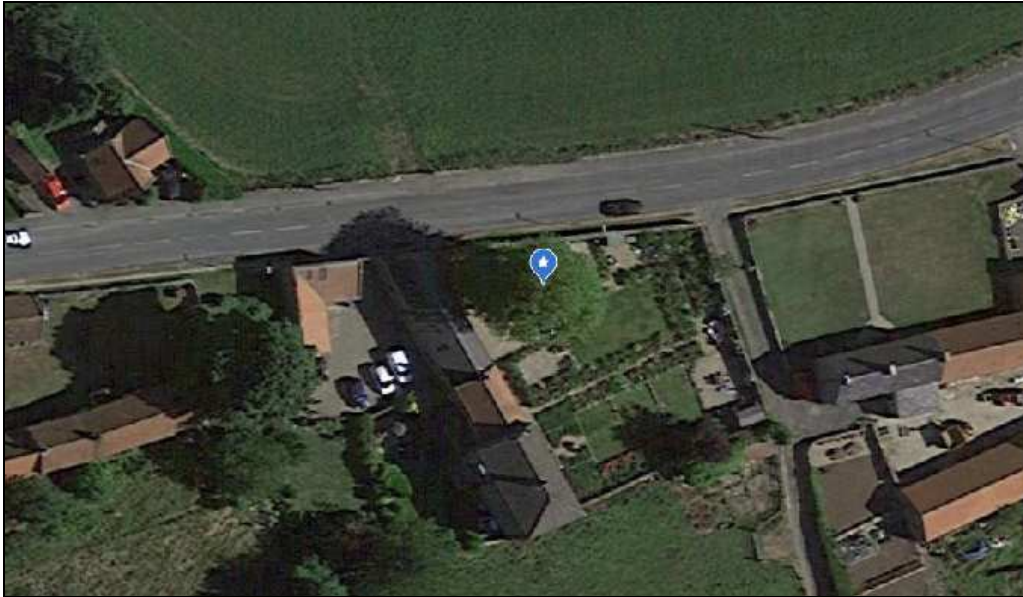
Figure 1: Tree location.

2.1 The tree is located within the front garden of the property, immediately adjacent to the public highway. Figure 1 shows the trees location:
