## DESIGN AND ACCESS STATEMENT

### Proposals for internal plaster repairs.

### THE OLD CHURCH OF ST STEPHEN FYLINGDALES NORTH YORKSHIRE

May 2018

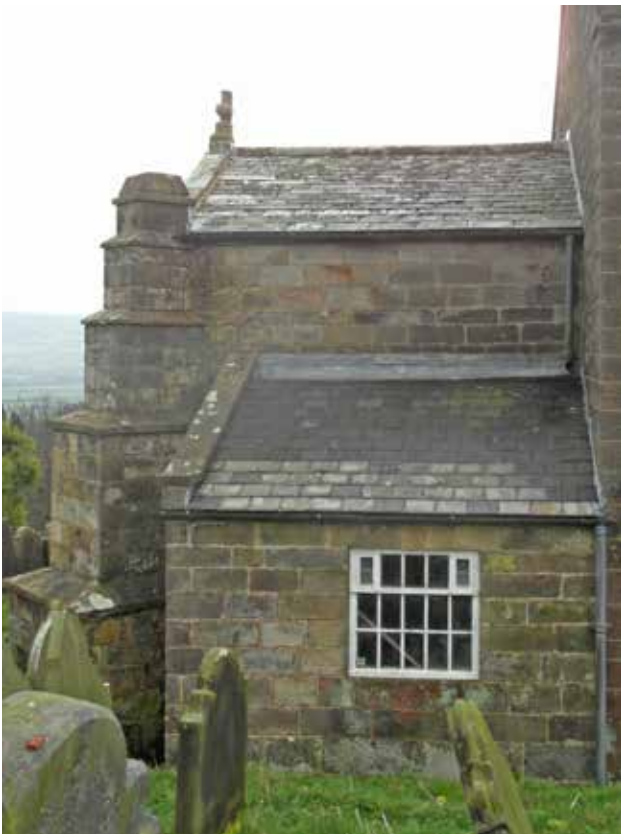
Vestry north side.

A retaining wall on the north side keeps the higher ground level away from the wall but the ground appears to abut the east wall.

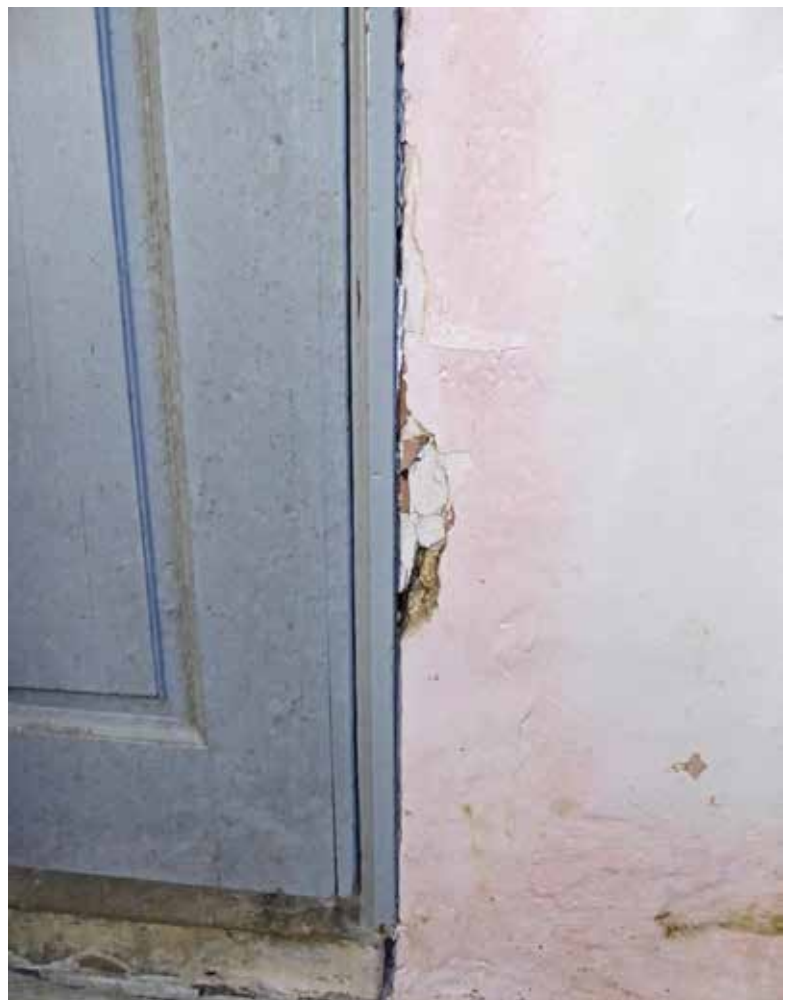
Chancel north wall.  
Plaster has failed to the side of the vestry door,  
on the east side a gypsum plaster repair has  
previously been carried out and this is now  
failing.

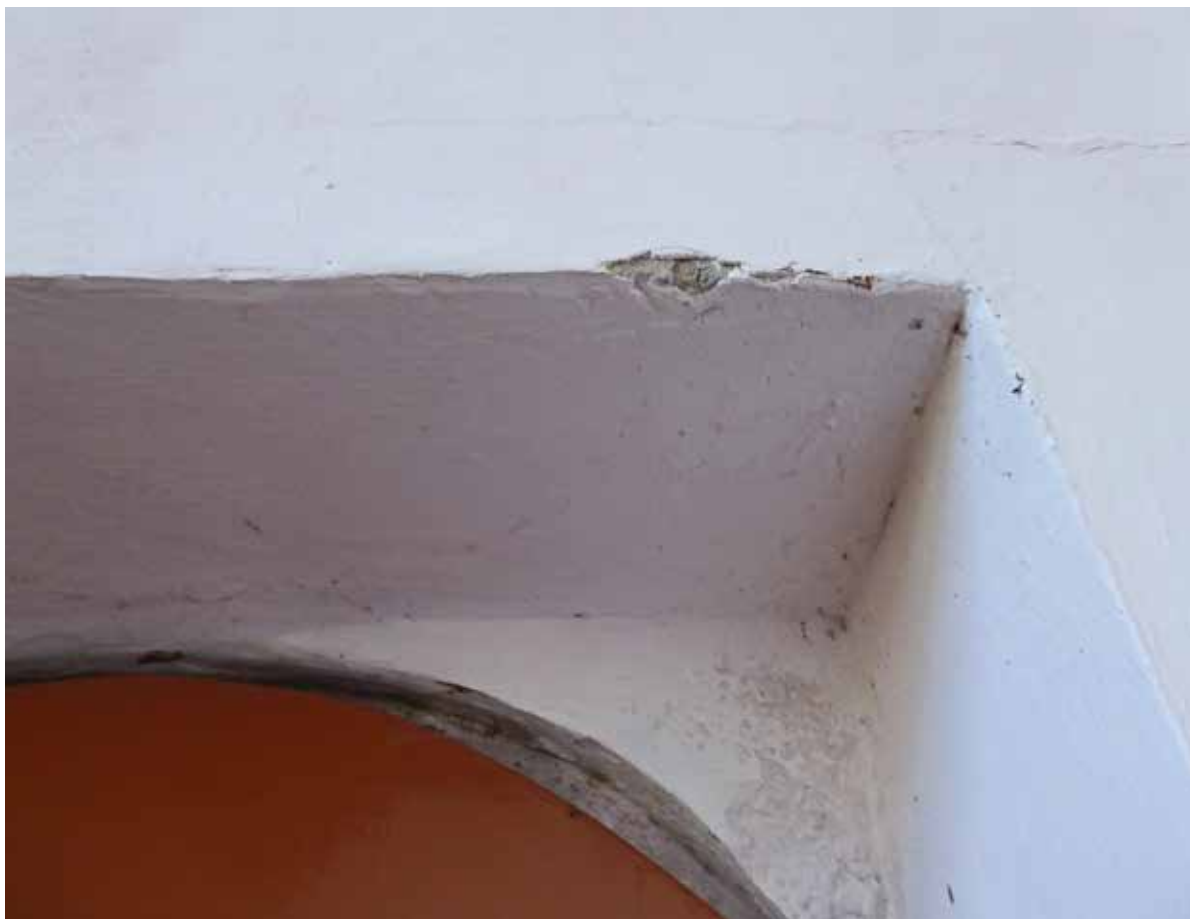
South chancel door.  
Much of the plaster around this door  
appears to have been replaced with a  
hard cement render.
