**STRUCTURAL REPORT
ON
BARNs AT
BEACON FARM
BEACON BROW ROAD
SCALBY
YO13 0PQ**

MCB/SLB/42192 Rpt001

**STRUCTURAL REPORT ON BEACON FARM, BEACON BROW ROAD,
SCALBY, YO13 OPQ**

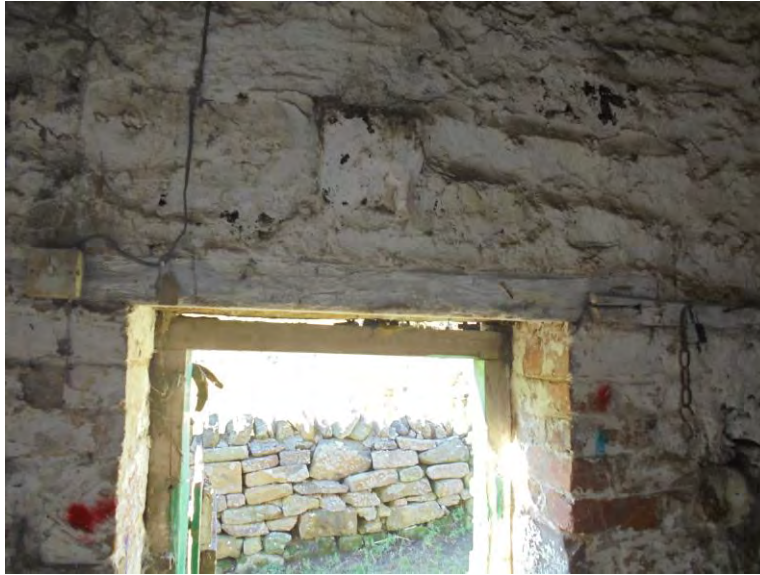
Photograph No. 25

- 3.15 The barn is separated into three sections by two brickwork spine walls from front to rear. Stone floors are present throughout. Floor levels step to each section.
- 3.16 The corner wall of the West end gable section is in a bad condition. Mortar joints are receded and previous repairs attempted. (See photo 24)
- 3.17 The timber lintel in the West end gable section above doorway is overloaded. (See photo 25)
- 3.18 The timber lintel in the West end gable section above the troughs is overloaded. (See photo 26)
